VIRGINIA ELECTRIC AND POWER COMPANY
RICHMOND, VIRGINIA 23261

VIRGINIA ELECTRIC AND POWER COMPANY (DOMINION)
NORTH ANNA POWER STATION UNITS 1 AND 2
NORTH ANNA INDEPENDENT SPENT FUEL STORAGE INSTALLATION
RESPONSE TO REQUEST FOR ADDITIONAL INFORMATION (RAI)
RESTART READINESS DETERMINATION PLAN

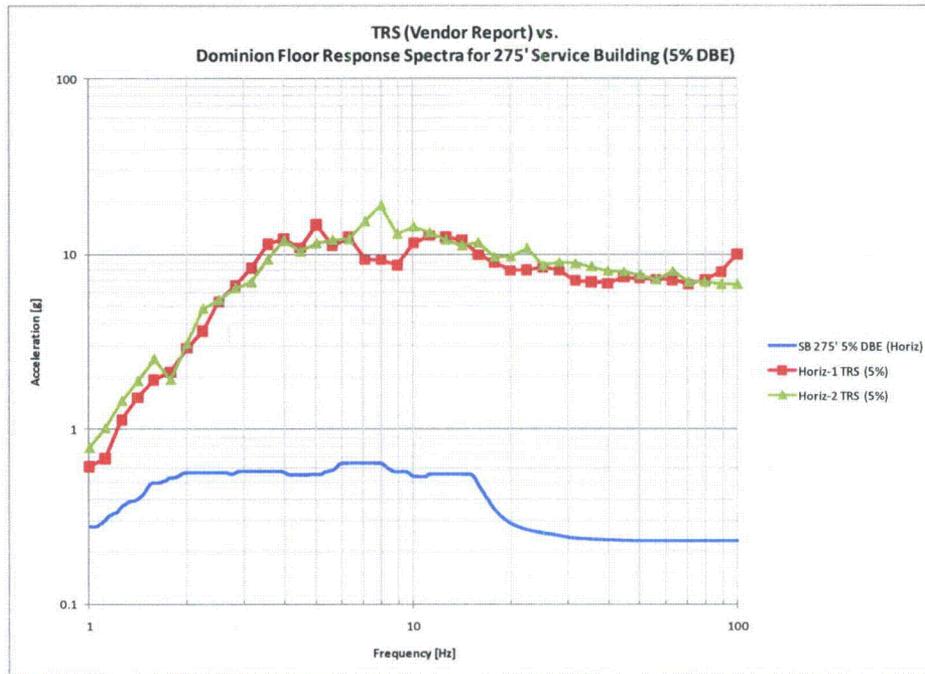
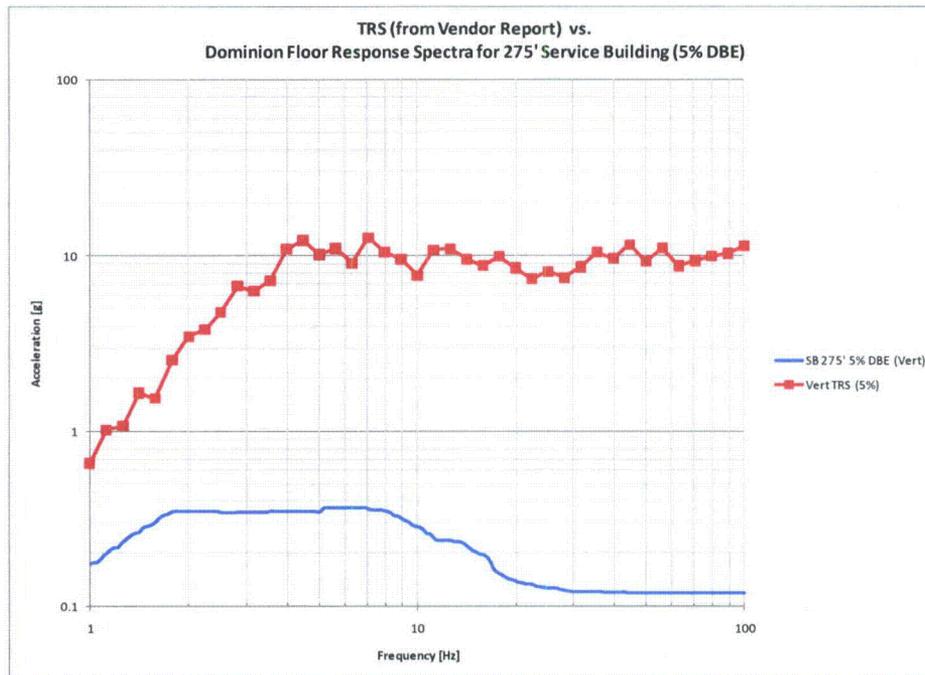
Figure 2 – EDG Battery Charger (Horizontal Comparison)

Figure 3 – EDG Battery Charger (Vertical Comparison)

The EDG battery charger (with a Lambda EMI filter) was seismically qualified in accordance with IEEE Std. 344-1975 to the generic SQRSTS Floor Levels, which envelop the spectra at the installed location of this charger with margin. As shown in Figures 2 and 3, the TRS significantly exceeds the site specific RRS with copious margin. No anomalies attributed to seismic concerns were identified during the test and the unit was qualified.

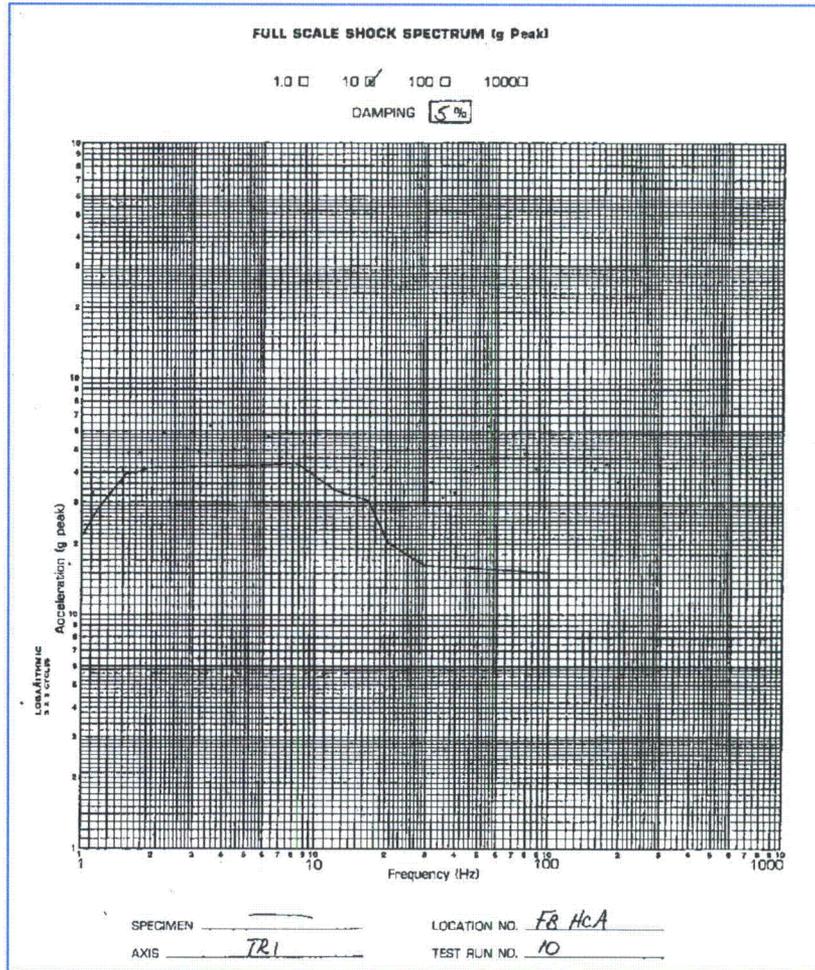
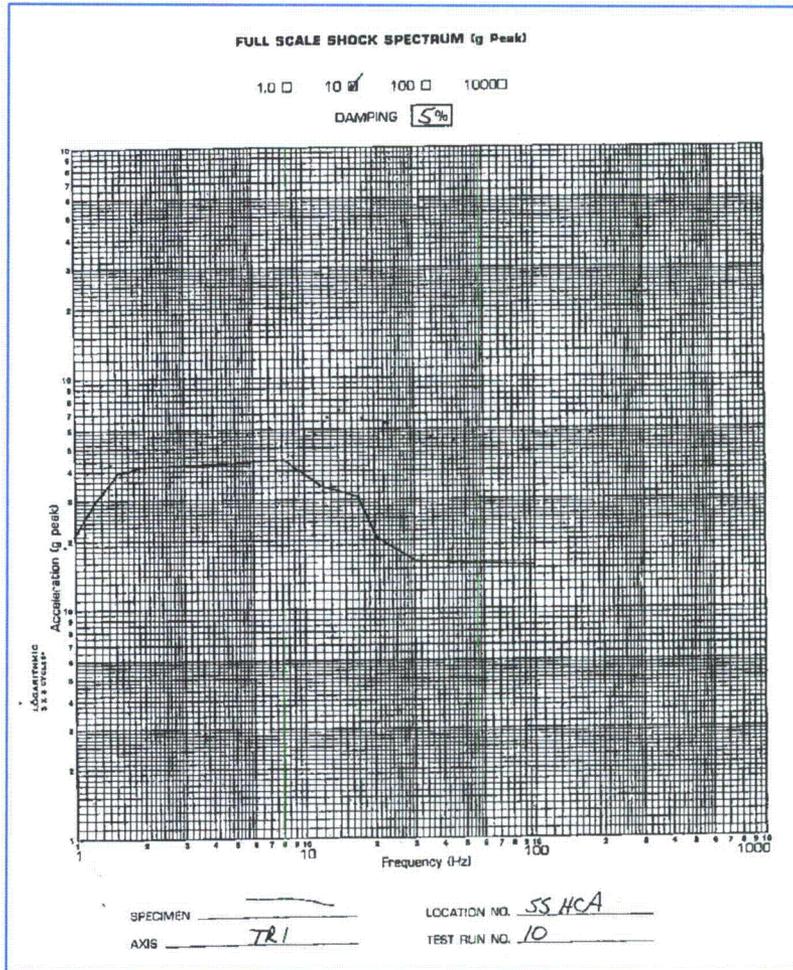
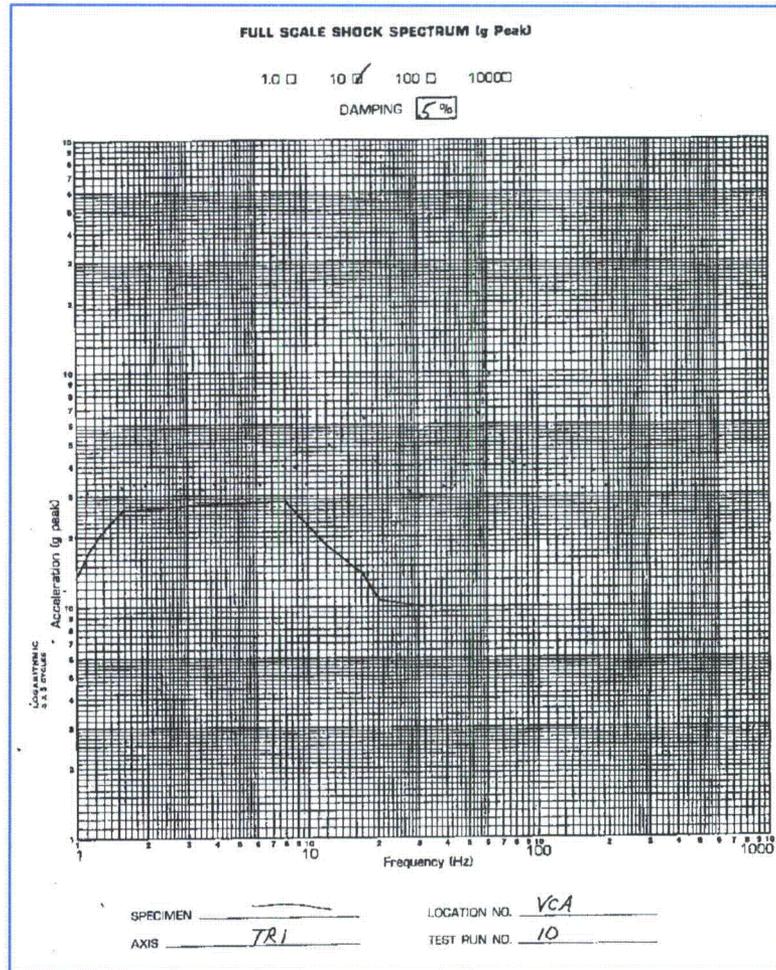
Figure 4 – Inverter (Front-to-Back)

Figure 5 – Inverter (Side-to-Side)

Figure 6 – Inverter (Vertical)

Std. 344-1987. The 15 KVA unit was qualified by the same vendor by analysis based on its similarity with the 20 KVA unit. Test results from the table control accelerometers (shown in Figures 4, 5, and 6) for the 20 KVA bus show additional margins for higher seismic demand.

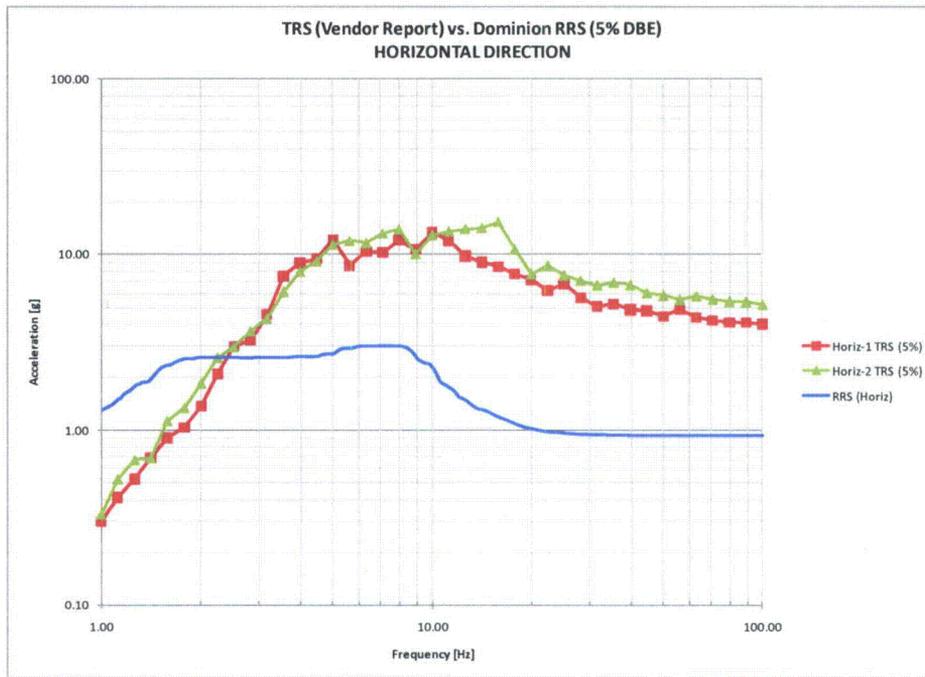
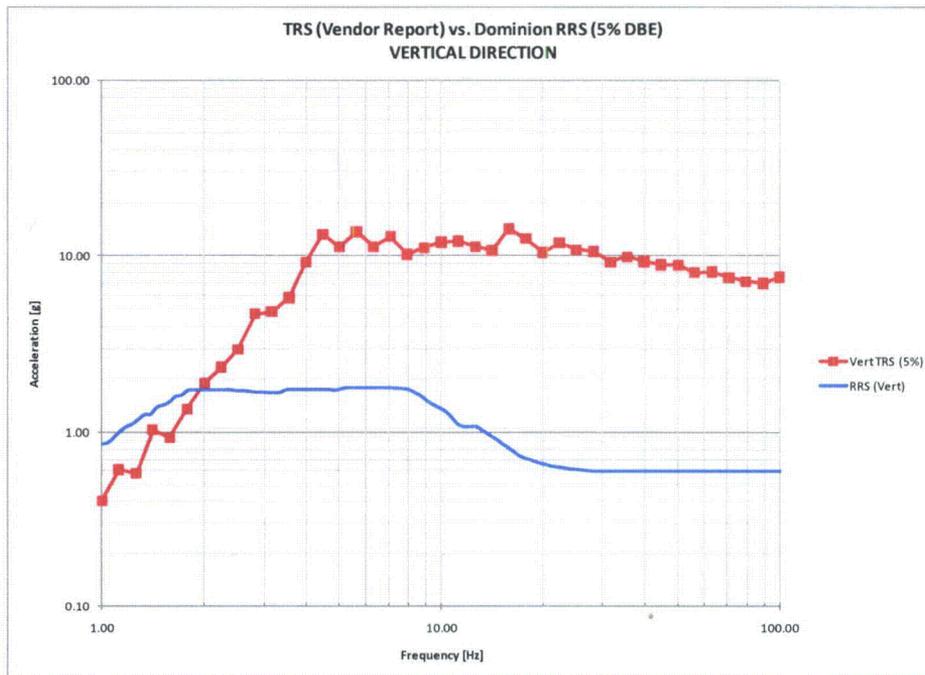
Figure 7 – ARD Relay (Horizontal)

Figure 8 – ARD Relay (Vertical)

This relay has been qualified per IEEE Std. 344 – 1975 to fragility levels well in excess of Dominion required design levels, as shown in the comparison plots in Figures 7 and 8. The SQRSTS Qualification Report documents that the relay was qualified to the levels without any measured contact chatter in excess of 2 milliseconds. It is noted that the TRS does not envelop the RRS below approximately 2.5 Hz, but this is acceptable per IEEE Standard 344.

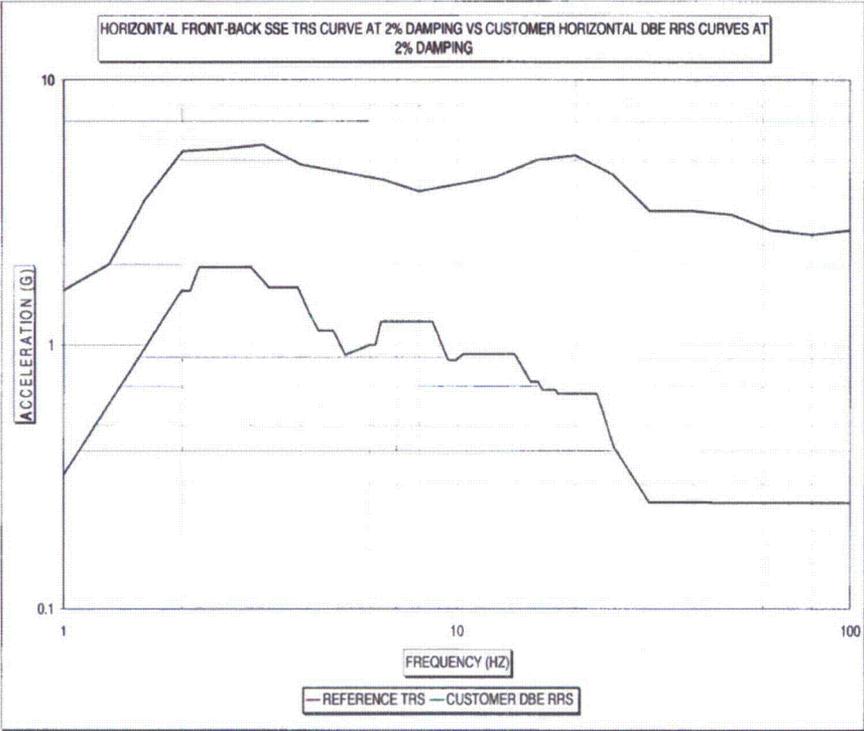
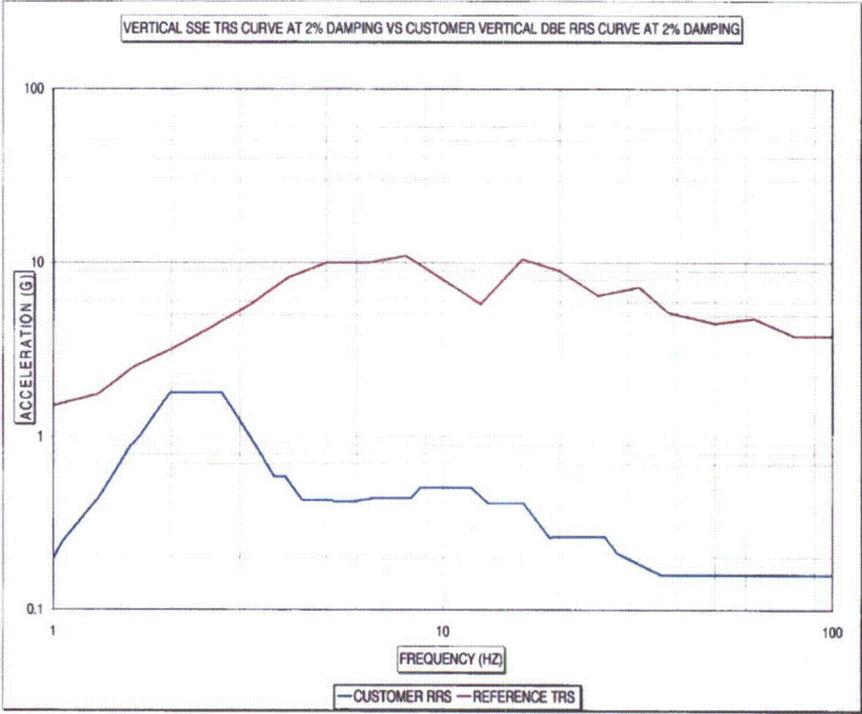
Figure 9 – ABB Transformer (Front-to-Back, Controlling Orientation)

Figure 10 – ABB Transformer (Vertical)

North Anna Unit 2 480V Emergency Switchgear 2J Transformer (2-EE-ST-2J), which is located in the Unit 2 Emergency Switchgear and Relay Room (Service Building 254 feet elevation) was recently replaced. This transformer is seismically qualified by test, as documented in a Wyle labs test report provided for the replacement equipment. Comparison between the DBE RRS and the TRS indicates significant margin (Figures 9 and 10).

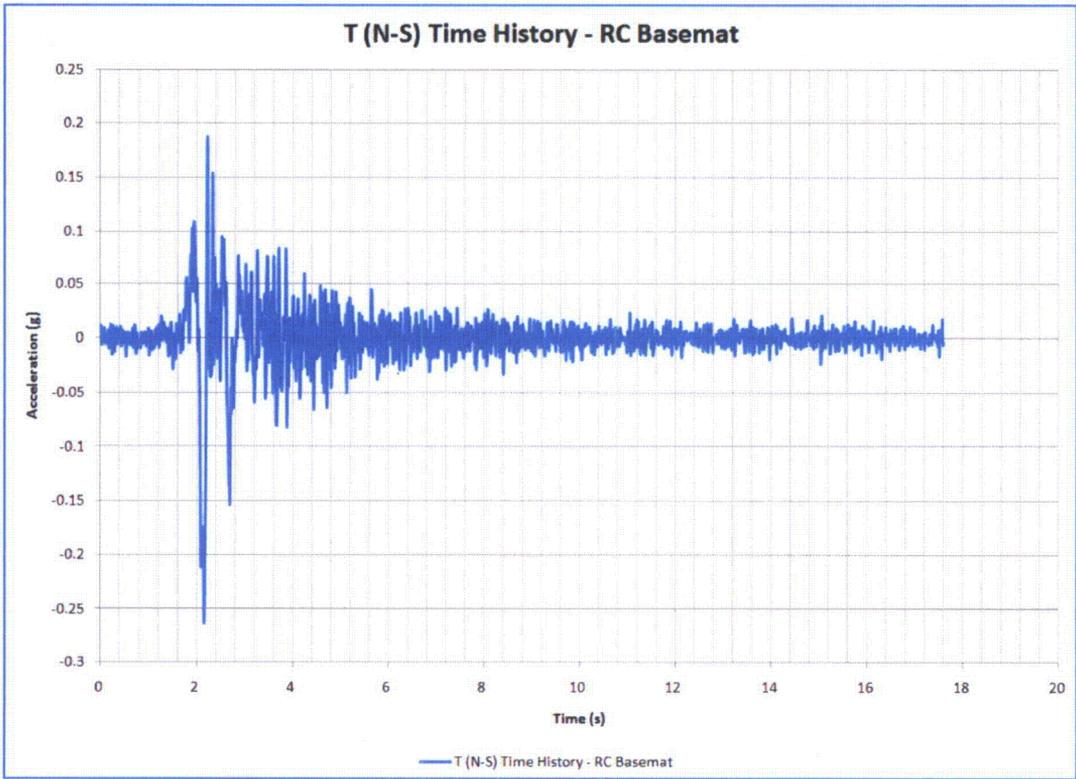
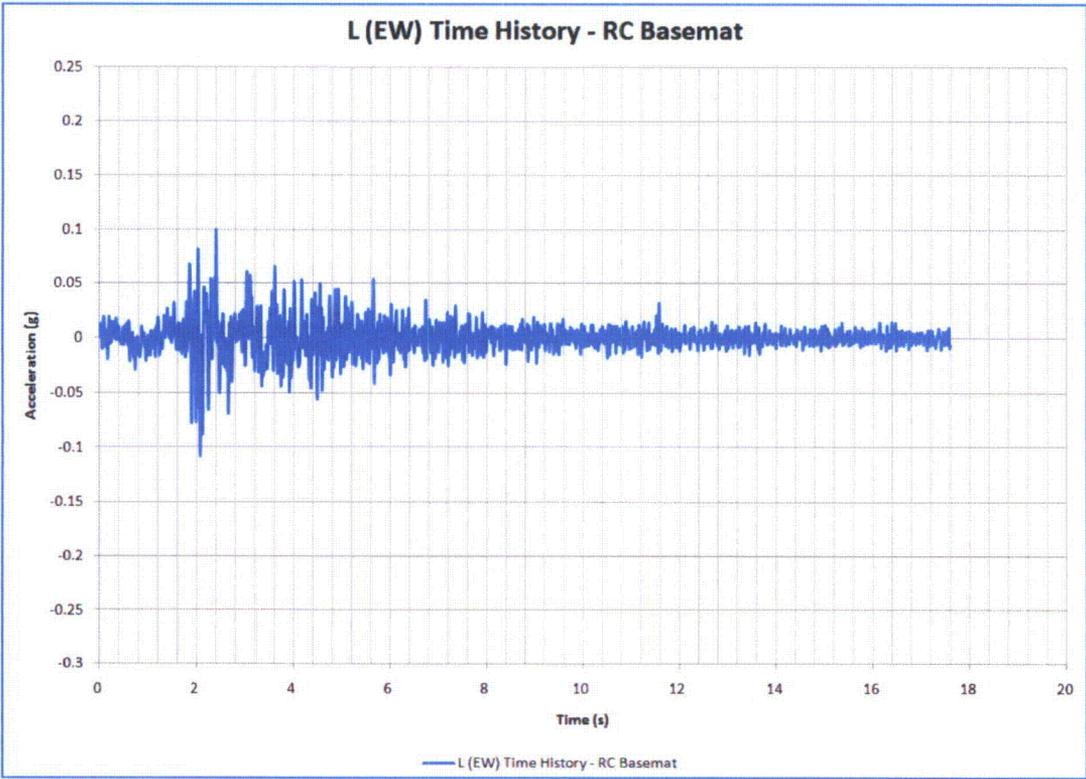
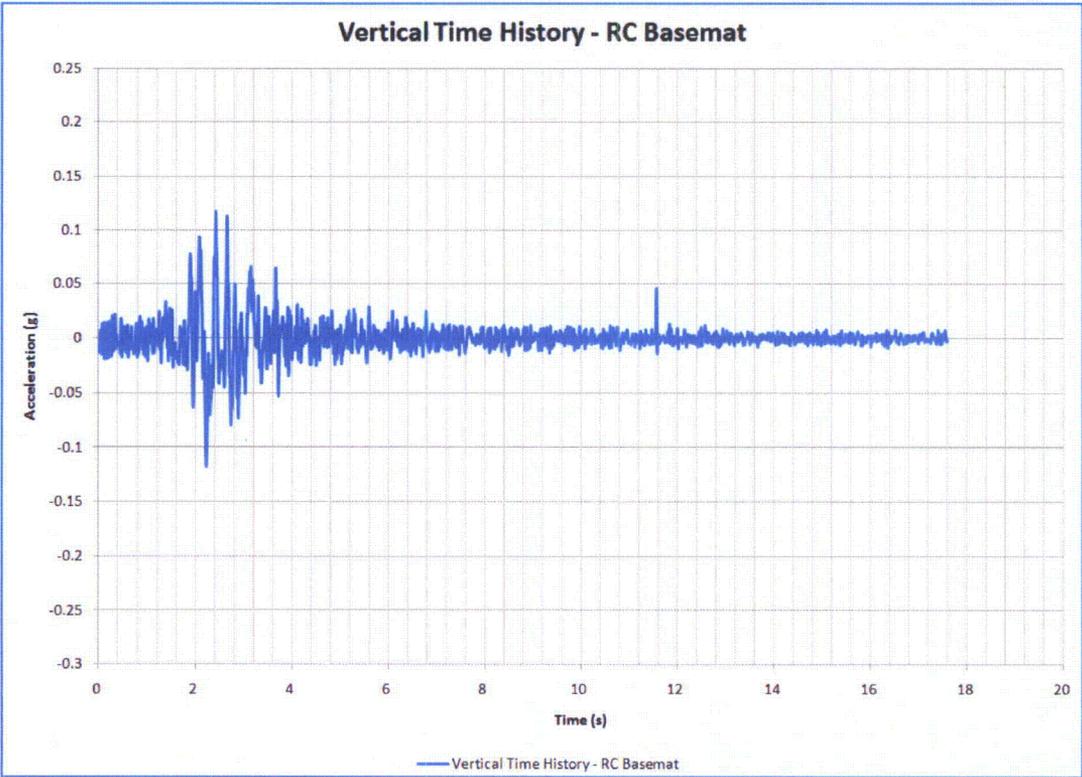
Figure 1 – Recorded Time-History, North-South Direction

Figure 2 – Recorded Time-History, East-West Direction

Figure 3 – Recorded Time-History, Vertical Direction

The time-histories of the recorded earthquake at the Containment basemat for the entire duration of earthquake including the strong motion portion were used in the calculation of the CAV values. The three orthogonal, baseline corrected, time-histories from the August 23, 2011 at the Containment basemat are shown in Figures 1, 2, and 3. It is noted that although CAV is required to be calculated from free-field recorded motions, the Containment is rock founded and the design spectra at the top of the basemat are very close to the free-field DBE spectra in each of the three directions. Therefore, the development of CAV values from these time-histories is reasonable; this was also the conclusion of independent consultants. The CAV values for the August 23, 2011 event were calculated by three independent consultants and each of them calculated about the same values. The average CAV values from the three consultants in each of the three directions are presented in Table 1.

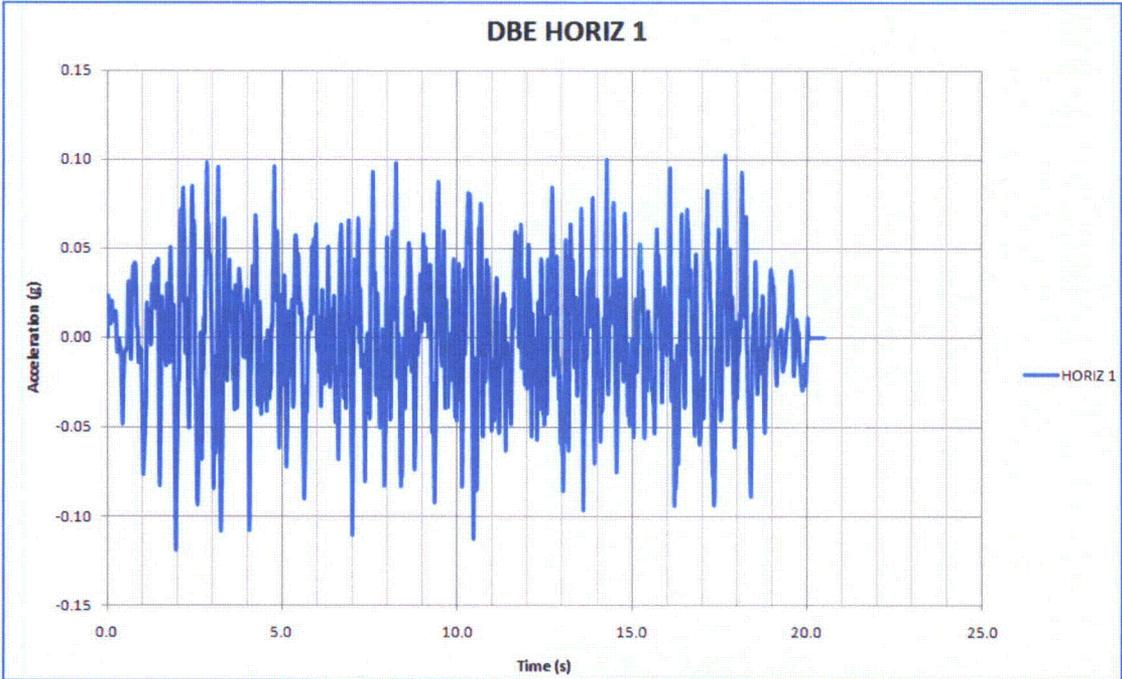
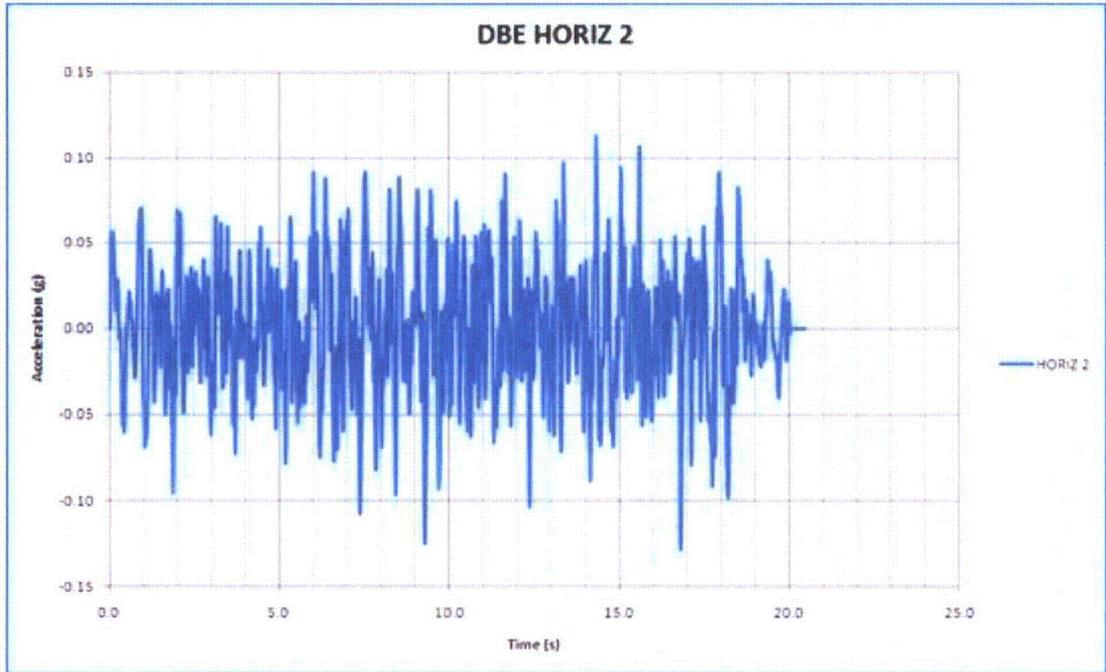
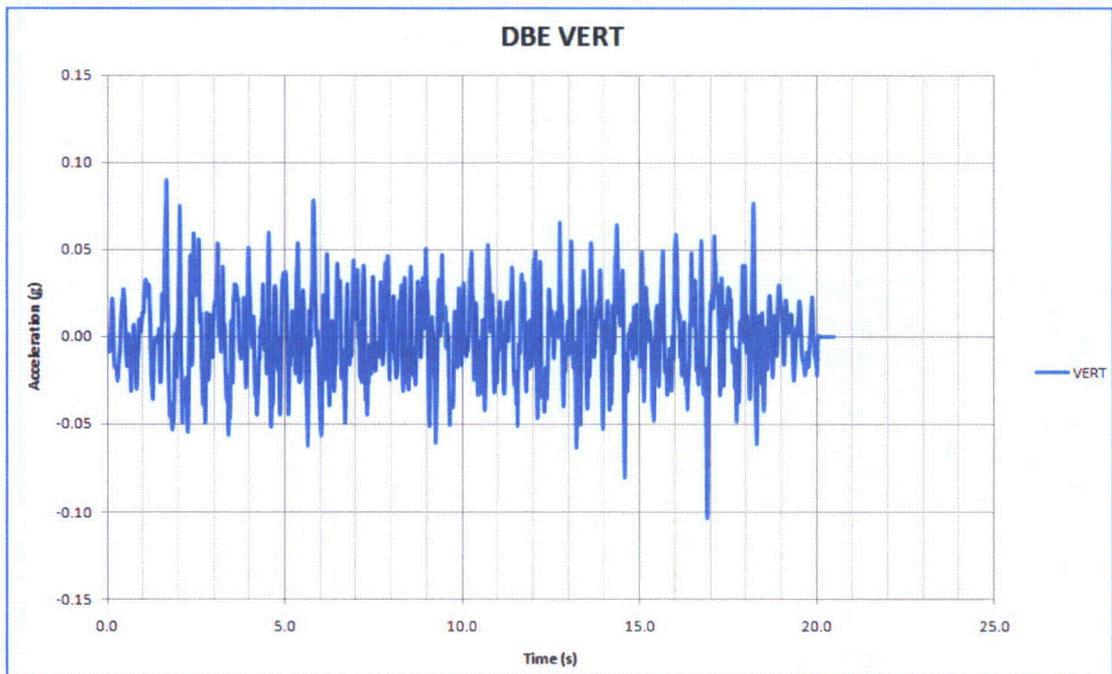
Figure 4 – DBE Synthetic Time-History, Horizontal Direction 1

Figure 5 – DBE Synthetic Time-History, Horizontal Direction 2

Figure 6 – DBE Synthetic Time-History, Vertical Direction

Dominion reviewed the DBE synthetic time-histories that were used in an analysis of the North Anna Reactor Containment structure. These time-histories, shown in Figures 4, 5 and 6, and calculated using a Fast-Fourier Transform (FFT) subroutine, are of 20 seconds duration each including rise and decay durations such that the strong motion duration would be at least 15 seconds and the time-histories would have stationarity. The response spectra from the synthetic time-histories closely matched the target spectra for each case, as shown in Figures 7, 8, and 9. The three orthogonal time-histories were not correlated and were calculated using a different random seed. It is noted that the time-histories that are typically used to determine shake-table motions for random, multi-frequency, multi-axis seismic testing of equipment are typically of 30 seconds duration and testing is performed to simulate five OBE and one DBE events.

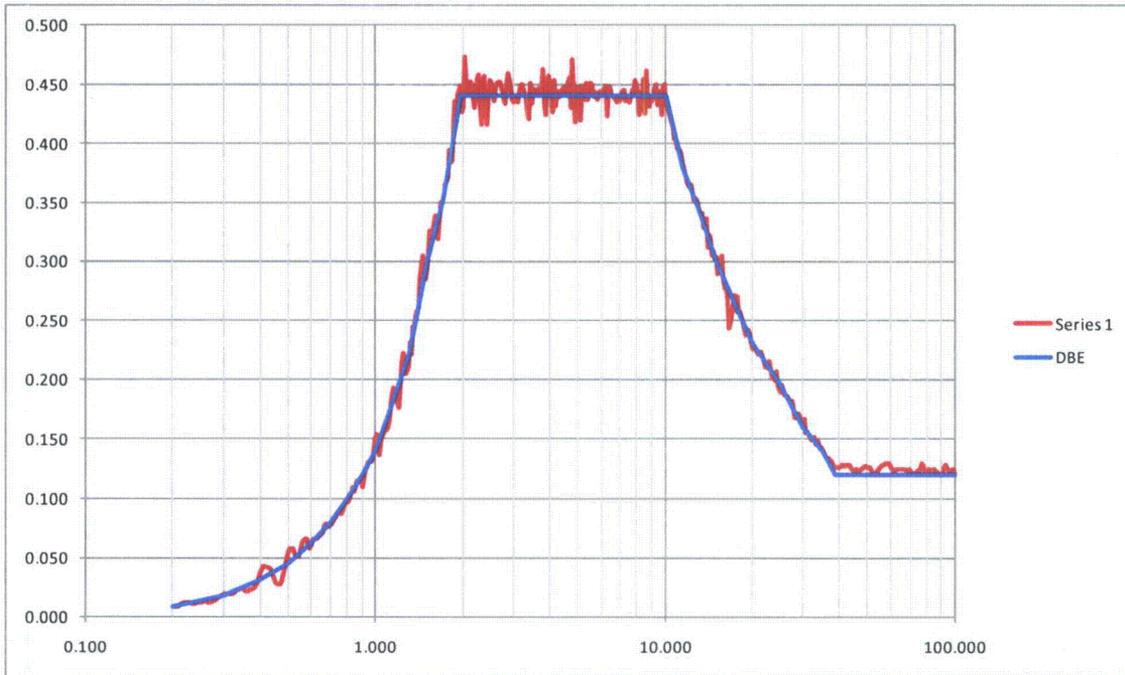
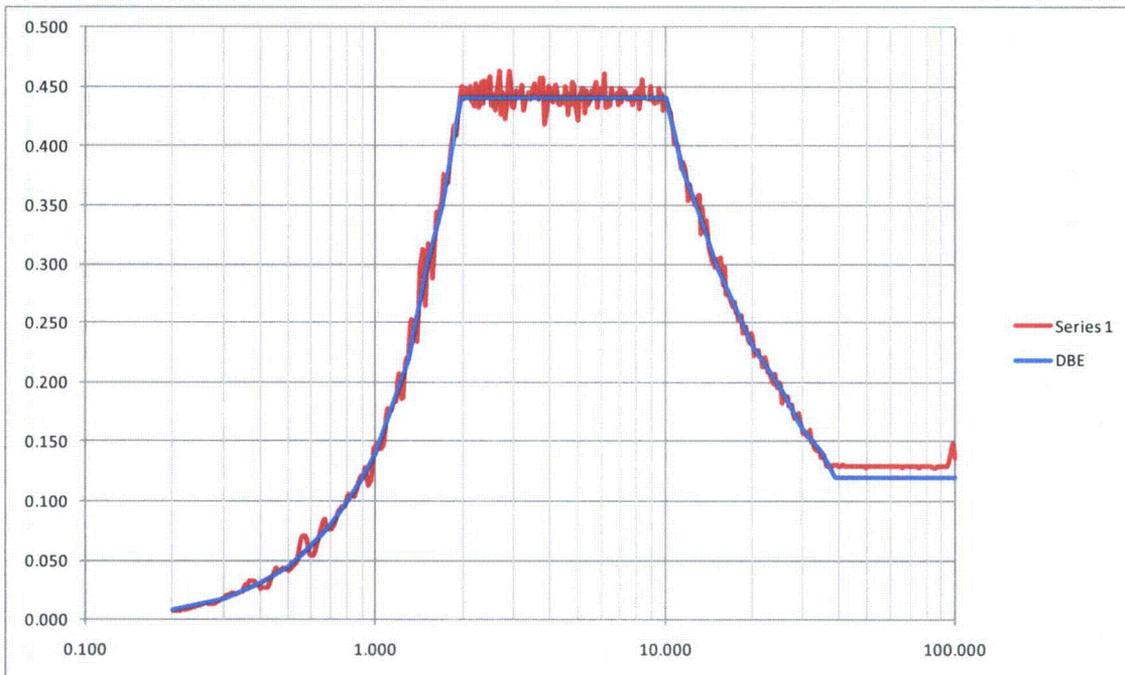
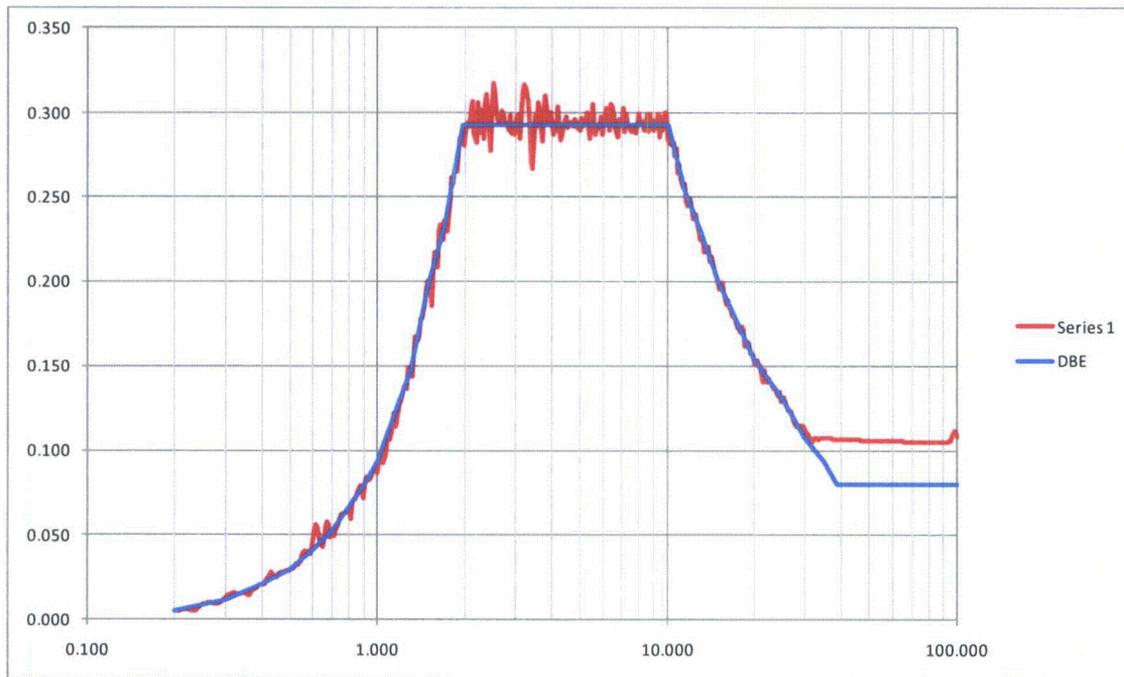
Figure 7 – Spectrum Comparison, DBE (5%) vs. Spectrum Created from Synthetic Time-History, Horizontal Direction 1

Figure 8 – Spectrum Comparison, DBE (5%) vs. Spectrum Created from Synthetic Time-History, Horizontal Direction 2

Figure 9 – Spectrum Comparison, DBE (5%) vs. Spectrum Created from Synthetic Time-History, Vertical Direction

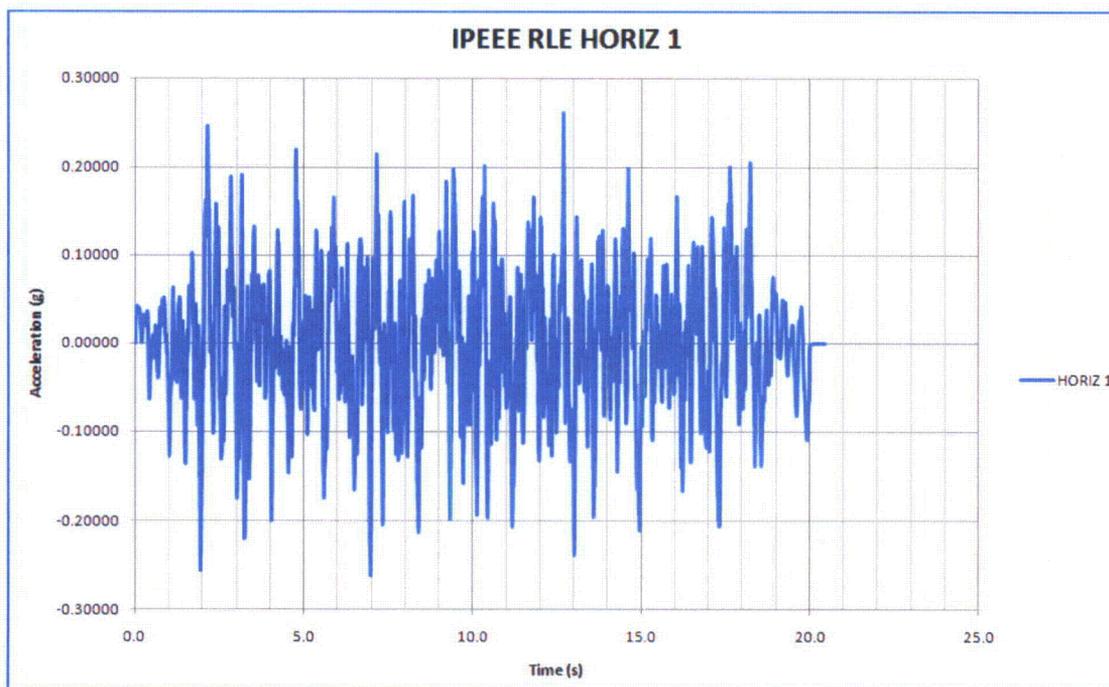
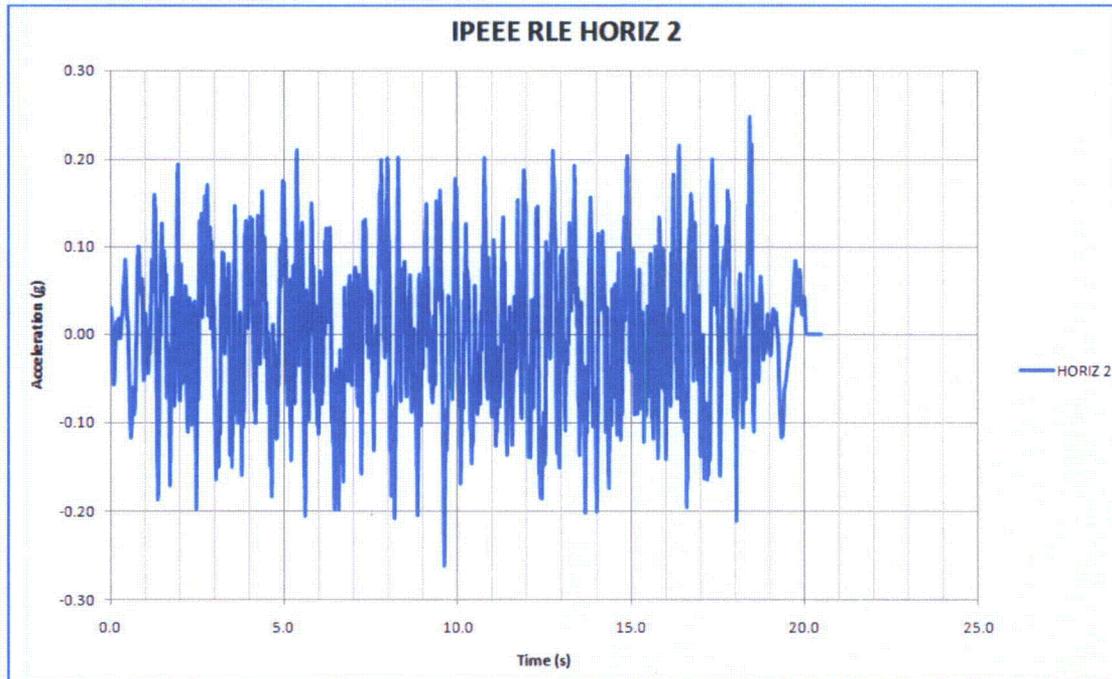
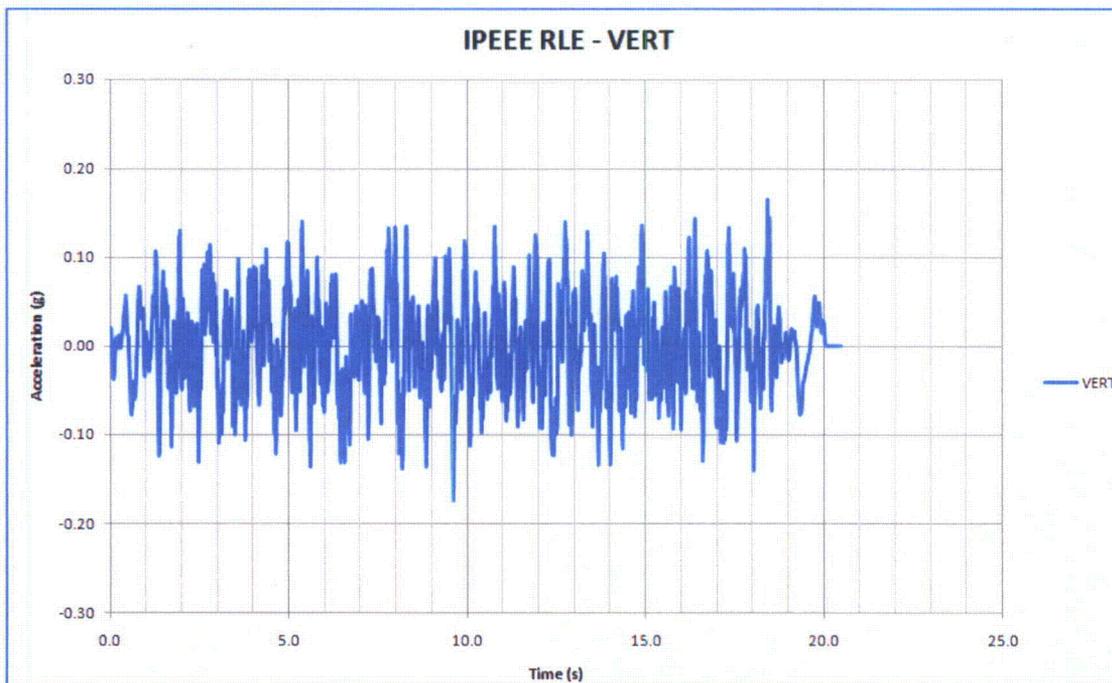
Figure 10 – IPEEE RLE Synthetic Time-History, Horizontal Direction 1

Figure 11 – IPEEE RLE Synthetic Time-History, Horizontal Direction 2

Figure 12 – IPEEE RLE Synthetic Time-History, Vertical Direction

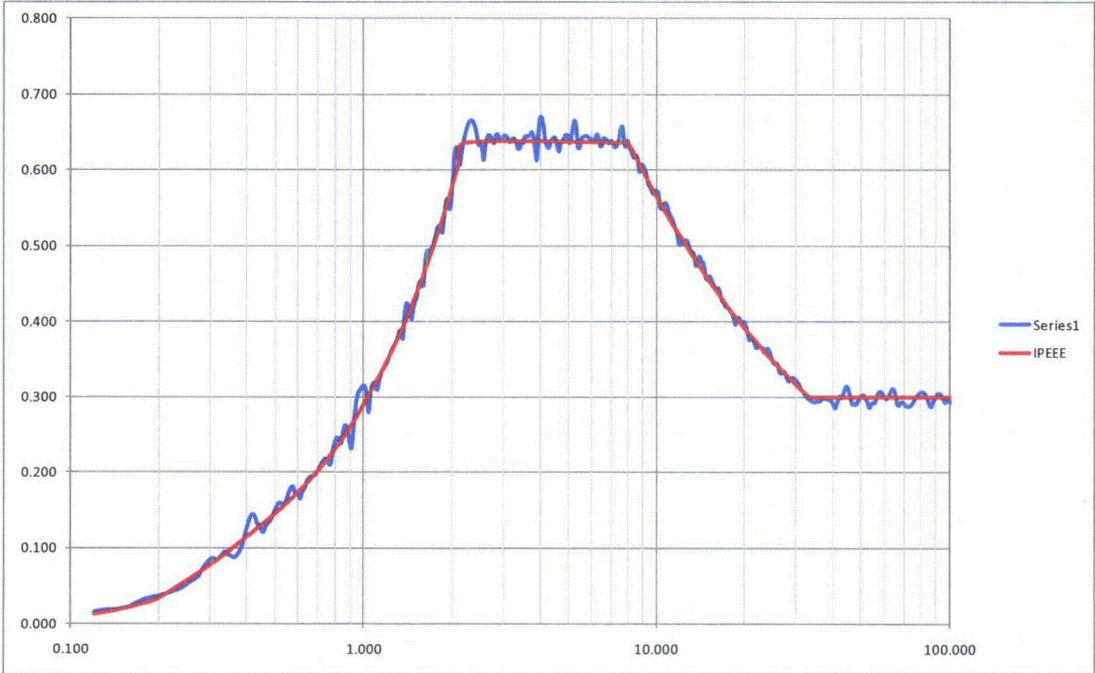
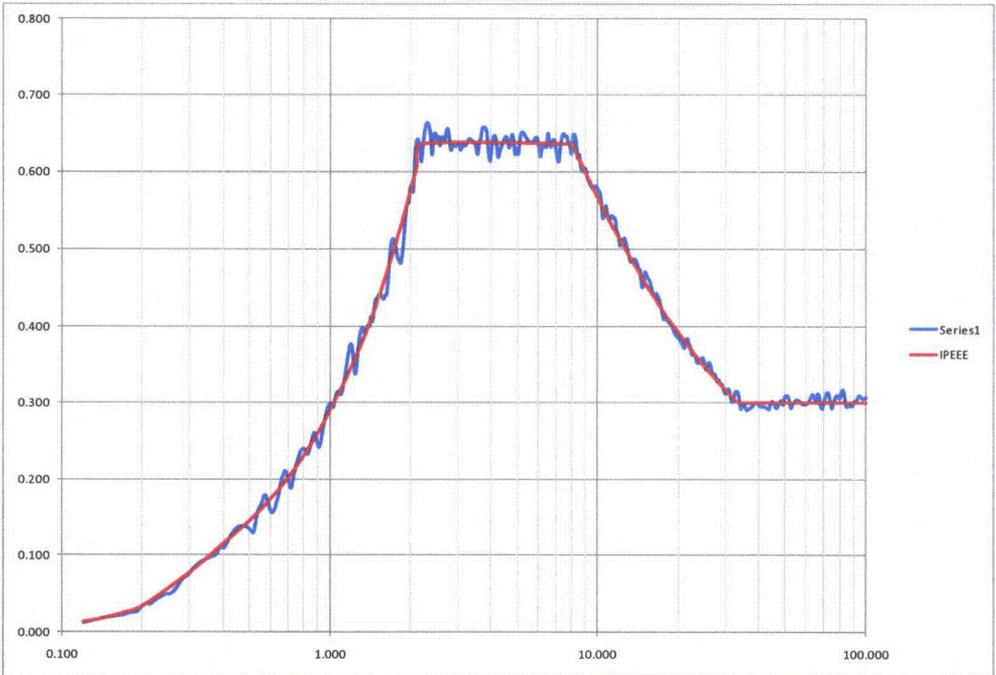
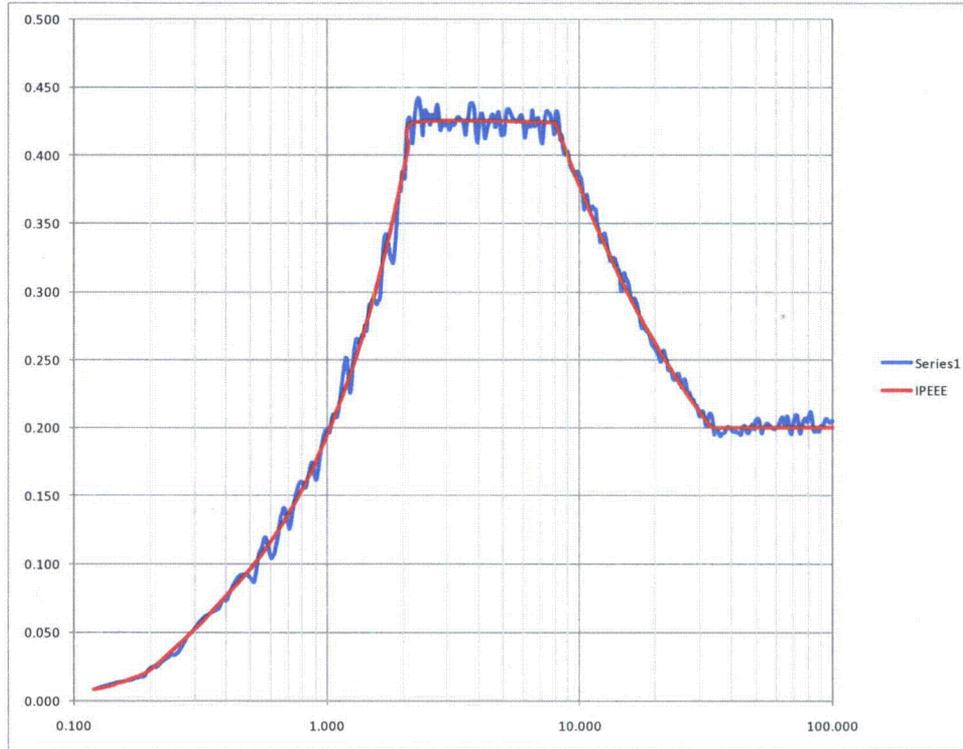
Figure 13 – Spectrum Comparison, IPEEE RLE (5%) vs. Spectrum Created from Synthetic Time-History, Horizontal Direction 1

Figure 14 – Spectrum Comparison, IPEEE RLE (5%) vs. Spectrum Created from Synthetic Time-History, Horizontal Direction 2

Figure 15 – Spectrum Comparison, IPEEE RLE (5%) vs. Spectrum Created from Synthetic Time-History, Vertical Direction

A dynamic analysis of the Containment was performed in the early 1990s for the RLE of IPEEE and it was difficult to retrieve the time-histories used at that time. Therefore, new synthetic time-histories, also of 20 seconds duration each, were developed using exactly the same approach as was done for the DBE. These time-histories are shown in Figures 10, 11, and 12. Comparisons of the response spectra from these time-histories to the target response spectra in the three directions are shown in Figures 13, 14 and 15. The CAV values from these time-histories are also shown in Table 1.

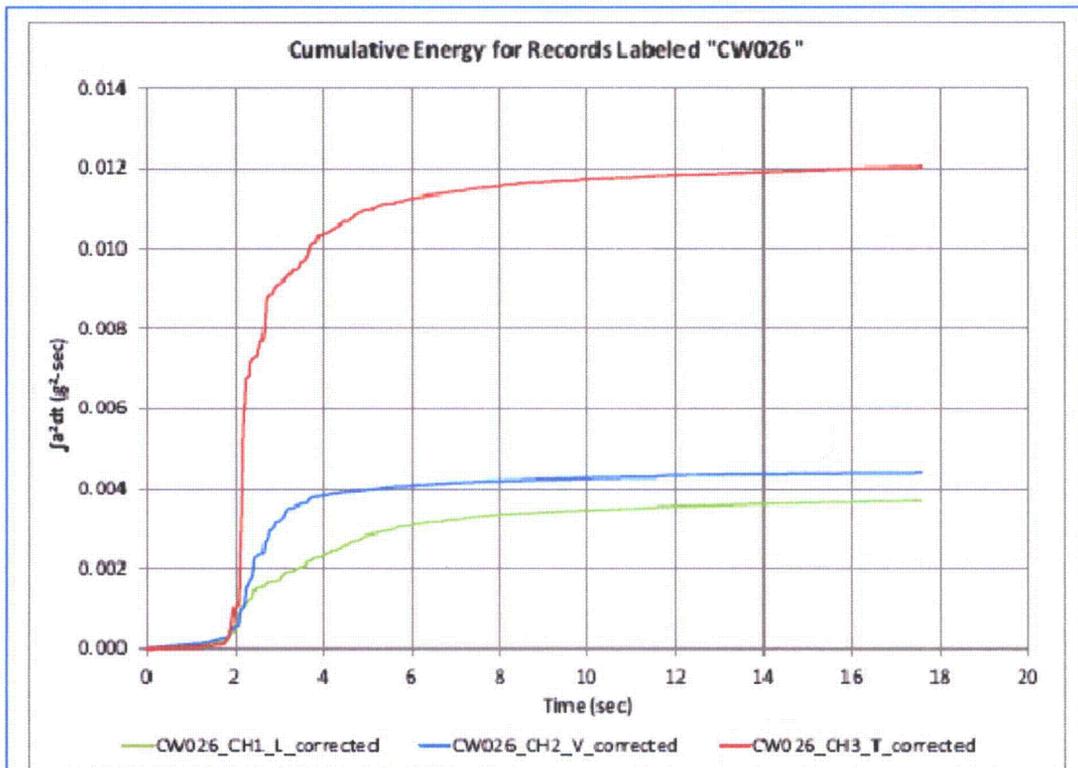
Figure 11 – Cumulative Energy (Reference NUREG/CR-3805) for the Containment Basemat Records

The cumulative energy calculations (Husid plots) from the Containment basemat time-history data show that the effective strong motion durations were very short. The effective strong motion duration was calculated following Equations 2-2 and 2-3 of NUREG/CR-3805. In accordance with the NUREG, the effective strong motion duration is defined as the duration between the times associated with 5% and 75% of the total cumulative energy. Based on the calculations (see below), in the East-West direction the effective strong motion duration was 3.1 seconds, in the vertical direction it was 1.5 seconds, and in the North-South direction it was 1.0 second. Along with the CAV, the short duration of effective strong motion is another indicator of the low damage potential of the August 23, 2011 earthquake.
