VIRGINIA ELECTRIC AND POWER COMPANY
RICHMOND, VIRGINIA 23261

VIRGINIA ELECTRIC AND POWER COMPANY (DOMINION)
NORTH ANNA POWER STATION UNITS 1 AND 2
NORTH ANNA INDEPENDENT SPENT FUEL STORAGE INSTALLATION
RESPONSE TO REQUEST FOR ADDITIONAL INFORMATION (RAI)
RESTART READINESS DETERMINATION PLAN

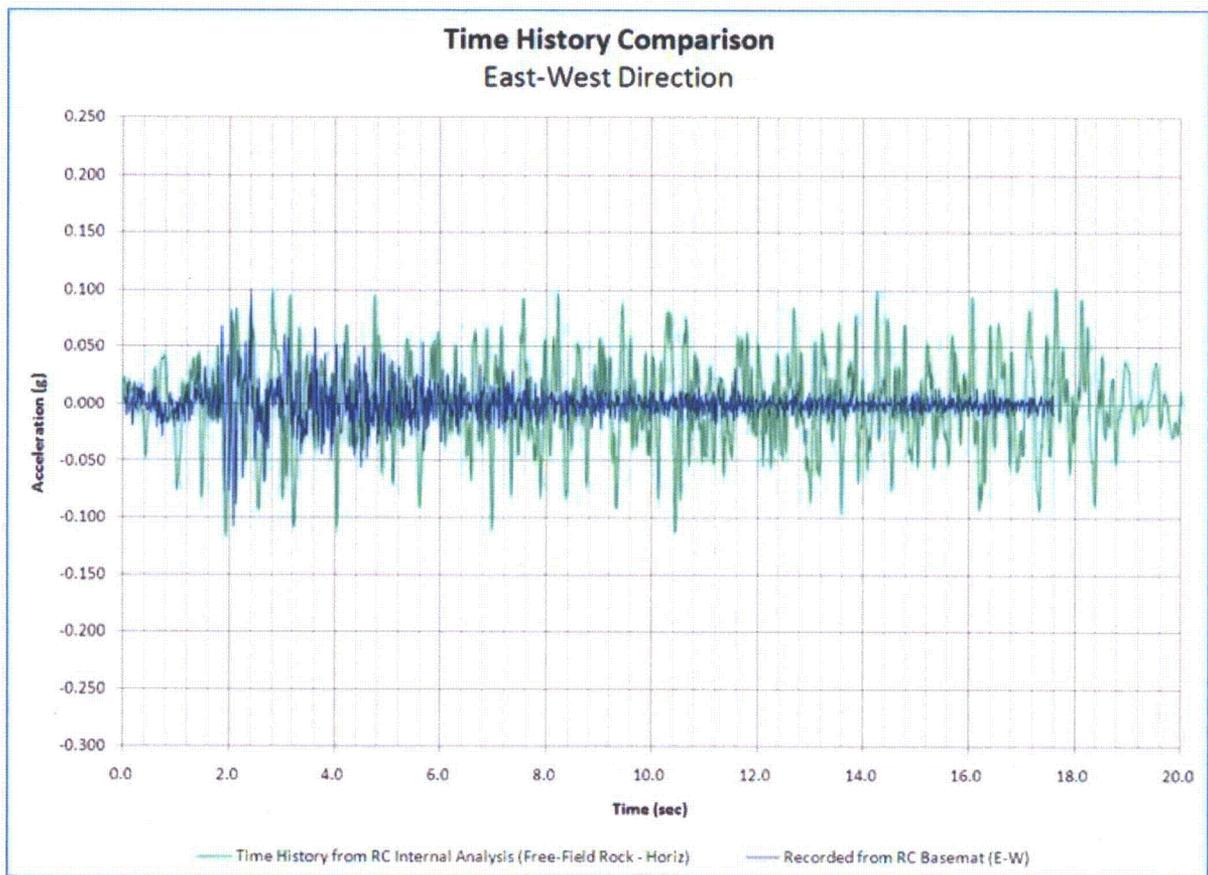
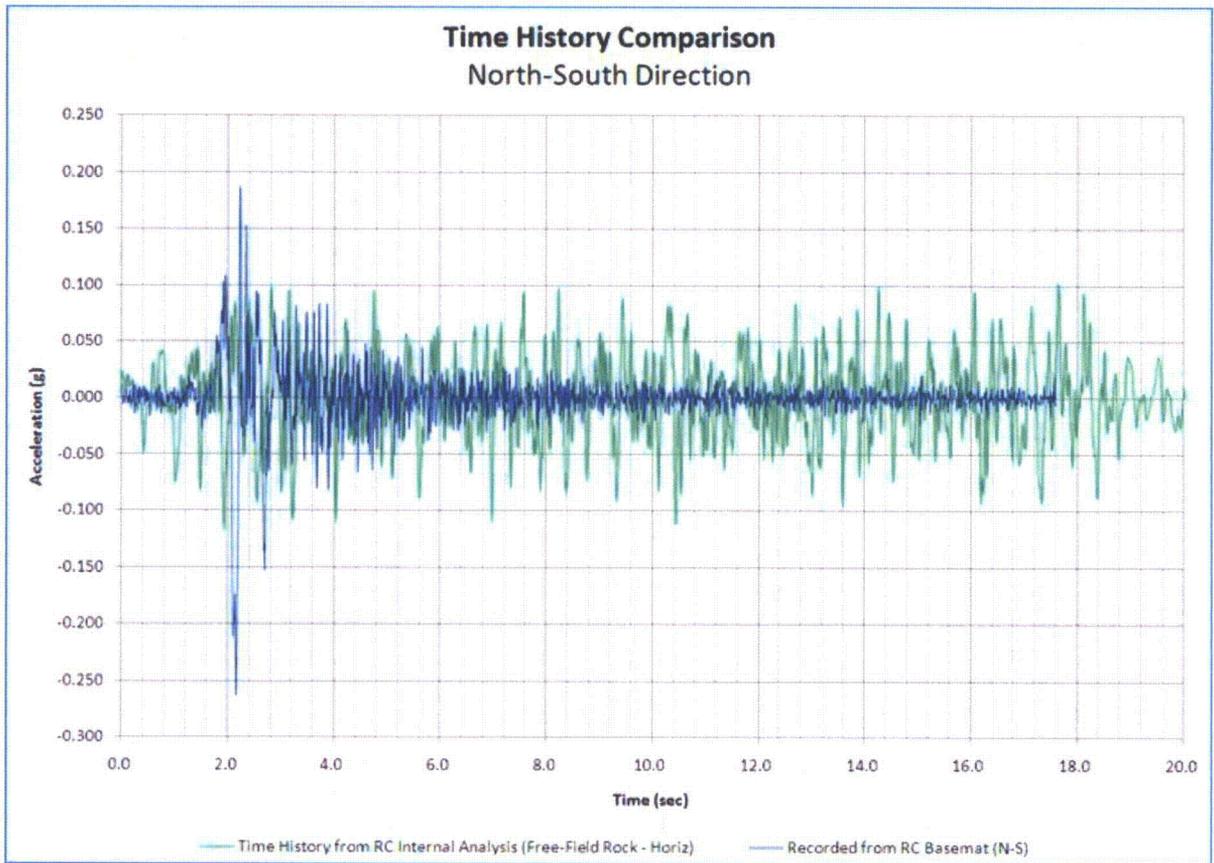
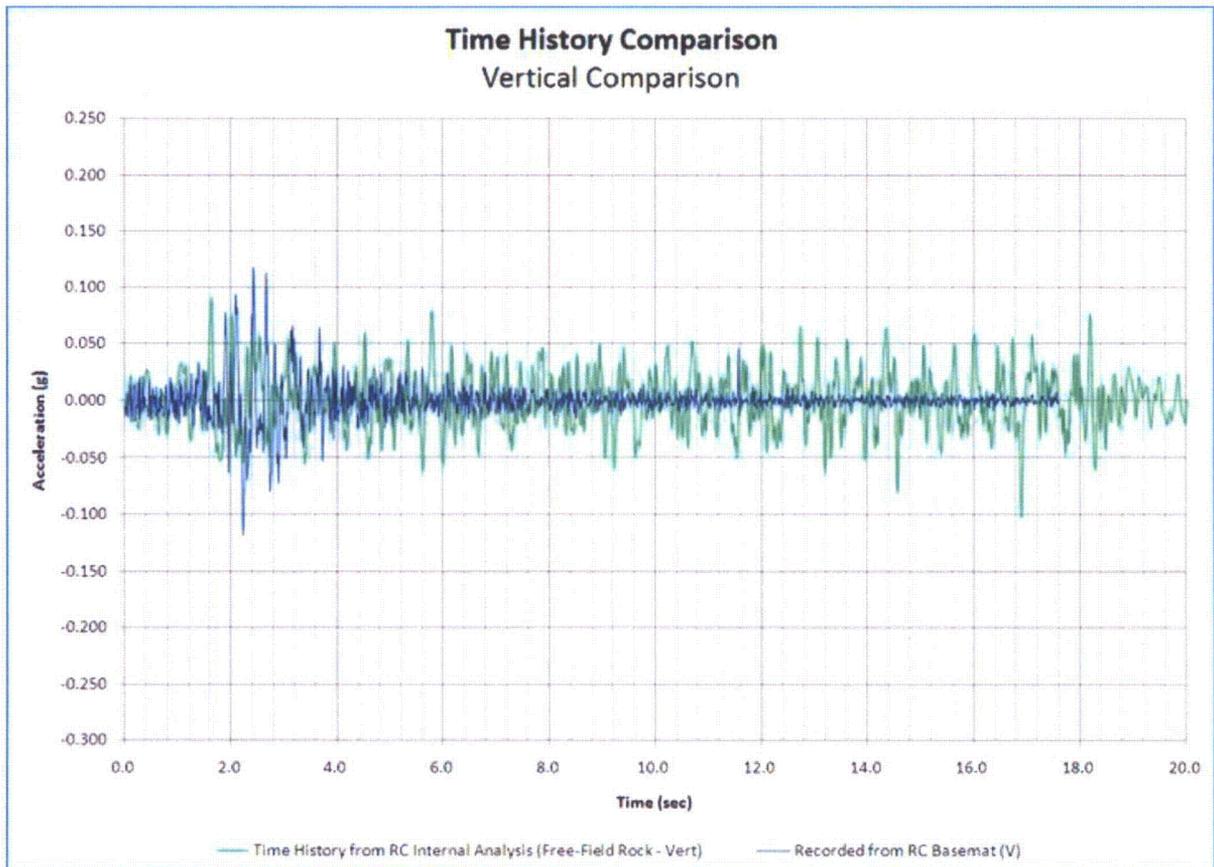
The short duration of the August 23, 2011 earthquake is further exemplified by comparison of the recorded horizontal direction time-histories at the Containment basemat to synthetic time-histories generated from the site ground rock DBE spectra used in the analysis of the North Anna reactor Containment model. These synthetic time-histories last for approximately 20 seconds, in accordance with the requirements of the Standard Review Plan. By comparison, the recorded data durations are approximately 17.6 seconds, but have a very limited duration of strong motion.

Though the synthetic time-histories in the figures below are those that were used in the analysis of rock-founded structures at North Anna, it is noted that the time-histories used for shake-testing of electrical equipment are similar – they are typically 30 seconds in duration for each of the 1 DBE and 5 OBE tests, have stationarity, e.g., if the time-history is divided into ten equal 3-second segments, the required frequency content will be present in each segment. Therefore, the energy content imparted to equipment that is qualified by shake table tests has strong motion content several times that of the August 23, 2011 event.

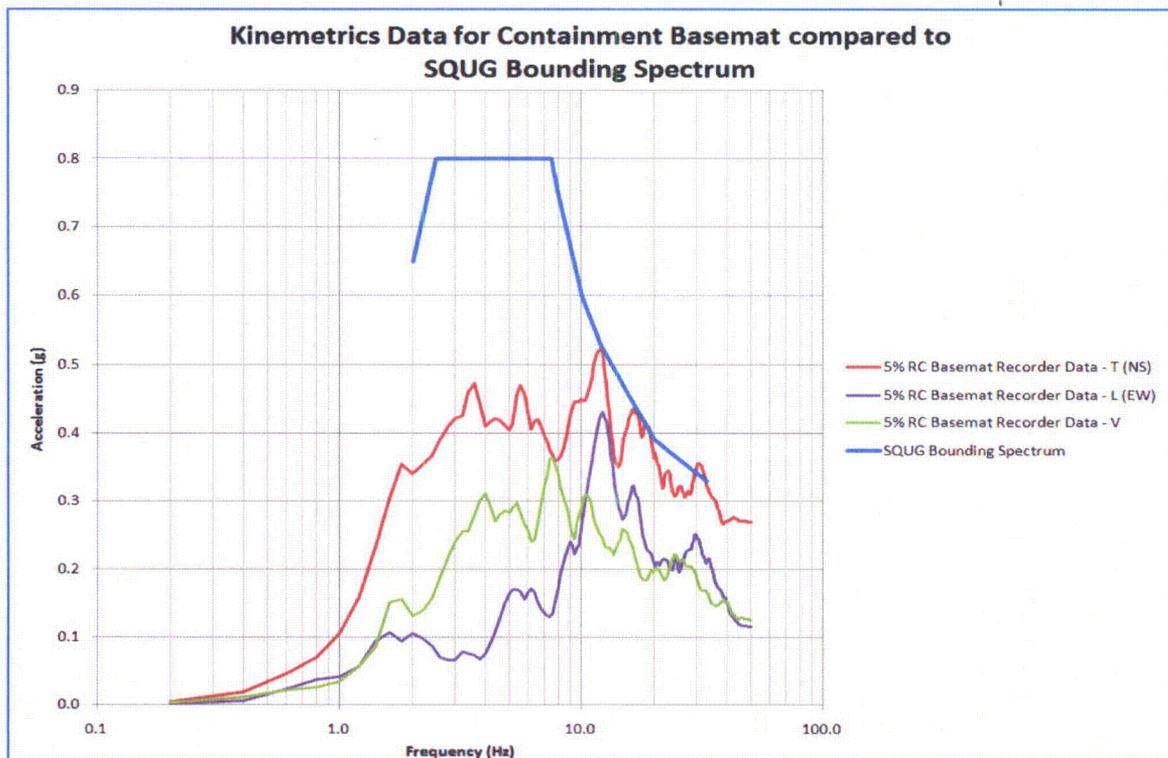
As shown below, the Bounding Spectrum effectively envelops the response spectra created from the recorded time-histories from the basemat elevation of the Containment, which are considered equivalent to the free-field since the Containment is rock-founded. There is only a very slight exceedance in the North-South direction around 33 Hz. Therefore experience data would indicate that the equipment qualified using the GIP Bounding Spectrum will remain acceptable (assuming that the load path and anchorage remains acceptable and that any sensitive electrical equipment has been evaluated using shake-test data).

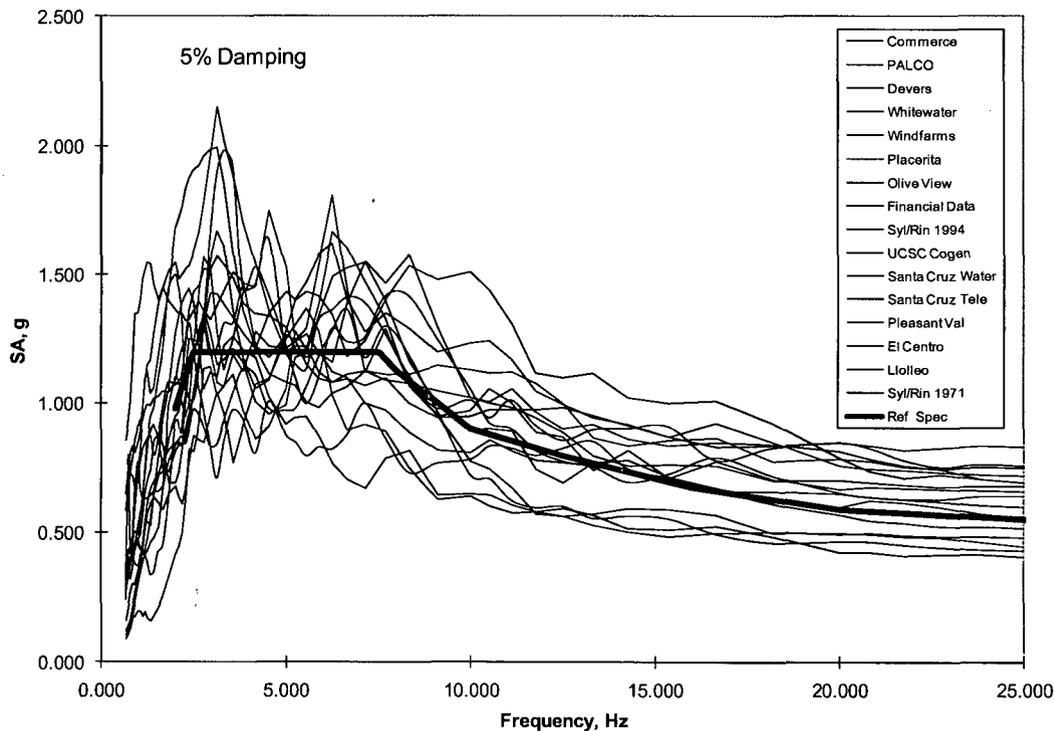
Figure 1. Average Horizontal Response Spectra for EPRI Database Sites Compared to Seismic Capacity Spectrum (also known as the Reference Spectrum)

Using the earthquake experience data collected on the equipment (now maintained by EPRI), SQUG was able to develop an earthquake Seismic Capacity Spectrum, which is referred to as the Reference Spectrum in original SQUG documents. The Seismic Capacity Spectrum assumes 5% damping and represents the estimated average free-field ground motion to which the database facilities were actually exposed at an estimated mean peak ground accelerations in excess of approximately 0.4g. As depicted in Figure 1 as the bolded spectra, the Seismic Capacity Spectrum is the average of various response spectra that are generated using data collected from past earthquakes. The Seismic Capacity Spectrum is a demonstrated level at which failure or malfunction of equipment has not occurred in past earthquakes. It does not represent a limiting capacity but rather a level for which there is a high confidence of a low probability of failure (HCLPF). The actual seismic fragility or failure/malfunction level is at least a factor of 2 to 4 times the Seismic Capacity Spectrum level [5]. This Seismic Capacity Spectrum can be compared to actual earthquake response spectra to assess whether plant-specific equipment has been subjected to ground motions that are comparable to those experienced by the database facilities.

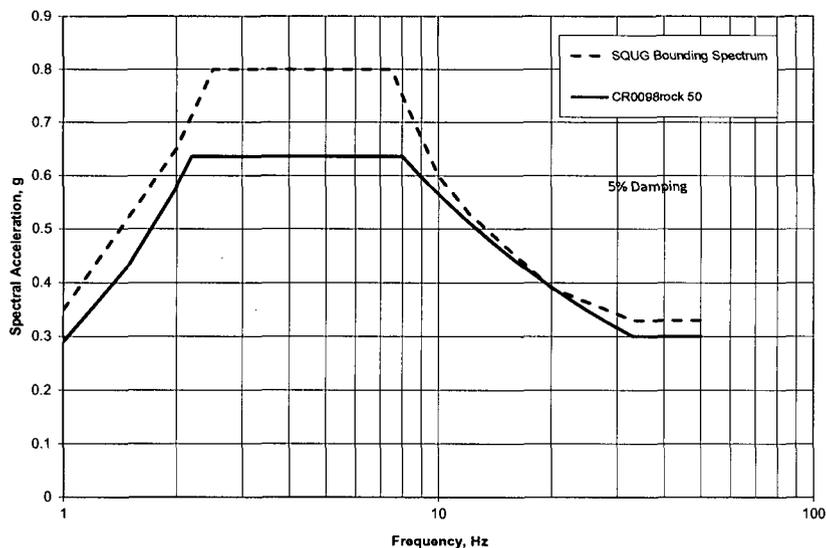
Figure 2. Comparison of Bounding Spectrum and NUREG/CR-0098 (Median) Spectrum

[7] median spectral shape anchored to 0.3g as the RLE. Many plants were also concurrently addressing the USI A-46 issue. Figure 2 compares the NUREG/CR-0098 spectrum which the Bounding spectrum used to resolve A-46. As can be noted, the Bounding Spectrum is slightly greater than the NUREG/CR-0098 spectrum, thus plants which were also addressing A-46 could demonstrate equipment seismic adequacy for the IPEEE RLE; however, the anchorage capacity of the equipment had to be equal to or greater than the RLE level rather than the plant SSE level. In the IPEEE program, plants had to identify all cases where equipment capacity was less than the selected RLE.

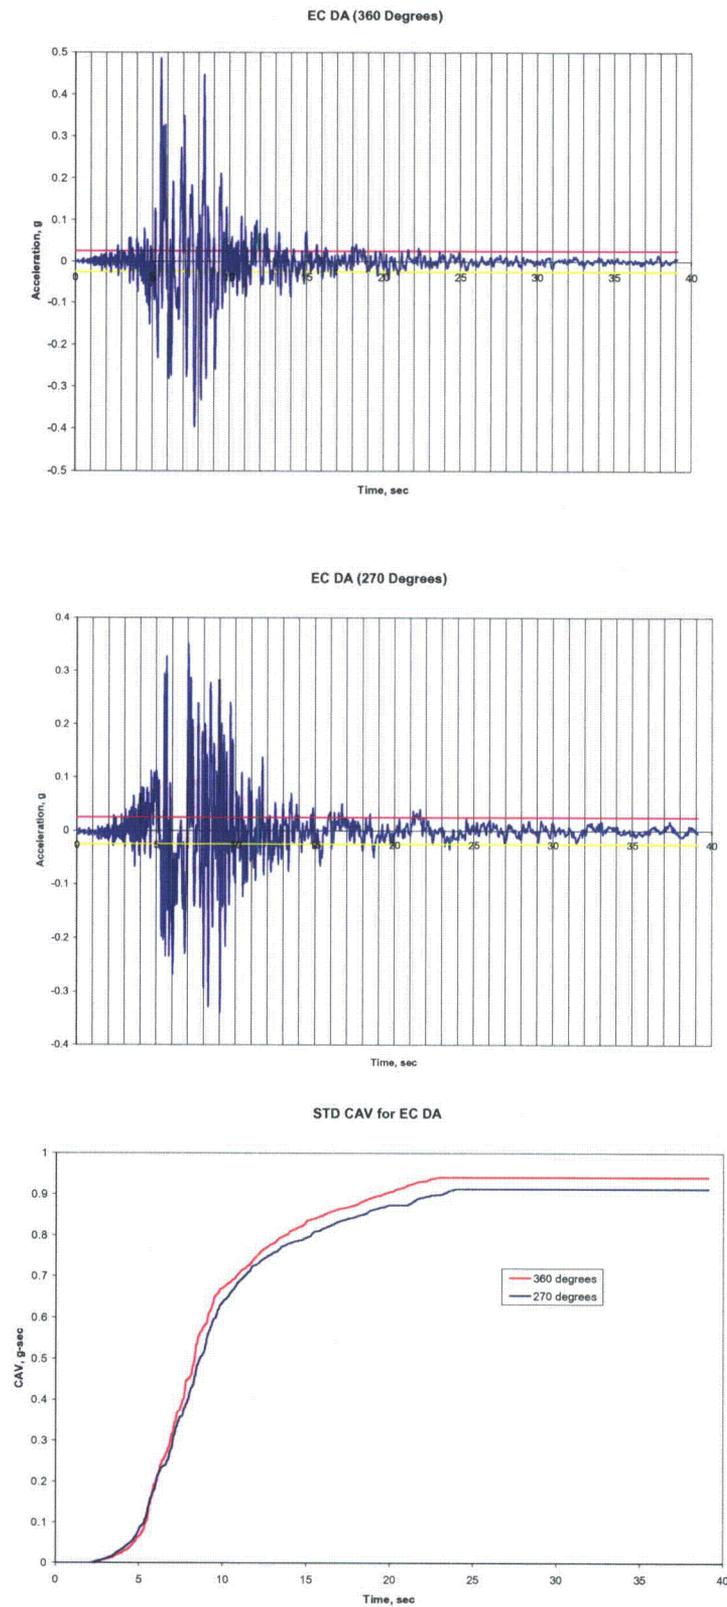
Figure 3. Time-History Records and Computed CAV Values Associated with the EI Centro Steam Plant (Differential Array, 1979 Imperial Valley, CA Earthquake; closest record to plant)

$W_i = 1$ for $|a| \geq 0.025g$ and zero otherwise, the generation of the total CAV value may be generated for the entire acceleration time-history record. For this calculation, the integration limits, t_i , are taken as integer values of time in seconds. Figure 3 shows a cumulative CAV function plot corresponding to the closest free-field acceleration records associated with the El Centro Steam Plant (1979 Imperial Valley CA Earthquake). This type of presentation indicates that the strong motion portion of each time-history record yields a region where the CAV value accumulates at an approximate constant rate. As can be noted in Figure 3, the cumulative CAV function for the El Centro Steam Plant includes the strong motion portion (5-10 sec) that contributes approximately 60% of the total CAV value. Thus, the computed CAV value is always larger than the strong motion contribution, resulting in a conservative damage measure when used as a lower bound exclusion criterion.

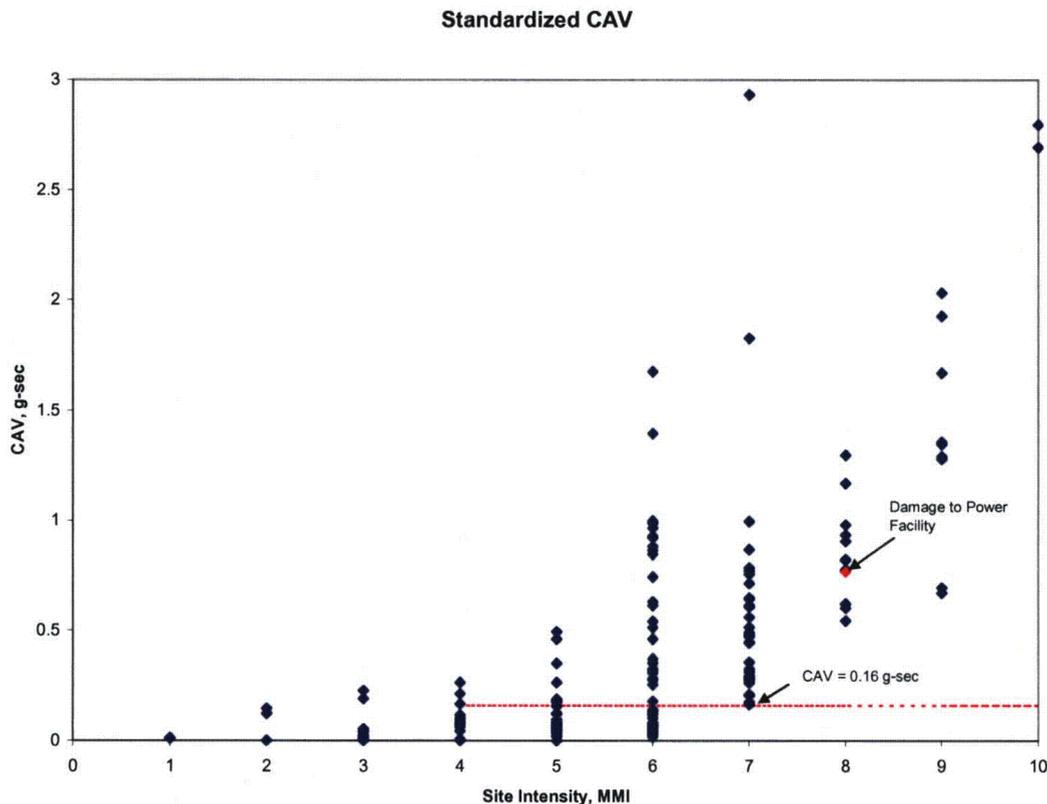
Figure 4. Plot of CAV vs. Site MMI Intensity for 177 Records (Reference 9)

Figure 4 shows the entire set of 177 CAV values from Reference 9 plotted against the assigned site MMI intensity. Note that CAV values as high as 3 occur for sites with MMI site intensity VII. The goal of the studies documented in References 8 and 9 was to establish a screening value which could be used as justification for continued nuclear plant operation following an earthquake, given that the threshold CAV determined from site (free-field) records was not exceeded.

The noted plant damage was structural only – minor concrete cracks and buckling of the boiler frame braces. The plant operating units were fully functional following the earthquake. The El Centro Steam Plant is one the reference data sites used by the SQUG to establish the USI A-46 resolution. The minimum CAV value for this plant is identified in Figure 4 as the lowest value for power plant structural damage (EC Array No. 8, CAV = 0.77 and 0.82; Diff. Array, CAV = 0.91 and 0.94). The other lower CAV values indicated in Figure 4 for MMI VIII are for commercial building structures with minor structural damage (CAV > 0.54).
