Edwin I. Hatch Nuclear Plant
Appeal to the Executive Director of Operations:
Backfit and Applicability of "Compliance Backfit" Exception

DEGRADED GRID PROTECTION FOR CLASS 1E POWER SYSTEMS
EDWIN I. HATCH NUCLEAR POWER PLANT, UNIT NOS. 1 AND 2

**GEORGIA POWER COMPANY
PLANT E. I. HATCH
DEGRADED GRID ISSUES
NOVEMBER 16, 1992**

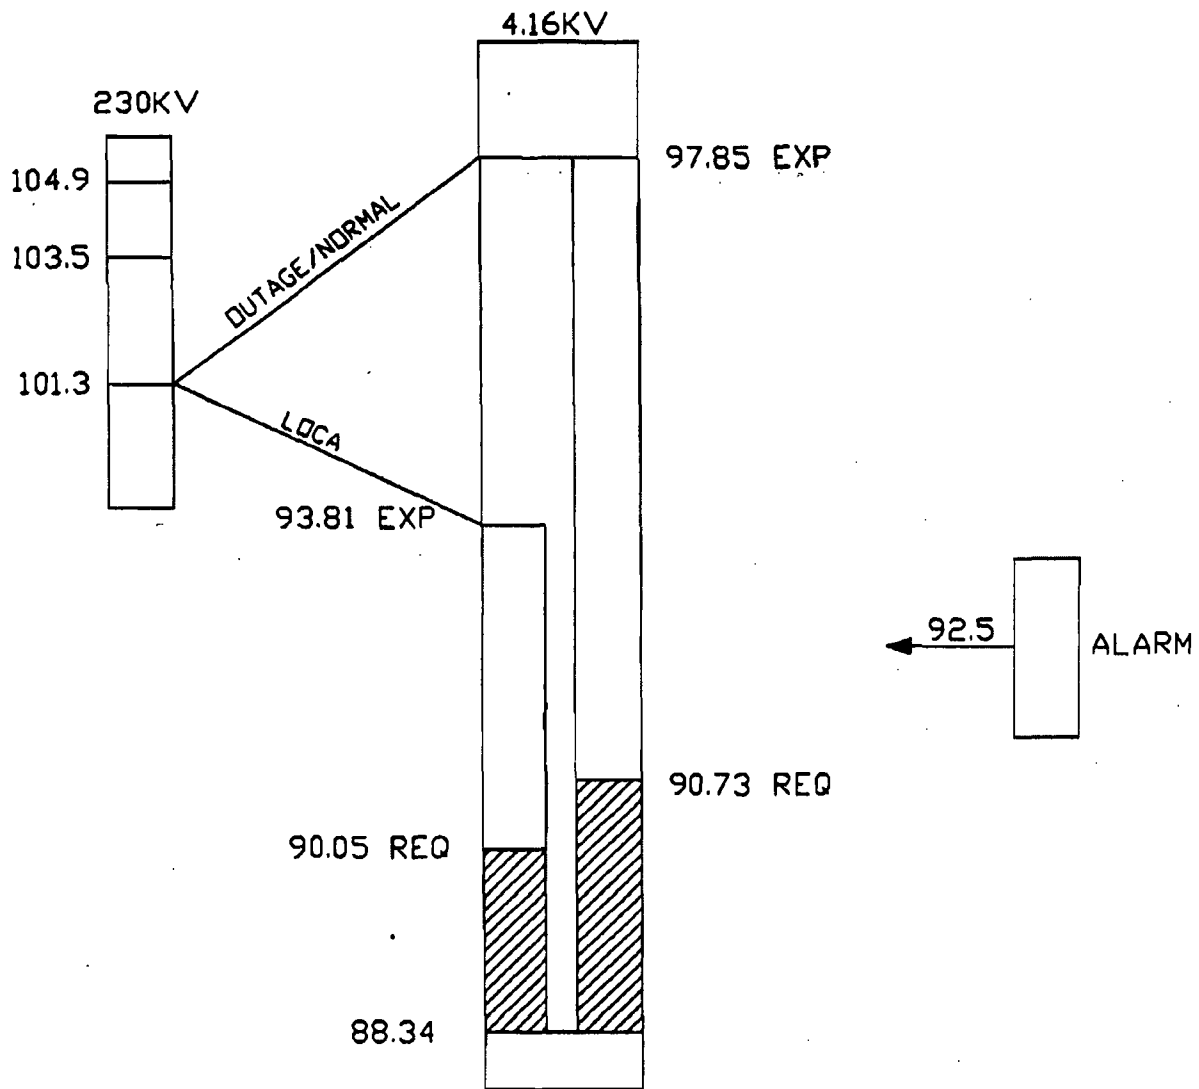
Plant Hatch Unit 2 Bus E

DEAD BAND
