SUBSECTION 2.5.3: SURFACE FAULTING
TABLE OF CONTENTS

Turkey Point Units 6 & 7
COL Application
Part 2 — FSAR

2.5.3 SURFACE FAULTING

PTN COL 2.5-4 This subsection evaluates the potential for tectonic and non-tectonic surface deformation within a 25-mile radius (site vicinity) of Units 6 & 7. Information contained in **Subsection 2.5.3** was developed in accordance with RGs 1.165 and 1.208 in order to demonstrate compliance with 10 CFR 100.23(c). RG 1.208 contains guidance on characterizing seismic sources, and it defines a “capable tectonic source” as a tectonic structure that can generate both vibratory ground motion and tectonic surface deformation, such as faulting or folding at or near the earth's surface, in the present seismotectonic regime.

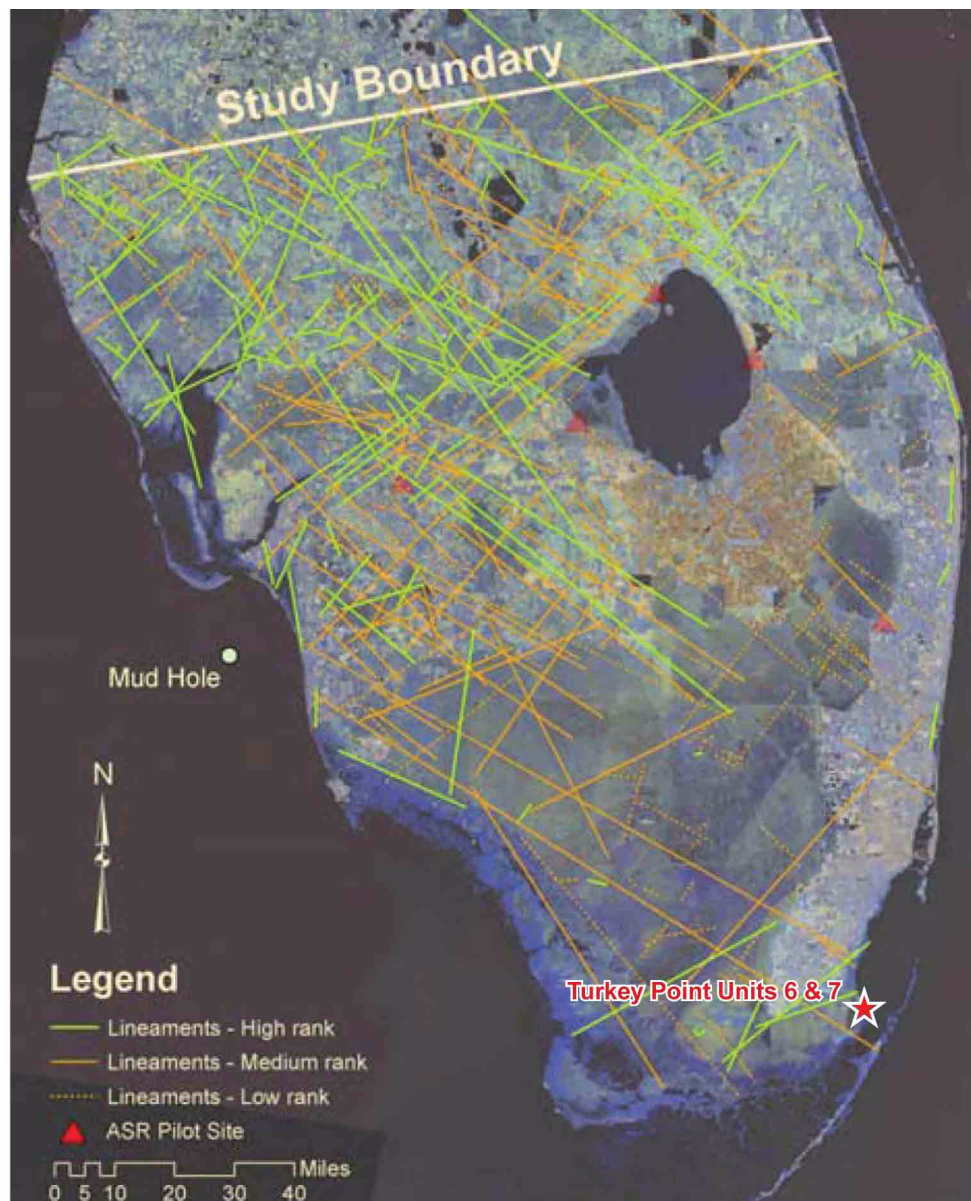
Figure 2.5.3-204 Lineament Analysis of South Florida for ASR Regional Study
