Re: Indian Point Units 2 & 3
Docket Nos. 50-247 & 50-286
NL-08-057

SUBJECT: Entergy Nuclear Operations Inc.
Indian Point Nuclear Generating Unit Nos. 2 & 3
Docket Nos. 50-247 and 50-286
Amendment 3 to License Renewal Application (LRA)

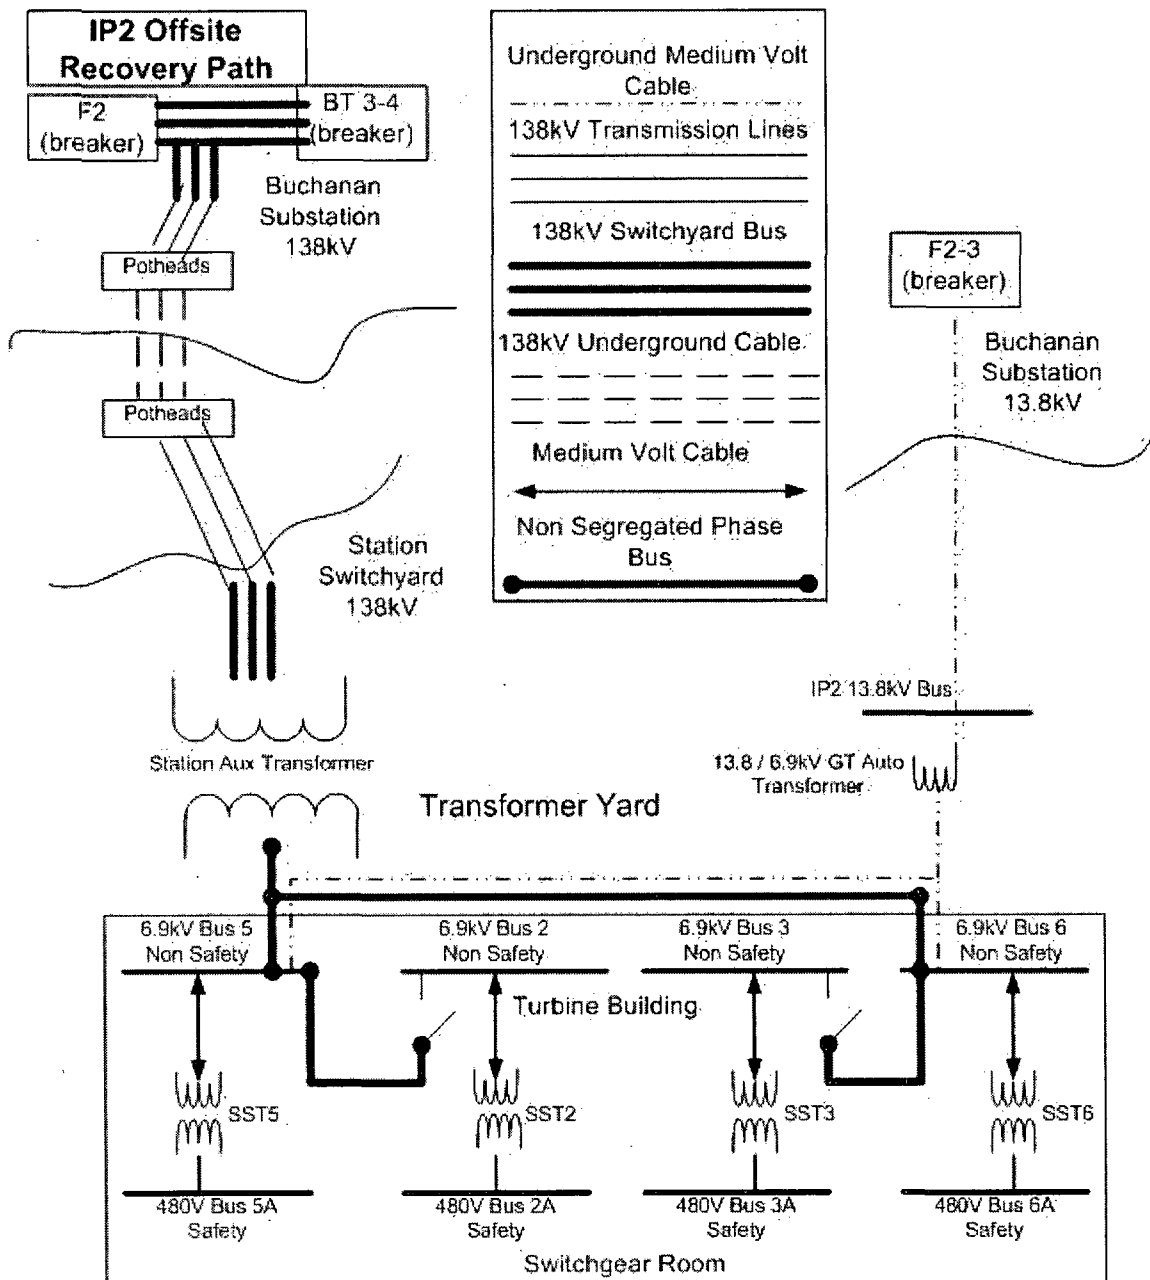
Figure 2.5-2
IP2 Offsite Power Scoping Diagram

As shown in the revised LRA Figure 2.5-2, the 6.9 kV buses receive offsite power from either the 138 kV / 6.9 kV station auxiliary transformer or the 13.8 kV / 6.9 kV GT autotransformer. The station auxiliary transformer is connected to the 138 kV Buchanan substation, the primary offsite power source, via switchyard bus, overhead transmission conductors, and underground transmission conductors through ~~motor-operated disconnect F3A~~ switchyard breakers F2 and BT 3-4, which ~~is~~ are located at the Buchanan substation. The GT autotransformer is connected to the 13.8 kV Buchanan substation, the secondary offsite power source, via underground medium voltage cable through breaker F2-3, which is located at the Buchanan substation.

Based on discussion with the NRC Staff on 12/4/07 and industry discussion with the NRC Staff on 12/12/2007 and 1/30/2008, the response to this RAI provided in Entergy Letter NL-07-138, Dated 11/16/2007 is being revised. The only section that requires revision is LRA Figure 2.5-2 and associated discussion.
