| <b>FSAR UPDATE</b> |
| <b>DIABLO CANYON ISFSI</b> |

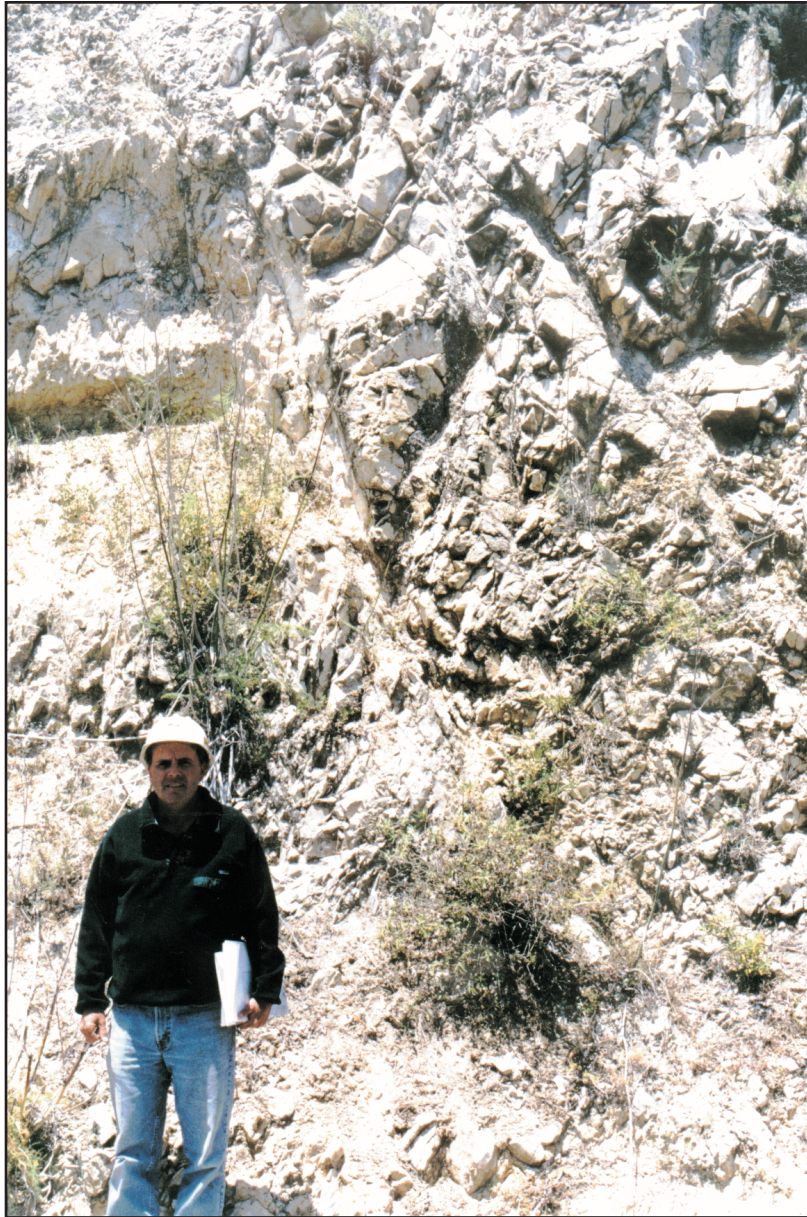
| <b>FIGURE 2.6-30</b> |

Northward view of Diablo Creek Road cut showing steeply dipping minor faults in dolomite of unit  $Tof_{b-1}$ . Slickensides and mullions on the fault plane indicate primarily strike-slip displacement, but bedding also suggests a component of down-to-the-east vertical separation of approximately 3 to 6 feet. These faults are located along projection of faults exposed in trenches at the ISFSI, approximately 800 feet to the southeast, that have similar strike and slickenside/mullion rakes. Photo roll JLB 5/16-1.

| <b>MINOR FAULTS ALONG DIABLO CREEK ROAD</b> |

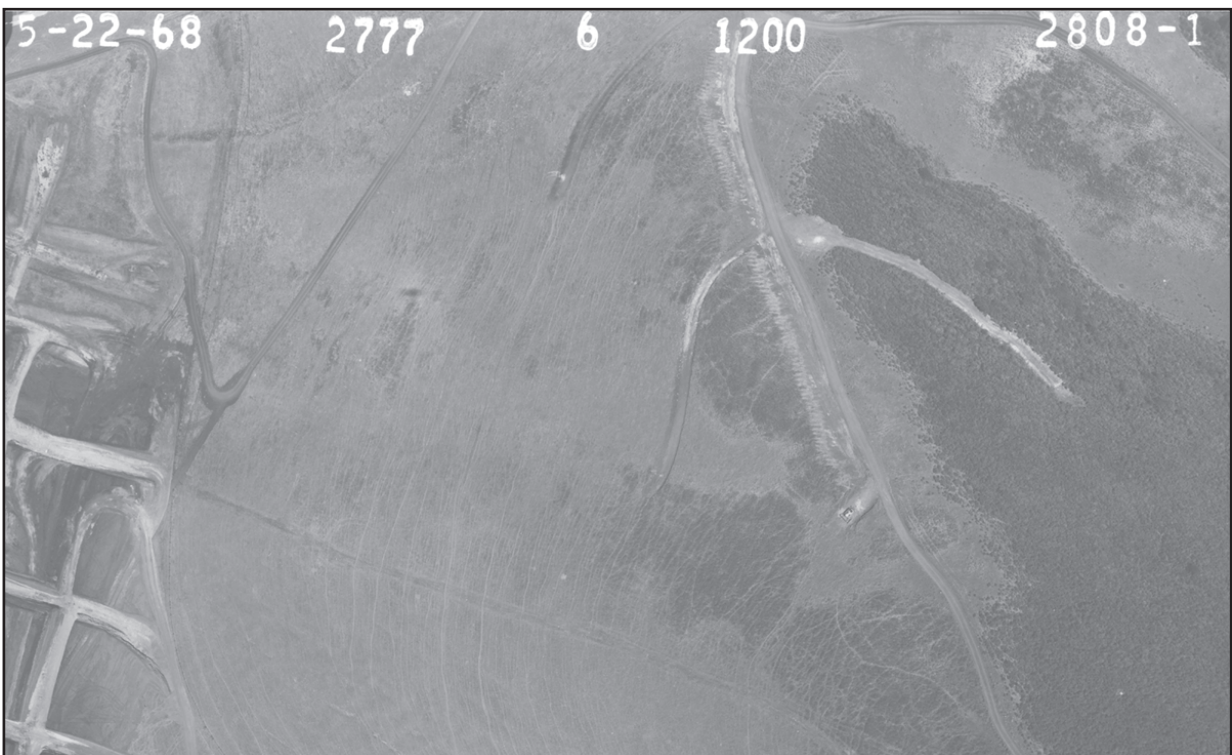
| <b>FIGURE 2.6-31</b><br><b>1968 AERIAL STEREO PHOTOGRAPHY</b><br><b>OF ISFSI STUDY AREA</b> |

1968 stereo air photos (2777; 2808-1 and 2808-2) of ISFSI study area prior to the 1971 excavation of the borrow site. Diablo Creek traverses the upper (northern) part of the photo. Trenches for the power block are evident in the lower left. The road that follows the ridge crest in center of photo was removed during 1971 excavation of the borrow area. No features indicating deep seated landslides are present at the site; large landslides are evident to the east, however. The small landslide south of the word "swale" is shallow and was removed in the 1971 excavations. See Figure 2.6-7 for unit descriptions. To view with a stereoscope, fold and adjust the photos as necessary.
