STUDENT MANUAL

Site Day 3

VALVE MO 8809A AND MO 8809B OPERATING CIRCUIT (SEE ATTACHED FIGURE 1)

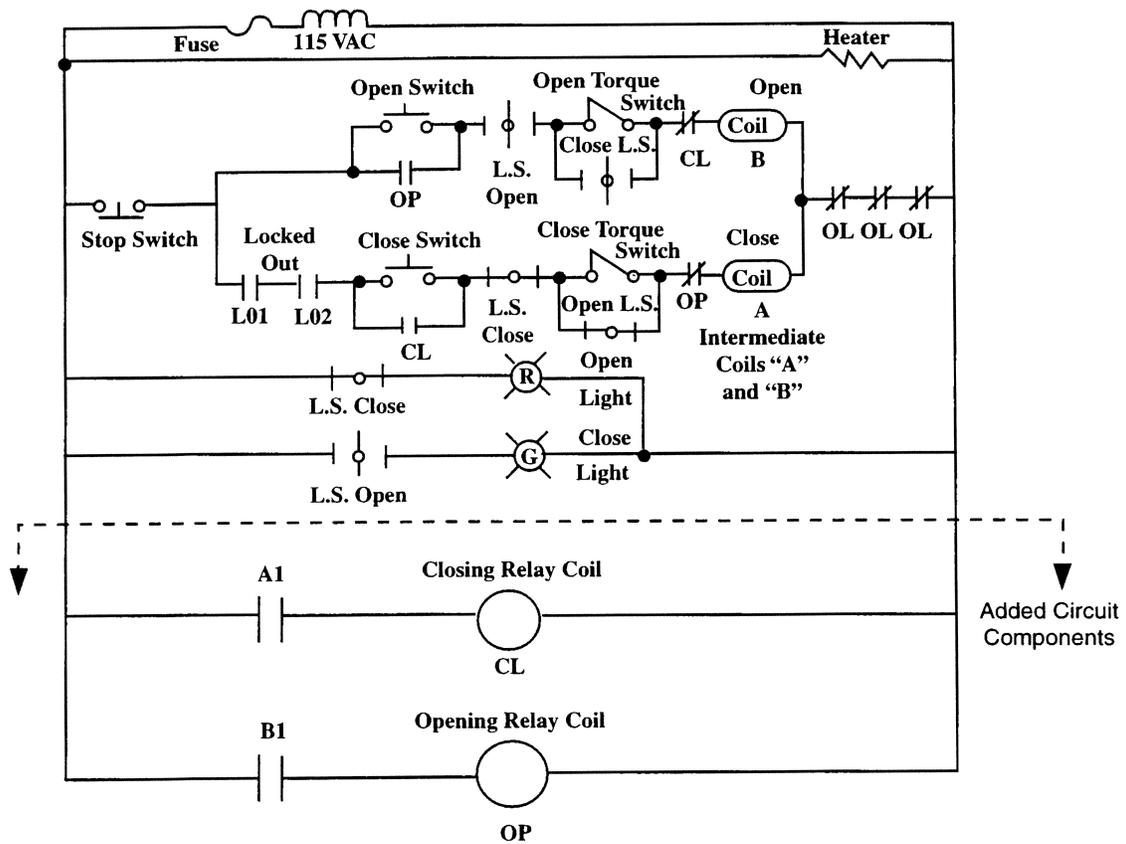
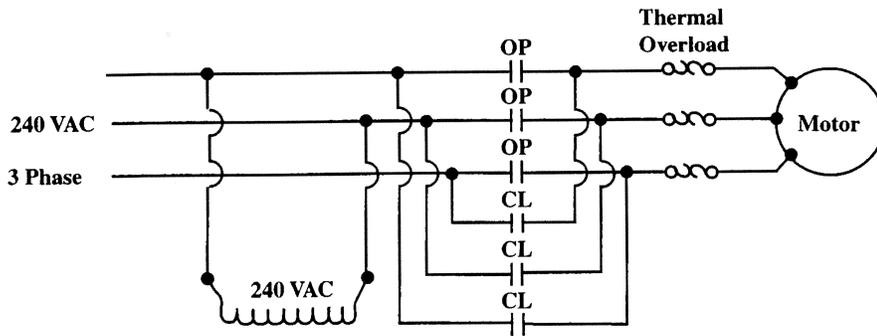
Figure 1. Valve Operating Circuit

Starter circuits such as this have two primary functions: 1) to change power phase rotation, which changes the direction of motor rotation, and 2) to provide mechanical and electrical safety interlocks that prevent the contacts for both directions of valve movement being closed at the same time, which would cause a direct short between phases. The operation of the reversing starter is based on using a small control current to control the larger motor current through electromagnetic switching of contacts. The coils shown in figure 1 operate the main contacts of the starter when an open or close pushbutton is pushed. The intermediate relay coils “A” and “B” were added in a design modification to ensure motor-valve operability under degraded voltage conditions.

A design review indicated that under worst case low voltage conditions, the main “CL” and “OP” relay coils, which were located where the new coils “A” and “B” are now, might not receive sufficient operating voltage because of line voltage losses in the cabling between the Control Room and the Motor Control Centers (MCC) where the relays are located. The power requirement for the intermediate coils is much lower in the new design, and the main relay coils receive full line voltage in the modified design.
