**TECHNICAL EVALUATION REPORT
CHRISTENSEN RANCH MINE UNITS 2 THROUGH 6 RESTORATION REPORT
URANIUM ONE USA, INC., WILLOW CREEK ISR FACILITY**

DATE: October 23, 2012

SITE: Willow Creek Christensen Ranch, Wyoming

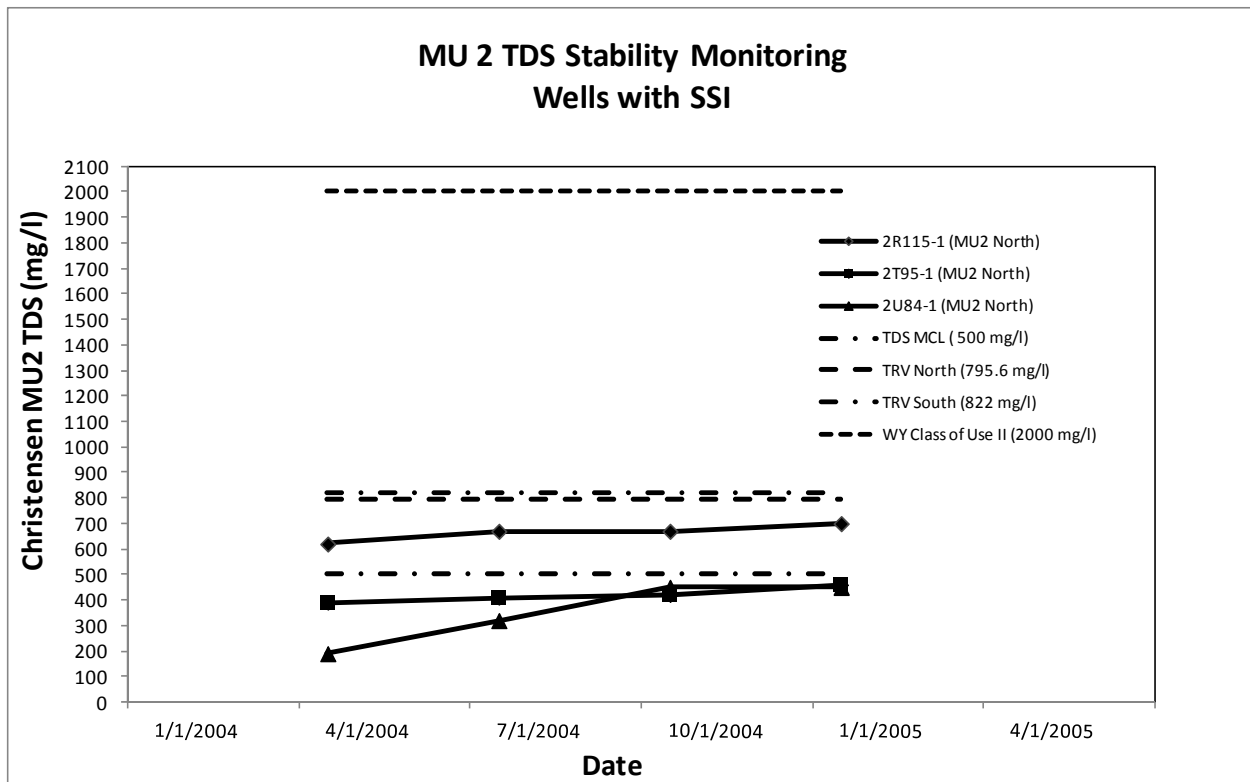
Figure 3a. MU2 North and South TDS Stability Monitoring Trend Analysis

The SSI trends for Mine Unit 2 North for TDS, uranium and radium-226 are shown in Figures 3a, b, and c respectively. In 2009, the licensee reported data from well 2S100-2 (Cogema, 2009a). The uranium and TDS concentrations in the groundwater at well 2S100-2 in 2009 reflect a significant decrease from concentrations reported during the 2004-2005 stability monitoring. Therefore, the SSI determination for well 2S100-2 was considered adequately addressed. The licensee did not report additional analyses for wells 2T92-2, 2R115-1, 2T95-1, or 2U84-1.

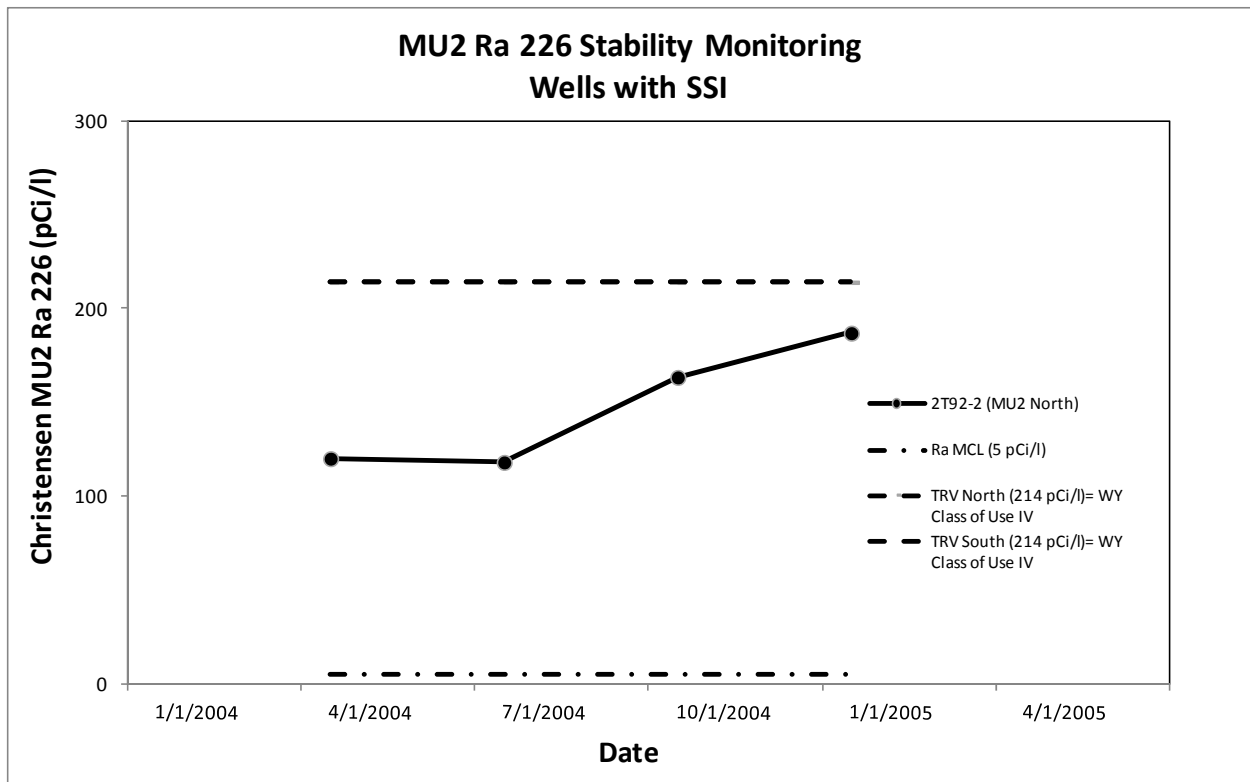
Figure 3c. MU2 North and South Radium-226 Stability Monitoring Trend Analysis

The SSI trend for Mine Unit 2 South for uranium in this well is shown in Figure 3c. It is of concern to the staff because it shows that uranium in this well is above the Class IV standard (background TRV) and is increasing.
