November 5, 2012
NOC-AE-12002925
File No.: G25
10 CFR 50.55a

South Texas Project
Units 1 and 2
Docket Nos. STN 50-498, STN 50-499
Response to Request for Additional Information Regarding Relief Request RR-ENG-3-10 for
Reactor Pressure Vessel Head Flange O-Ring Leakoff Lines Non-Destructive Examination
(TAC Nos. ME9863 and ME9864)

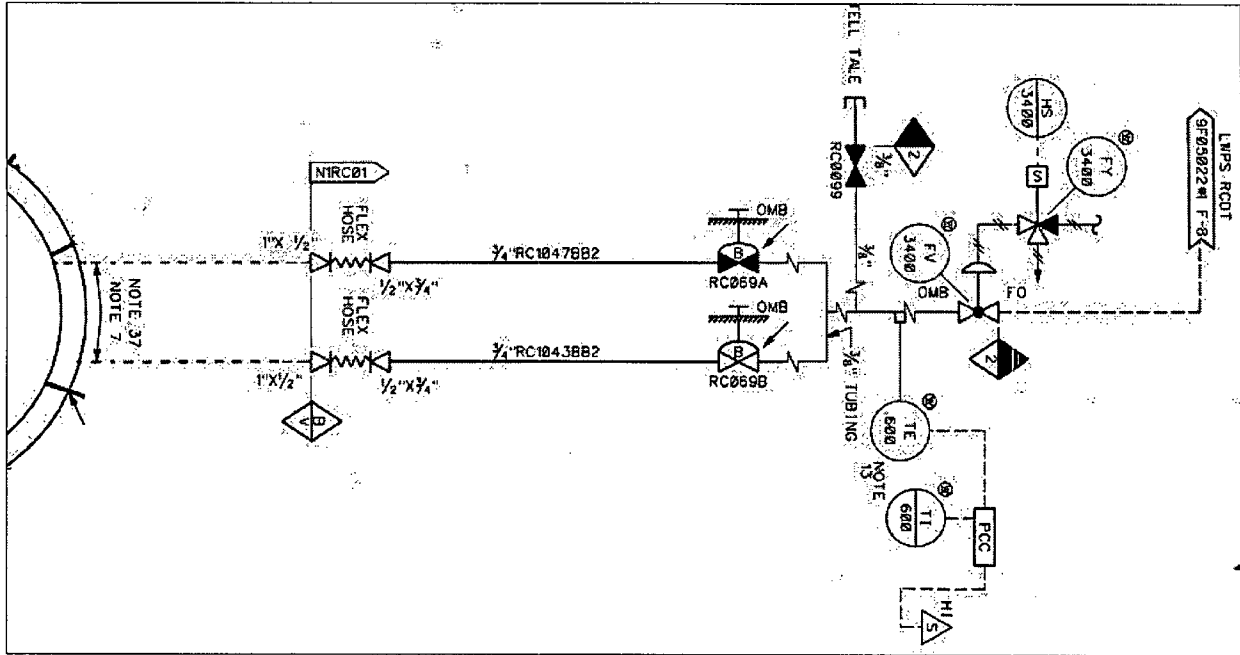
Figure RAI-2: Piping and Instrumentation Diagram

- b. As depicted below in Figure RAI-2, Piping and Instrumentation Diagram, each leakoff line consists of a 1-inch monitor tube connected to a flexible hose, then to 3/4-inch piping to isolation valves, then to 3/8-inch tubing to the Reactor Coolant Drain Tank (RCDT). The monitor tubes connect to the reactor vessel flange, which contains 3/8-inch passages downstream of each O-ring to collect leakage (refer to Figure RAI-3 below).

- a. Describe exactly how an operator would visually examine the leakoff line (where and how).
 - b. Confirm that each leakoff line as shown in Figures 1 and 2 consists of a monitor tube of 1-inch in diameter coming off the O-ring area and is connected to a smaller piping of 3/4 inch in diameter.
