Callaway Plant

**DOCKET NUMBER 50-483  
CALLAWAY PLANT UNIT 1  
UNION ELECTRIC CO.  
FACILITY OPERATING LICENSE NPF-30  
RESPONSES TO RAI SET #16 AND AMENDMENT 16 TO THE CALLAWAY LRA**

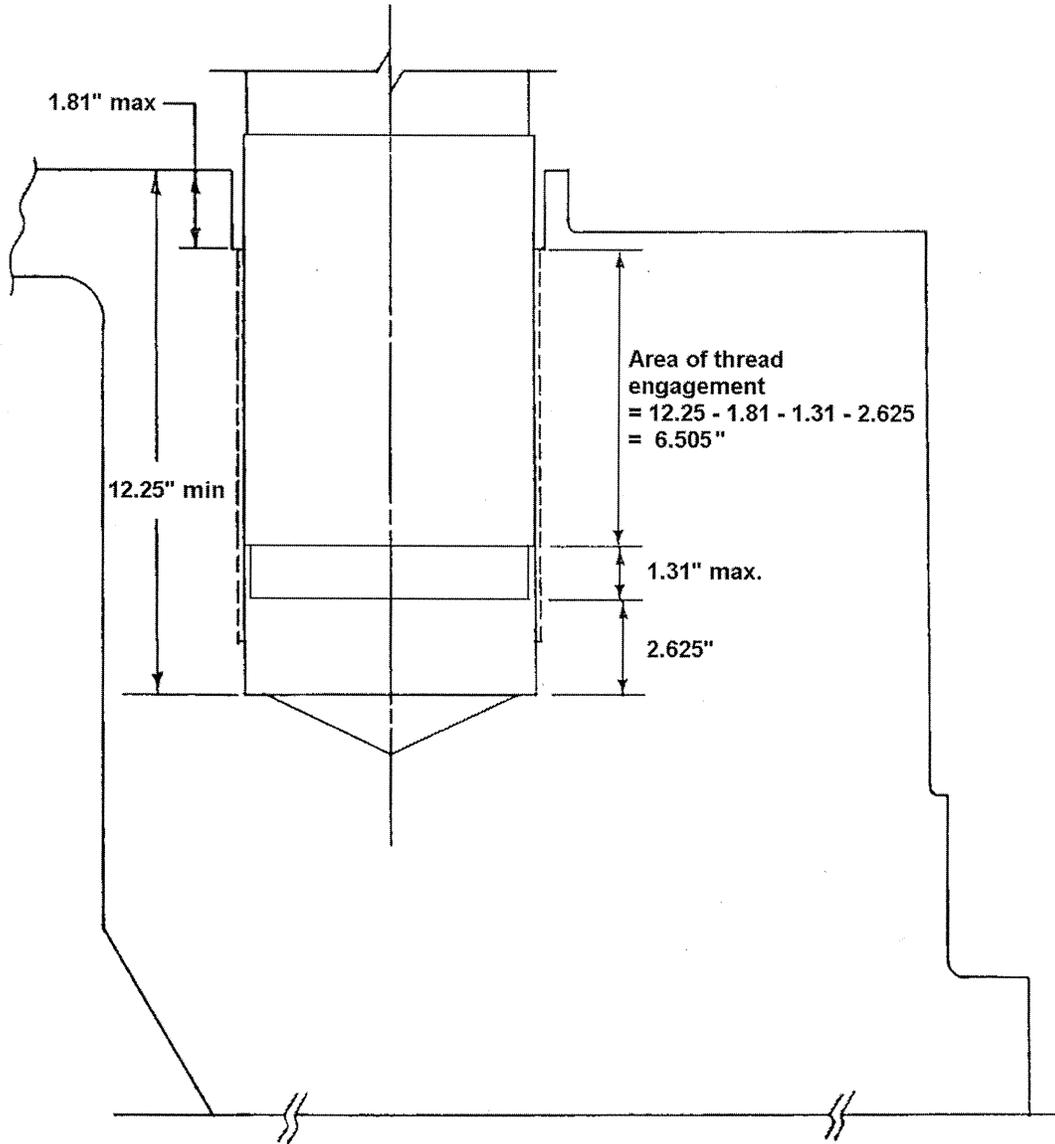
FIGURE 1

The length of thread engagement for stud 18 is calculated as follows. A sketch (Figure 1) follows this RAI response. The depth of the stud hole is a minimum of 12.25 inches. The distance from the top of the stud hole to the top of the threads in the stud hole is a maximum of 1.81 inches. The distance from the bottom of the stud hole to the bottom of the stuck stud is 2.625 inches. The distance from the bottom of the stuck stud to the bottom of the threads on the stuck stud is a maximum of 1.31 inches. Thus, the length of thread engagement is  $12.25 - 1.81 - 2.625 - 1.31 = 6.505$  inches.

The threads of reactor vessel stud 18 and stud hole 18 were inspected immediately prior to installation of the stud. At that time, the threads were intact. When the stud became stuck, excessive force was not used in an attempt to free the stud. Therefore, no threads were damaged by installation of the stud. Although the threads of stud 18 have not been inspected for damage due to wear or corrosion, the other 53 reactor vessel studs and stud holes have been inspected. In the 20 years since 1992, no damage to the threads of the other studs and stud holes has been observed due to corrosion, wear, or any other cause. Since stud 18 is exposed to the same environment as the other studs except during refueling, it is reasonable to conclude that damage to the threads due to corrosion or wear has not occurred. During
