United States Nuclear Regulatory Commission Official Hearing Exhibit
 Entergy Nuclear Operations, Inc.
 (Indian Point Nuclear Generating Units 2 and 3)

**FLOW ACCELERATED CORROSION INSPECTION POINTS FOR 3R14
 ER IP3-05-24045**

3R14 FLOW ACCELERATED CORROSION INSPECTION SUMMARY REASONS FOR SELECTION OF 114 INSPECTION LOCATIONS

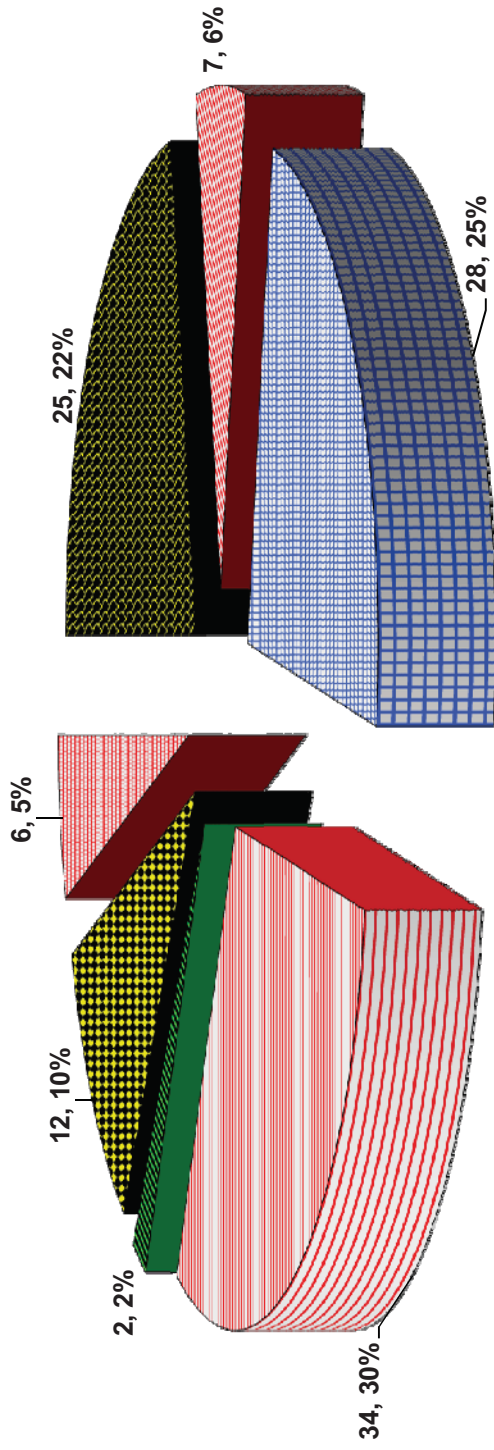
- CHECWORKS
- INDUSTRY OE
- IPPEC OE
- CALCULATION REINSPECTION
- SNAPSHOT SCOPE ASSESSMENT
- POWER UPRATE
- DEFERRALS
