United States Nuclear Regulatory Commission Official Hearing Exhibit

Entergy Nuclear Operations, Inc.  
(Indian Point Nuclear Generating Units 2 and 3)

ASLBP #: 07-858-03-LR-BD01  
Docket #: 05000247 | 05000286  
Exhibit #: ENT000245-00-BD01  
Admitted: 10/15/2012  
Rejected:  
Other:

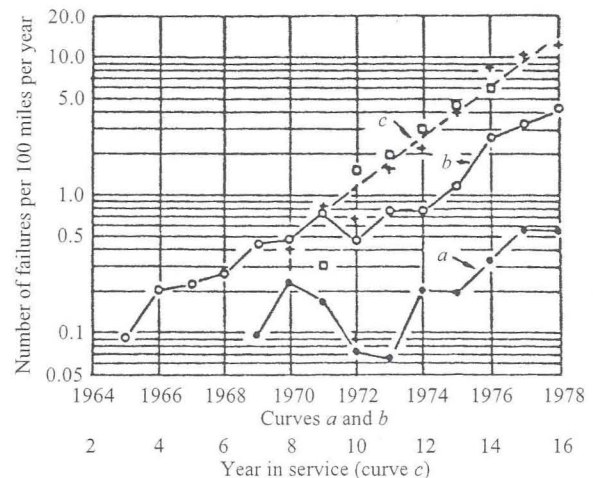
**Figure 3.12** Failure rates of polymeric power cable rated 5–35 kV: after Thue [46]: (a) and (b). Average failure rate for all cables operating in a particular year: (a) XLPE and (b) PE. (c) Failure rate versus number of years in service: XLPE + PE.
