**UNITED STATES  
NUCLEAR REGULATORY COMMISSION  
OFFICE OF NUCLEAR REACTOR REGULATION  
WASHINGTON, D.C. 20555**

April 7, 2005

**NRC INFORMATION NOTICE 2005-09: INDICATIONS IN THERMALLY TREATED ALLOY 600 STEAM GENERATOR TUBES AND TUBE-TO-TUBESHEET WELDS**

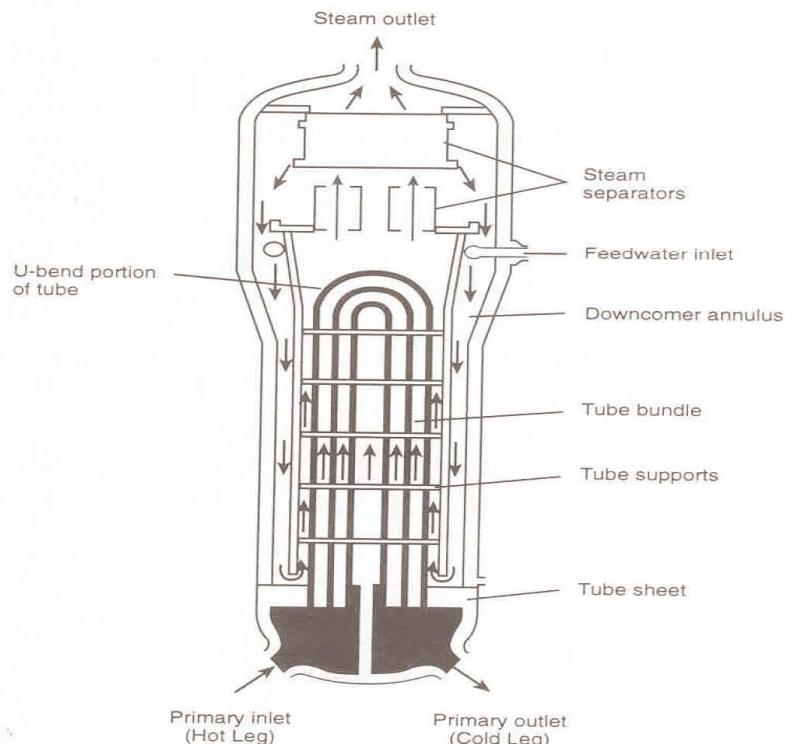
PWR Recirculating Steam Generator

Catawba Nuclear Station, Unit 2, has four Westinghouse Model D5 recirculating steam generators. Each steam generator has approximately 4,600 tubes fabricated from thermally treated Alloy 600 (Figure 1). During fabrication of the steam generators, a portion of the U-shaped tubes are inserted into a thick plate called a tubesheet. The tubesheet is approximately 21 inches thick and has two holes for each tube (one hole on the hot-leg side of the steam generator and one hole on the cold-leg side). The lower end of the tubes were tack-expanded into the tubesheet for approximately 0.70 inch (Figure 2). This tack expansion is performed to facilitate welding of the tube to the primary side of the tubesheet. In the case of Catawba Unit 2, this region is frequently referred to as the tack roll region since the tack expansion was accomplished by mechanically rolling the tube into the tubesheet. The tack expansion forms a temporary expansion transition (i.e., a roll transition in the case of Catawba). Following welding, the tubes were hydraulically expanded for the full depth of the tubesheet. The transition from the expanded portion of tube within the tubesheet to the unexpanded portion of the tube at the top of the tubesheet is referred to as the expansion transition region of the tube.

Attachments: 1. PWR Recirculating Steam Generator Figure 1  
2. Tube Installed in the Tubesheet Figure 2

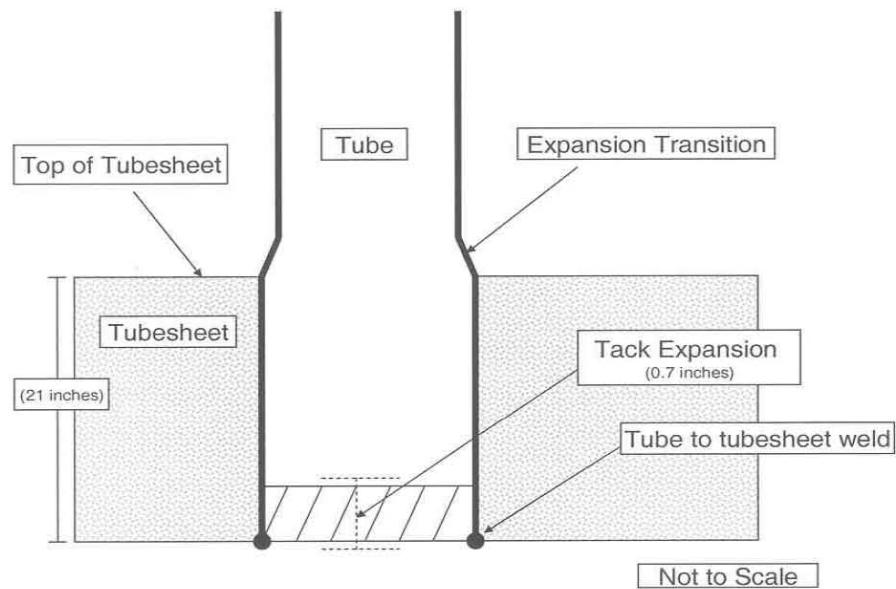
Figure 2

Tube Installed in the Tubesheet
