Status: ☒ Y ☐ N ☐ U**Area Walk-By Checklist (AWC)**

Location (Bldg, Elev, Room/Area): Area : AUX, 2026, 1401

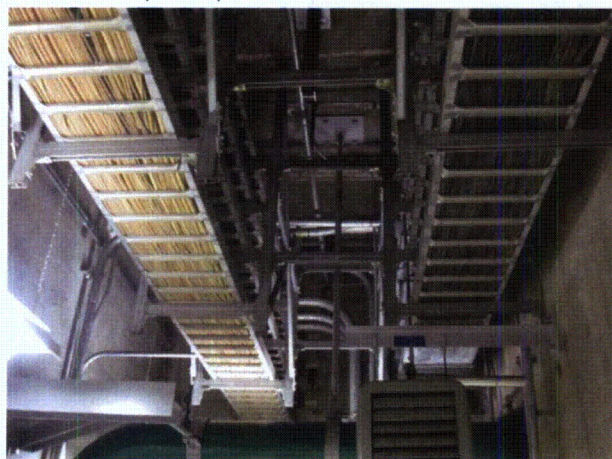
Area # AUX, 2026, 1402 9-20 136

The SWT also observed vertical HSS cable tray supports welded to the floor and connected to the ceiling above. Connection at ceiling appears to be a jacket connection that only transfers lateral load. If the ceiling connection transfers vertical load, there is a concern the support's connections will fail in an SSE event due to differential floor displacement. Verification is required to determine whether either the ceiling connection transfers vertical load or if the support and its connections are designed for the vertical load transfer due to SSE.

Licensing Basis Evaluation: HSS section verified to only react lateral load at its top connection per Detail 3 on C-1408. Therefore, there is no adverse seismic condition.
