PSEG Power, LLC

PSEG Site ESPA
Part 2, Site Safety Analysis Report

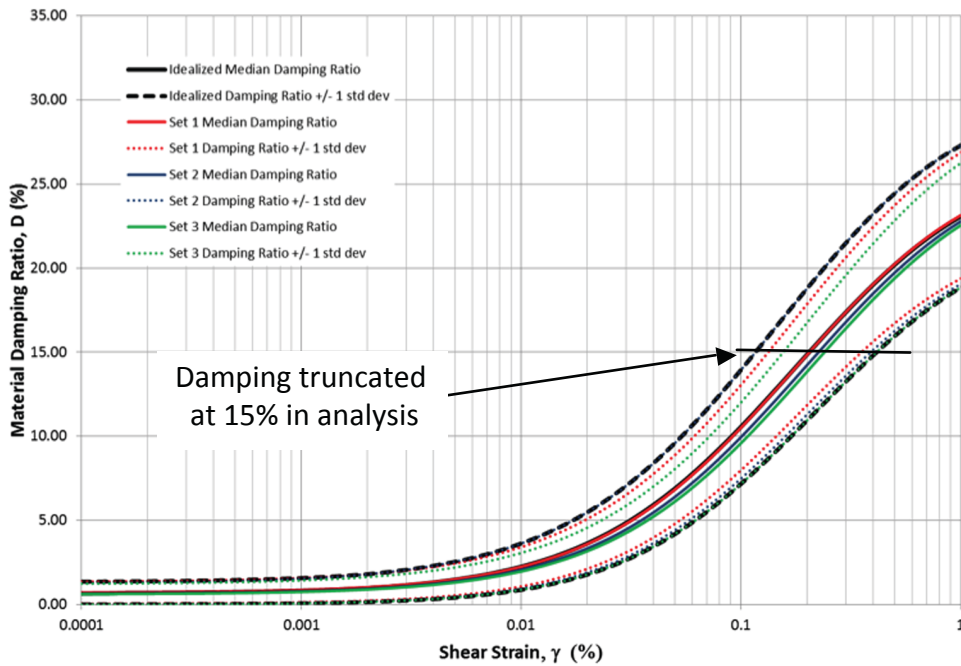
FIGURE 2.5.2-80 Rev 0

G/Gmax and Material Damping
Curves for Soil Layers 9A and 9B
