SUBJECT: Response to Request for Additional Information Regarding Inservice Inspection  
Program Relief Request ISI-PT-02  
Vermont Yankee Nuclear Power Station  
Docket No. 50-271  
License No. DPR-28

Reactor Pressure Vessel Head Flange Leak-Off Lines Piping and Instrumentation  
Diagram; Drawing 5920-00327 and Drawing 5920-02051

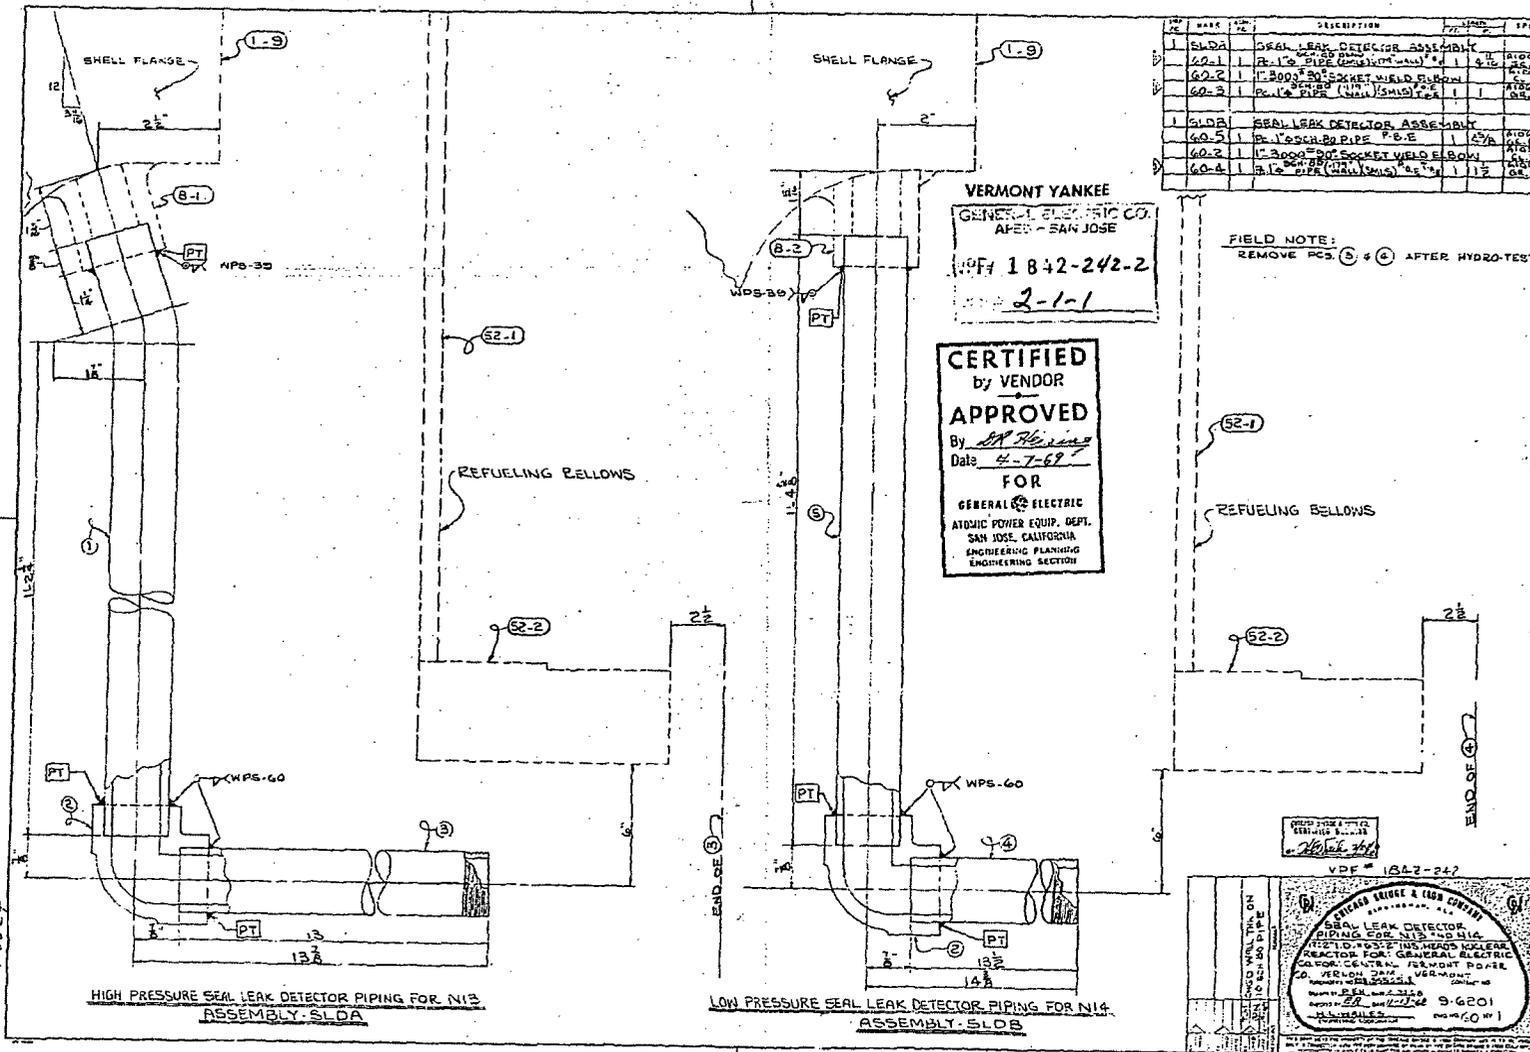
REACTOR SEAL LEAK DETECTOR PIPING FOR N13 & N14 (2-1)

SEAL LEAK DETECTOR PIPING FOR N13 AND N14  
 REACTOR FOR GENERAL ELECTRIC  
 COLORADO CENTRAL VERMONT POWER  
 CO. VERMONT  
 9-6201  
 11/1/67

N14 tap does not connect to pressure switch PS-102. The N14 line is separate from the line originating from N13. In order for the N14 line to become pressurized, both the inner and outer seal rings need to fail. If the N14 line becomes pressurized, the inner seal has failed and would pressurize the N13 line.
