SUBJECT: IOEB ANALYSIS TEAM STUDY ON COMPONENT AGING -
INSIGHTS FROM INSPECTION FINDINGS AND REPORTABLE
EVENTS

Enclosed is the study on component aging with insights from inspection findings and reportable events. The study was briefed to the Office of Nuclear Reactor Regulation Executive Team on November 8, 2012.

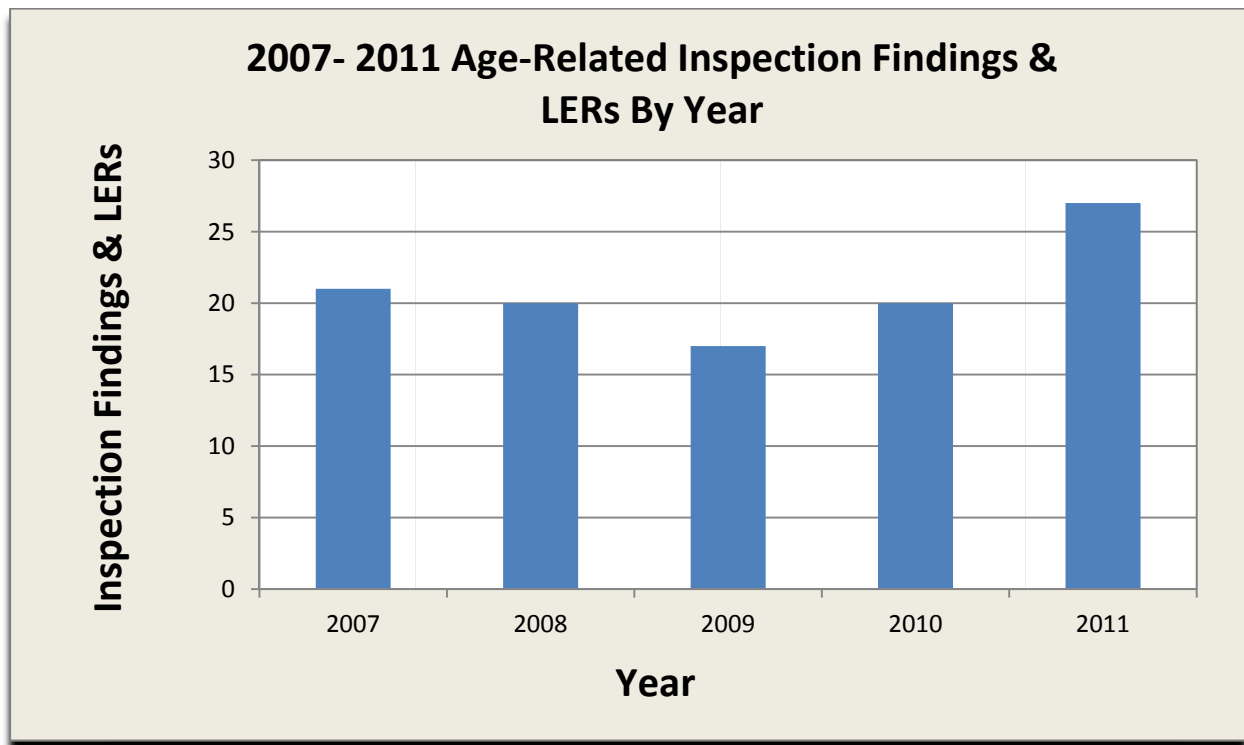
Figure 1: 2007-2011 Inspection Findings/LERs for Age-Related Failures of Safety-Related and Important-to-Safety Equipment

[Note: No overall trend in the number of findings involving age-related failures of important-to-safety SSCs, but the number of findings involving failures of SSCs that has been in service for greater than 15 years since 2009 are increasing.]

Many of the failure reports in the industry data do not reach the threshold of NRC reportability and do not involve performance deficiencies that rise to a level that would be documented in an inspection report. This study focused only on those inspection findings and LERs that met the criteria either for reportability or for a more than minor performance deficiency. IOEB determined that the majority of these failures occurred with components that typically are within the scope of the Maintenance Rule (see Figure 1 below).

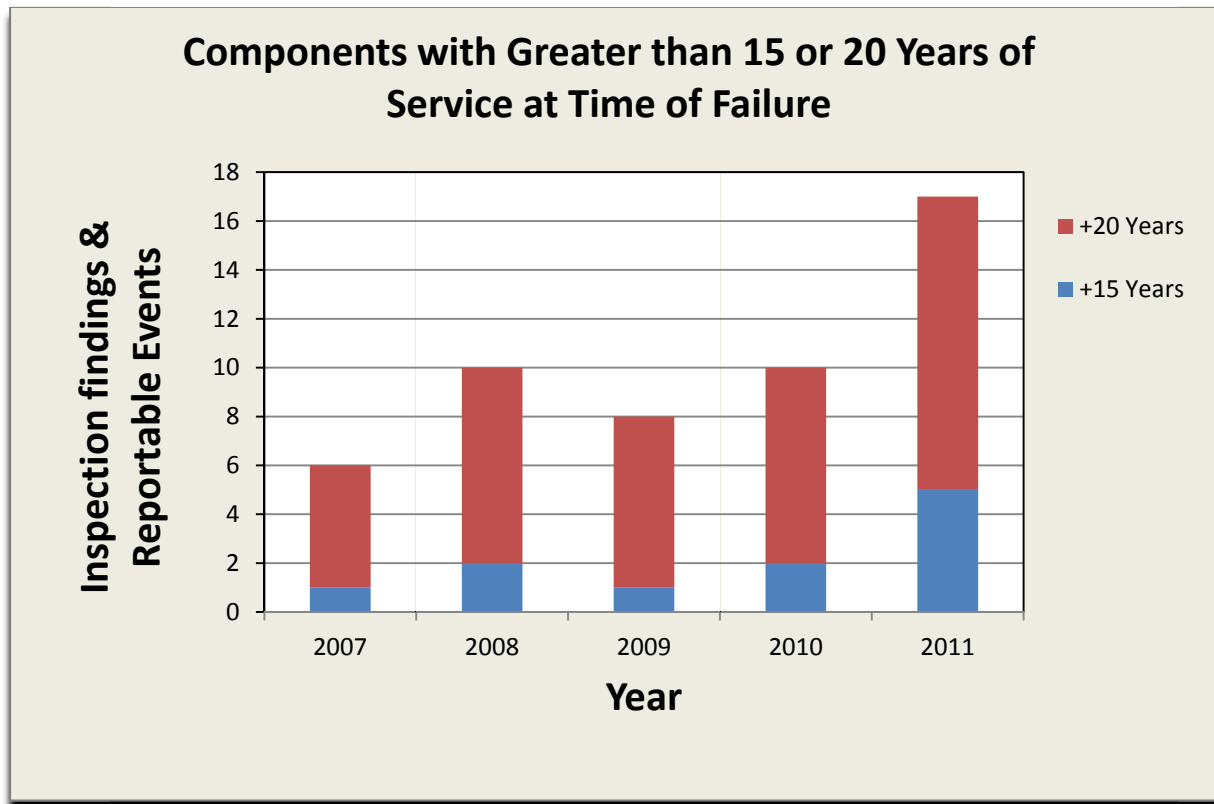
Figure 2: 2007-2011 Inspection Findings & LERs Involving SSCs with a Known In-Service Time of 15/20 Years or Greater

One hundred and five (105) inspection findings and LERs were identified for the years 2007-2011 that involved age-related degradation of SSCs associated with safety-related and important-to-safety equipment (see the Appendix). Although the data set may not be statistically significant, the number of findings involving failures of SSCs that have been in service for 15-20 years or greater has been gradually increasing since 2009. About 50 percent of the 105 inspection findings and LERs involved SSCs that were known to have been in service for at least 15 years, with a majority in service for greater than 20 years, and some with in-service times approaching 40 years (see Figure 2 below). Although in-service time could not be determined for approximately 30 percent of the failures, it is probable that since the failures were all age-related, most of the components involved were in service for greater than 15 years.

More than 70 percent (77 findings) of the 105 inspection findings and LERs involve age-related failures of SSCs that were in service beyond expected service life. Many of the SSCs left in

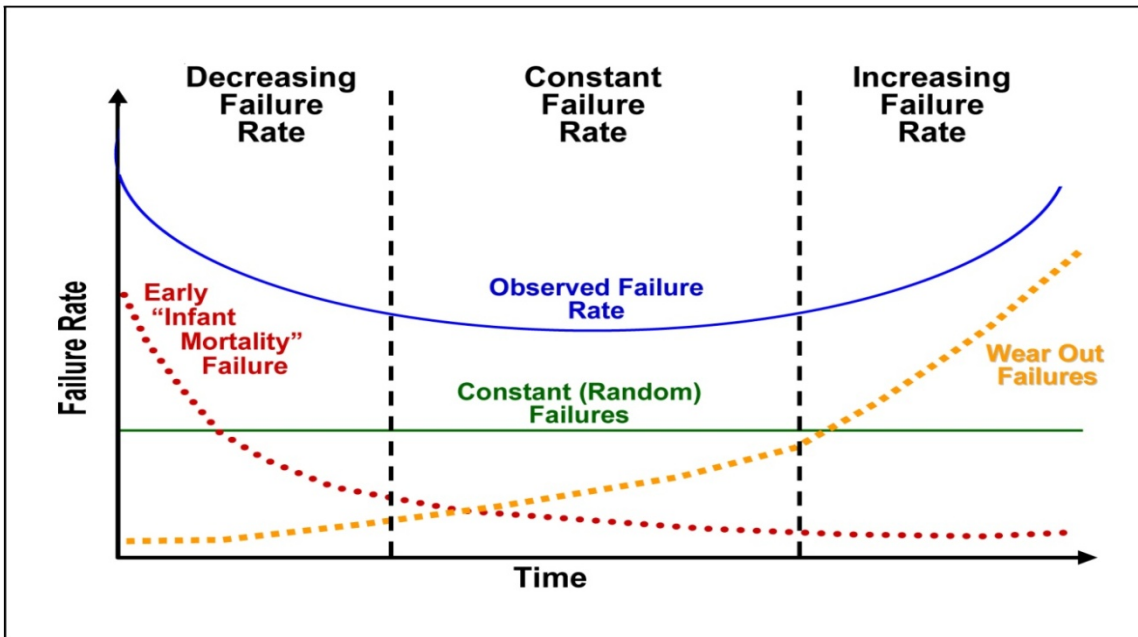
Figure 3: Bathtub Curve Hazard Function

Performance-based maintenance is at the heart of the NRC's Maintenance Rule. Performance-based maintenance is typically performed on safety-related equipment, and several industry studies cite this strategy as best suited for monitoring SSC performance and maintaining component reliability. The bathtub curve occupies a place of considerable importance in reliability practice, although it is not without criticism, particularly with some of the underlying assumptions with infant mortality on the left side of the curve (see Figure 3 and IEEE Transactions on Reliability, Vol. 52, No. 1, March 2003).

But, for those SSCs operating beyond their qualified service life (i.e., on the right side of the bathtub curve), performance-based maintenance, if not used in conjunction with other preventive maintenance strategies, may not be enough to ensure continued reliability. Without an effective life cycle management program, it is likely that plants are, or soon will be, operating equipment in that portion of the Bathtub Curve where the probability of experiencing failures is notably increased. The data compiled by this study suggests that some licensees did not implement effective life cycle PM strategies, despite the fact that they were conducting performance-based maintenance in accordance with the Maintenance Rule. Life cycle management takes into account preventive and predictive measures, refurbishment intervals, and ultimately, equipment replacement. However, there are a growing number of plants approaching (and exceeding) 40 years of operation that still have equipment in service that dates to original plant startup.

Station transformers are an example of how highly reliable components can fail when left in service without adequate life cycle maintenance, showing a decrease in reliability consistent with operation on the right side of the Bathtub Curve. In 2008, the industry identified an increasing trend in transformer failures from 1991-2001, and in 2009, IOEB conducted a review of large oil-cooled transformers failures from 2007-2008. Although many station transformers are not safety-related, they still fall within scope of the Maintenance Rule. The NRC staff found that some licensees were not maintaining station transformers in accordance with established PM practices as recommended by vendor and industry guidelines. The staff also noted that large transformer failures resulted in six declared events and that the primary contributors to the trend were: 1) over-reliance on contractors to perform maintenance, 2) equipment no longer supported by the original manufacturer, 3) non-standard designs, and 4) loss of technical knowledge on high voltage equipment. The industry noted that many transformer failures occur because *life cycle management* of transformers is a concept that has not been widely practiced.
