SUBJECT: Media Alert - Chart of three modes of San Onofre Unit 2 operation, 100%, 70% and MSLB with multiple tube failures

**The DAB Safety Team: February 27, 2013**

### Charts: San Onofre Unit 2 Modes Of Operation

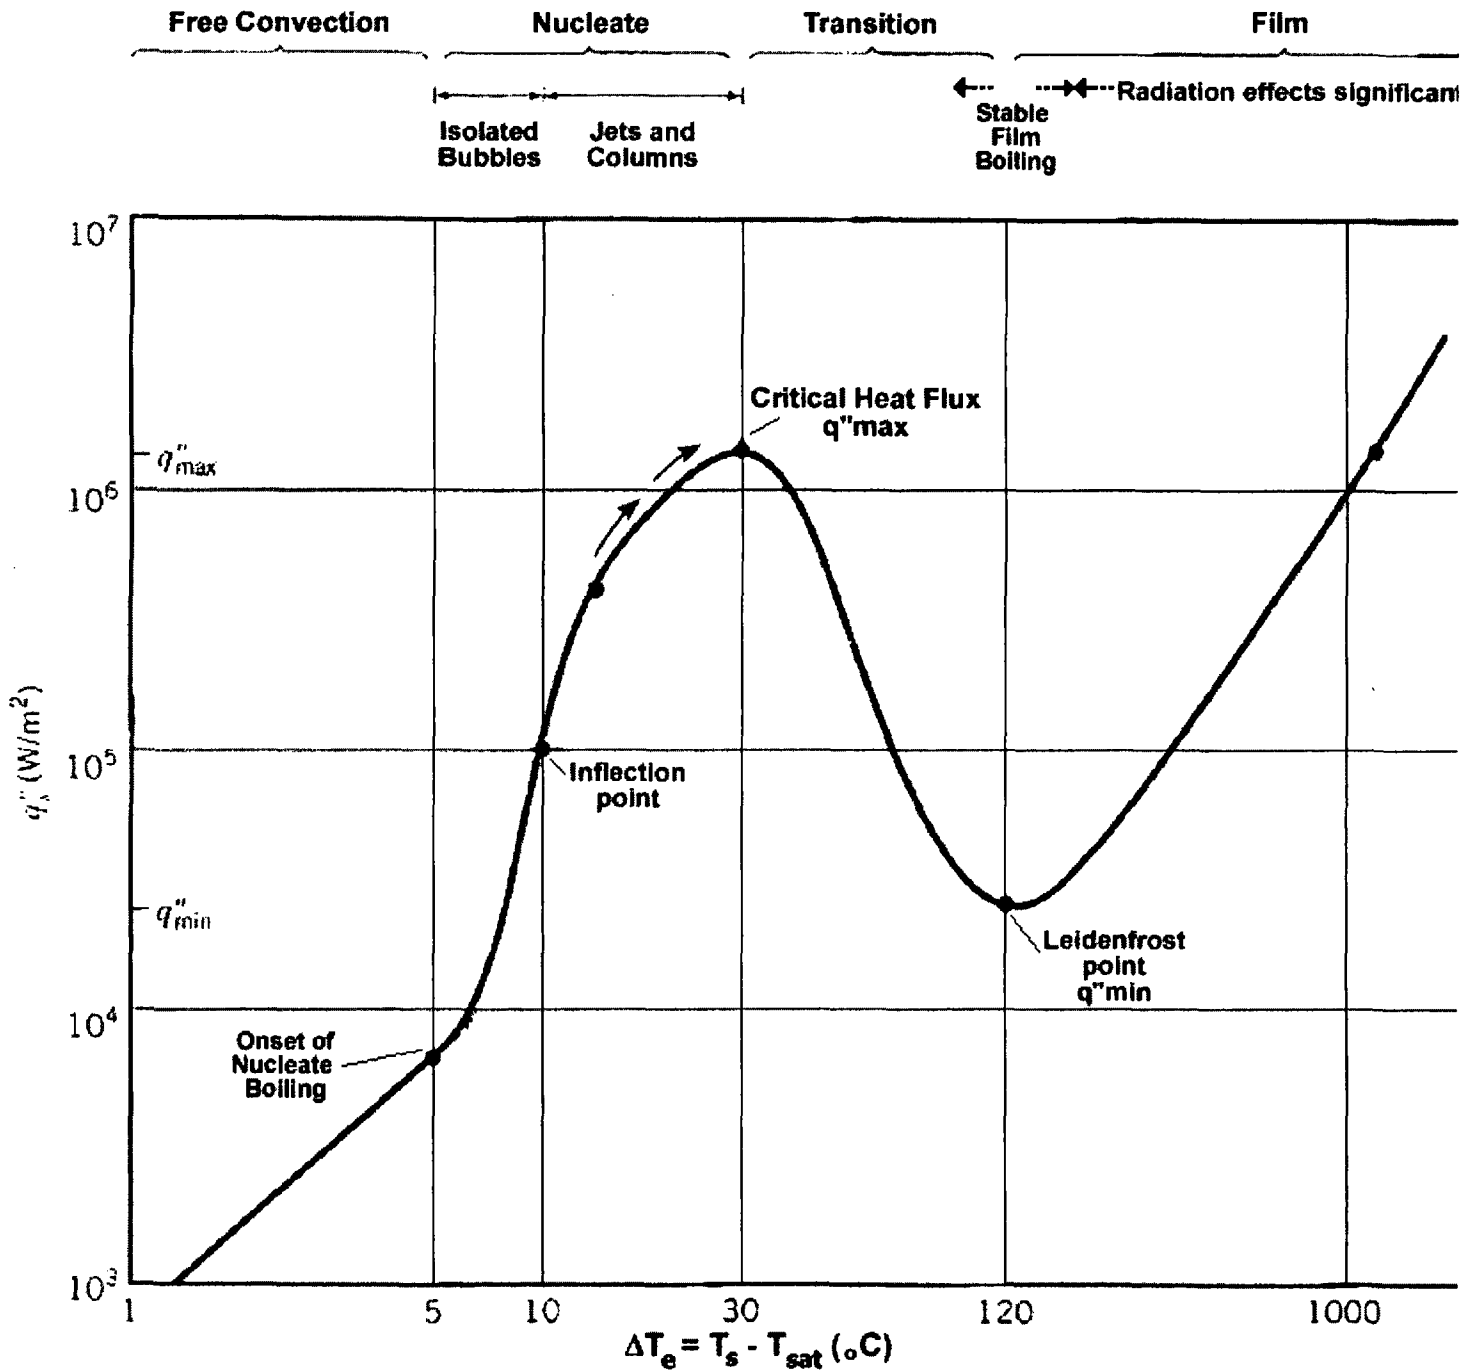
### Boiling Regimes

**Boiling Curve for water at 1 atm.**  
 Surface heat flux  $q''$  as a function of excess temperature  $\Delta T_e = T_s - T_{\text{sat}}$

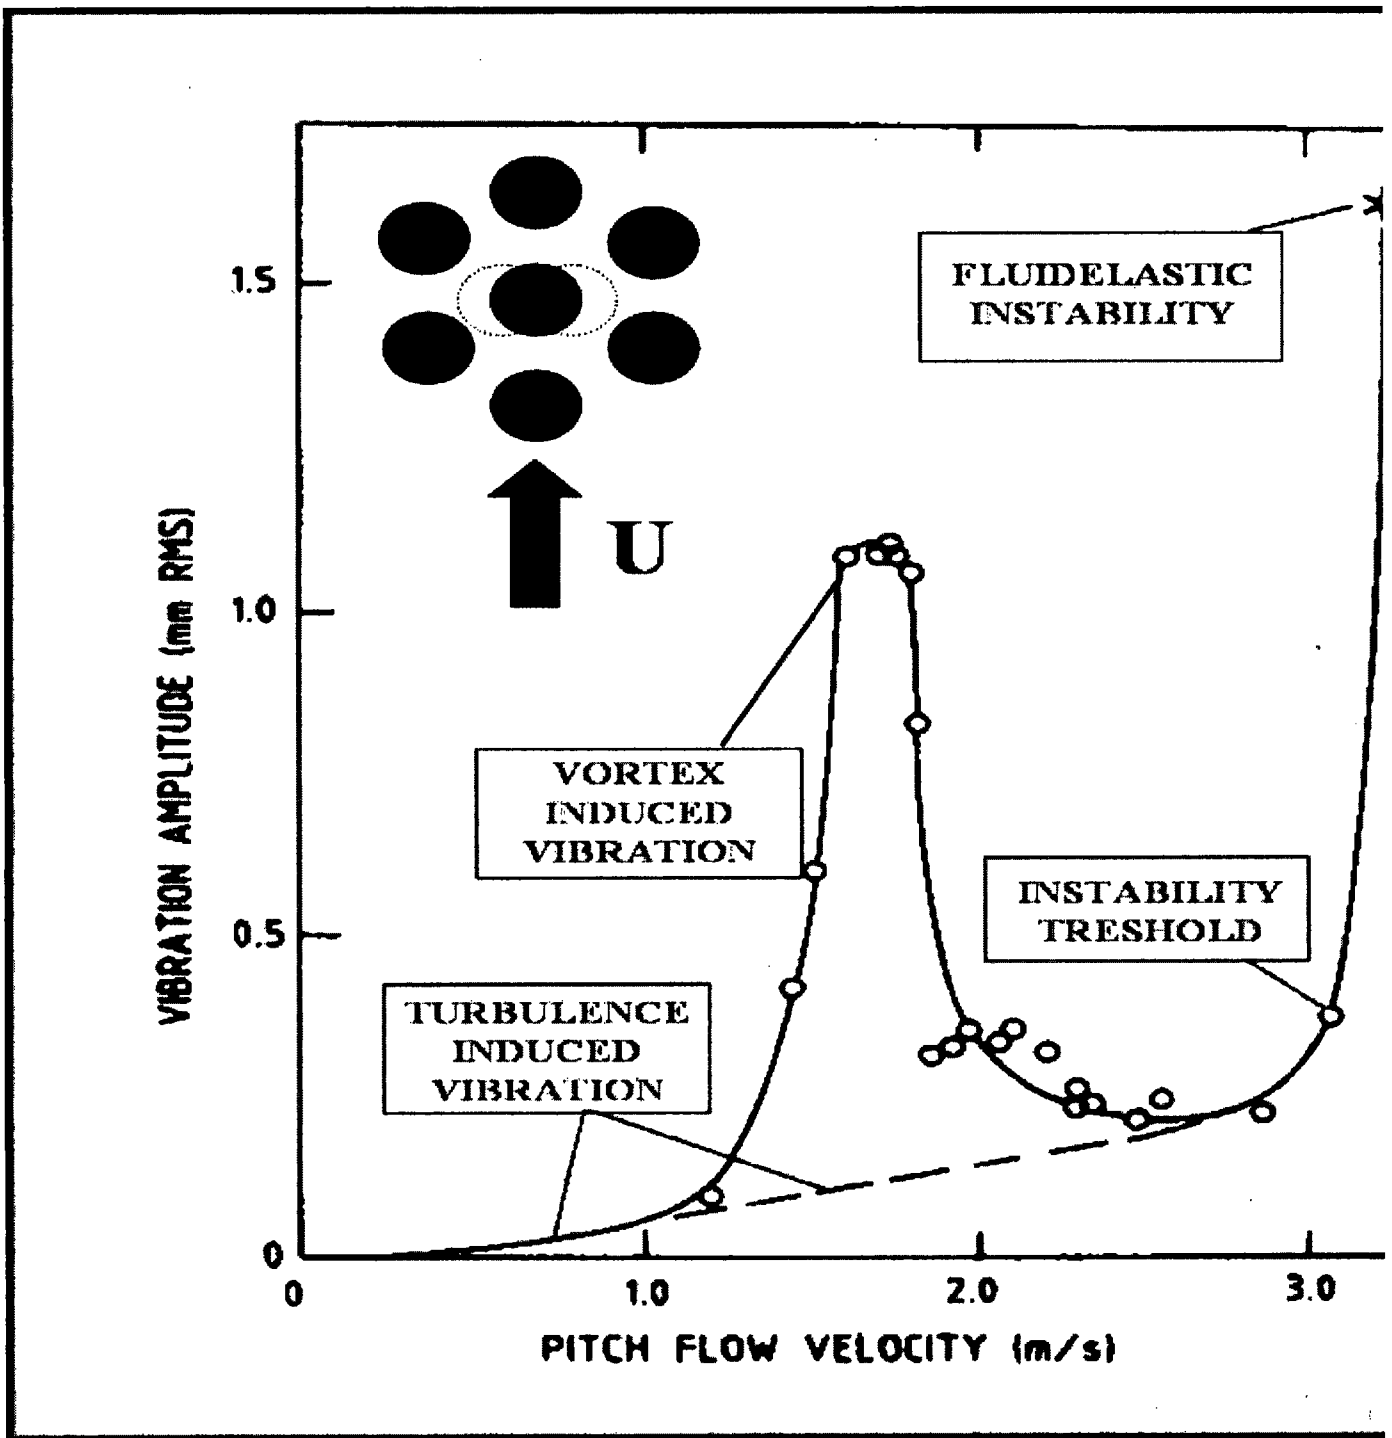
Figure 1 – Vibrations amplitude as a function of flow pitch velocity for a flexible cylinder in a rigid duct (from Pettigrew et al. 1991). The cylinder is free to vibrate in the cross-flow direction.
