WCAP-17369-NP
Revision 1

February 2013

ABWR Dryer Operating Experience for STP Units 3 and 4

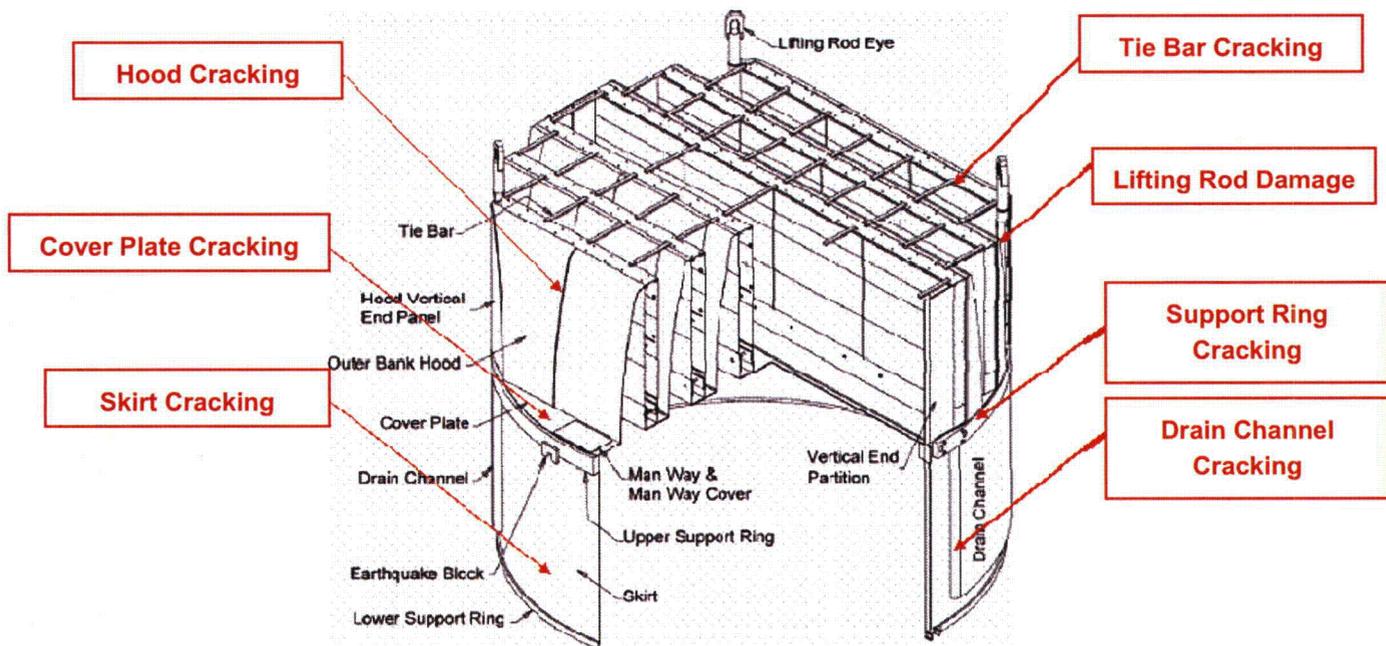
Figure 4-1 Field Cracking in BWR Steam Dryers

Figure 4-1 shows the different locations where cracking has occurred in BWR steam dryers. BWRVIP-139-A Figure 2-51 (Reference 2) shows the number of U.S. BWR plants with steam dryer cracking (by location). It is seen that the support ring and the drain channel welds are the most likely locations for cracking. The details of the cracking, cause and design fixes or repairs are discussed below:

Drain channel cracking has occurred in many U.S. BWR dryers and is attributed to high cycle fatigue and IGSCC. In Type 304 stainless steel dryers, welded regions are subject to weld sensitization and the weld heat affected zone (HAZ) can experience IGSCC. However, even when crack initiation is due to IGSCC, subsequent crack growth can occur due to fatigue. There have been many instances of fatigue cracking in the drain channel welds. The cracks were generally through the throat of vertical welds that attach the side of the drain channel to the exterior of the dryer skirt. The cracks are thought to have originated at the bottom of the drain channel where there is maximum stress in the welds. The high fatigue strength reduction factor at the fillet weld, weld residual stresses and flutter vibration of the relatively thin drain channel are believed to be the contributors to the cracking. The design fixes for the cracking include stop-hole drilling at the crack tip (short term) and increasing the weld size. The weld was also modified to wrap around the bottom of the attachment (where the drain channel is open at the end) to eliminate the sharp notch.

Support ring cracking has been found in many U.S. BWRs (at least 19 plants). The accepted cause of cracking has been IGSCC with potential contributors being weld sensitization and cold working during the fabrication process. Unlike fatigue crack growth, IGSCC crack growth rates decrease as the crack driving force from the residual stress attenuates. Most plants with support ring cracking have chosen to monitor the cracks and no repairs are planned.

Tie bar fatigue cracking has been reported in several U.S. BWR plants. The tie bars connect different dryer banks and increase the overall stiffness of the dryer. Fatigue cracking has been observed in plants with slender tie bars made of angle iron. The fact that plants with stiffer tie bars have not experienced fatigue cracking suggests that the potential for cracking is related to the size of the cross section of the tie bar itself.

Outer hood cracking has occurred in 11 U.S. BWR plants, more often so in square hood design dryers. These hood cracks were attributed to high cycle fatigue. The curved hood provides higher structural capability when compared to the square hood designs. The fix for the hood cracking has been to increase the weld size and in some cases, increase the thickness of the hood plate.
