Annual Radioactive Waste Tank Inspection Program - 2011

Savannah River Remediation

R. S. Waltz, Jr.
W. R. West

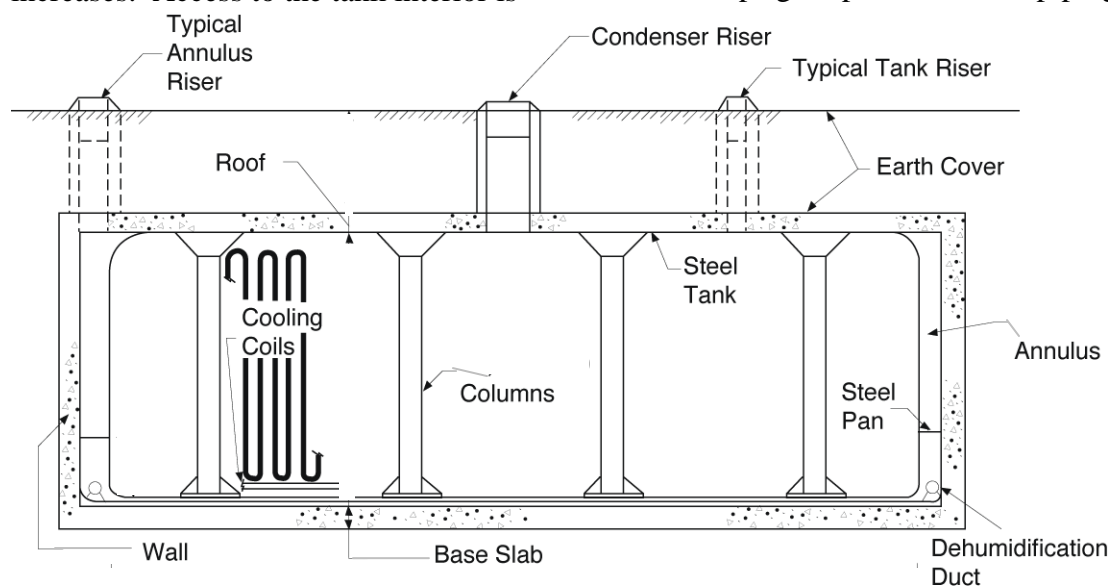
Figure 1. Cooled Waste Storage Tank, Type I (Original 750,000 Gallons).

The 12 original storage tanks constructed between 1951 and 1953 are designated Type I tanks. Tanks 1 through 8 are in F Area and Tanks 9 through 12 are in H Area. Each primary tank has a capacity of 750,000 gallons. Figure 1 shows the general features of Type I tanks, including the primary tank, the secondary pan, and the concrete support structure.

provided at eight locations, and to the annular space at four locations, through riser pipes. Each of the 12 riser pipes is capped at the top with a concrete plug. Each plug is provided with two 5-inch-diameter ports equipped with removable plugs unless equipment has been installed to support waste removal or tank closure activities. The center plug port may provide access through three 4 to 8 inch diameter ports. Some of these ports provide access for inspections.

All welds in the pan and primary tank were radiographically inspected, defects were corrected, and the welds were rechecked radiographically. The welds in the flat bottoms of both the pan and tank were vacuum-tested for leaks. Additionally, both vessels were hydrostatically tested. The water was maintained at full height in the tank for 24 hours before inspection for leaks was made. Cooling water piping was hydrostatically tested at 300 psig and then leak-tested with 100 psig air pressure in the piping.

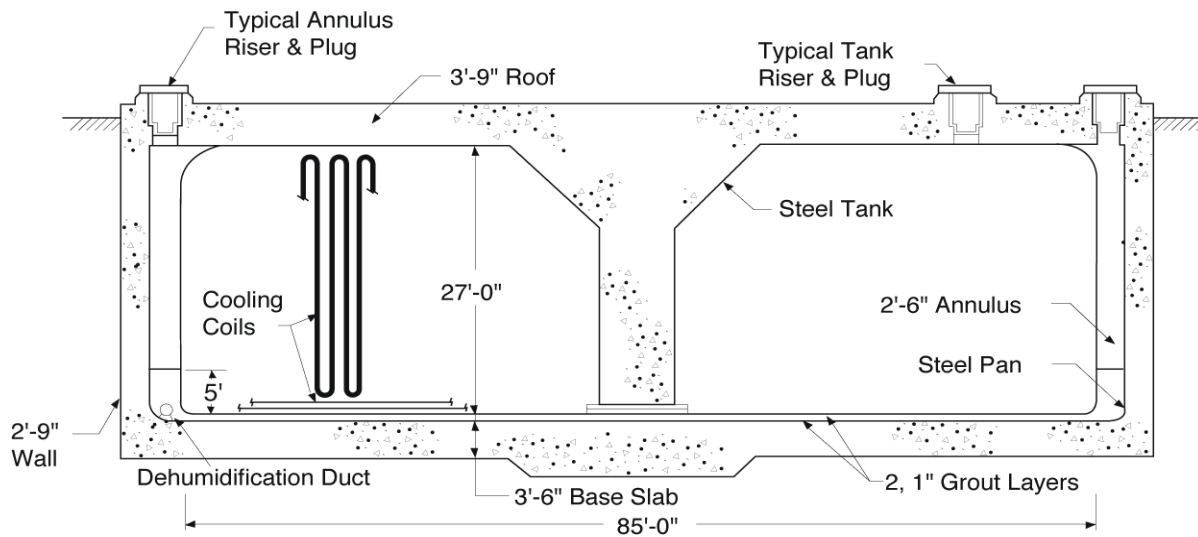
Figure 2. Cooled Waste Storage Tank, Type II (Original 1,030,000 Gallons).

Tanks 13 through 16, constructed in H Area in 1955 and 1956, are designated Type II tanks. Figure 2 is a cross section of this type of tank. Each primary tank has a capacity of 1,030,000 gallons.

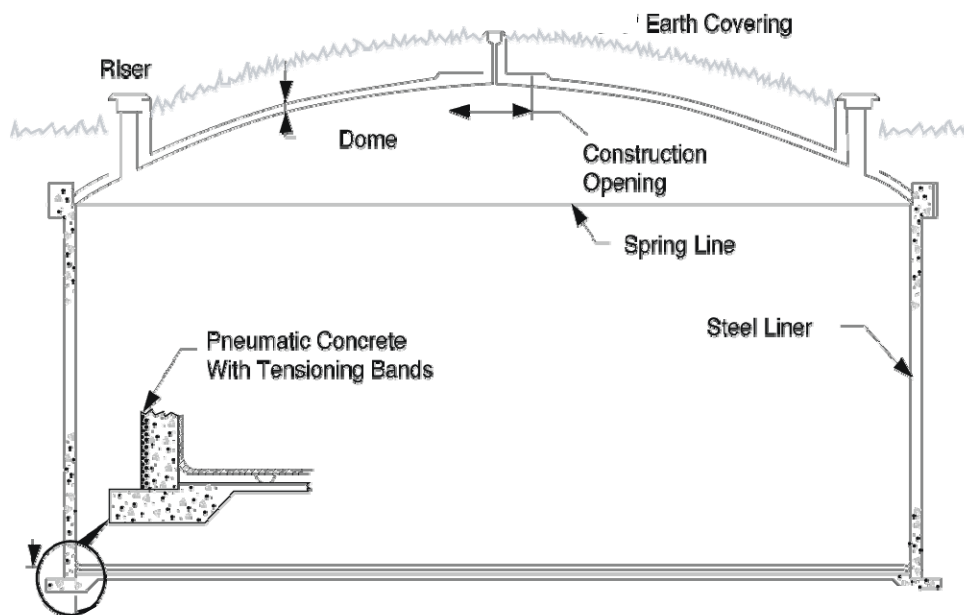
Figure 3. Uncooled Waste Storage Tank, Type IV (Prestressed Concrete Walls, 1,300,000 Gallons).

1,300,000 gallons. Figure 3 shows the general features of Type IV tanks. Each Type IV tank is basically a steel-lined, prestressed-concrete tank in the form of a vertical cylinder with a domed roof. Carbon steel plates were used to form the cylindrical sides and flat bottom portion of the steel liners. Concrete was built up around the steel vessel by the "shotcrete" technique.

Access to the interior of the tank is provided at six locations through riser pipes. Each riser pipe is capped at the top with a concrete plug. Some of these risers provide access for inspection.

All welds in the steel liners were radiographically inspected. All of the welded tank-bottom seams and the upper seams of the knuckle rings were vacuum leak-tested. Prior to the back-filling operation, each tank was hydrostatically tested by filling with water to the normal fill line. The tank was allowed to remain filled until it was to be placed in use for waste storage.

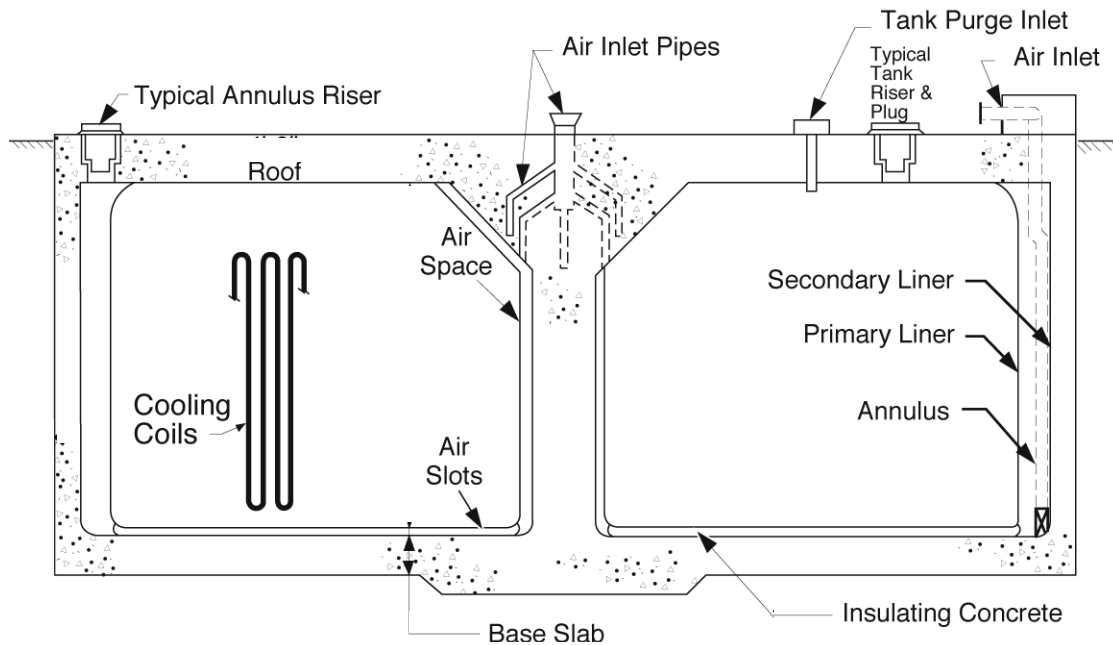
Figure 4. Cooled Waste Storage Tank, Type III (Stress Relieved Primary Liner, 1,300,000 Gallons).

The most recently constructed tanks are designated as Type III tanks (Figure 4). Twenty-seven tanks were built between 1966 and 1981. Figure 4 shows the general features of the Type III tanks. Type III tanks are designated as compliant. The Type III tank design was developed after an investigation into the causes of the leaks from the primary vessel of the Type I and Type II tanks. The study concluded that the leak-producing mechanism was nitrate-induced, stress-corrosion cracking at sites in or near the weld seams, and that stress relieving after fabrication should eliminate the cracking. For the Type III tanks, means were provided for heating each finished tank to relieve the stresses generated during fabrication. In addition, some stress patterns were avoided, or minimized, by mounting the roof supporting column on the foundation pad rather than on the bottom of
