PSEG Power, LLC

PSEG Site ESPA  
Part 2, Site Safety Analysis Report

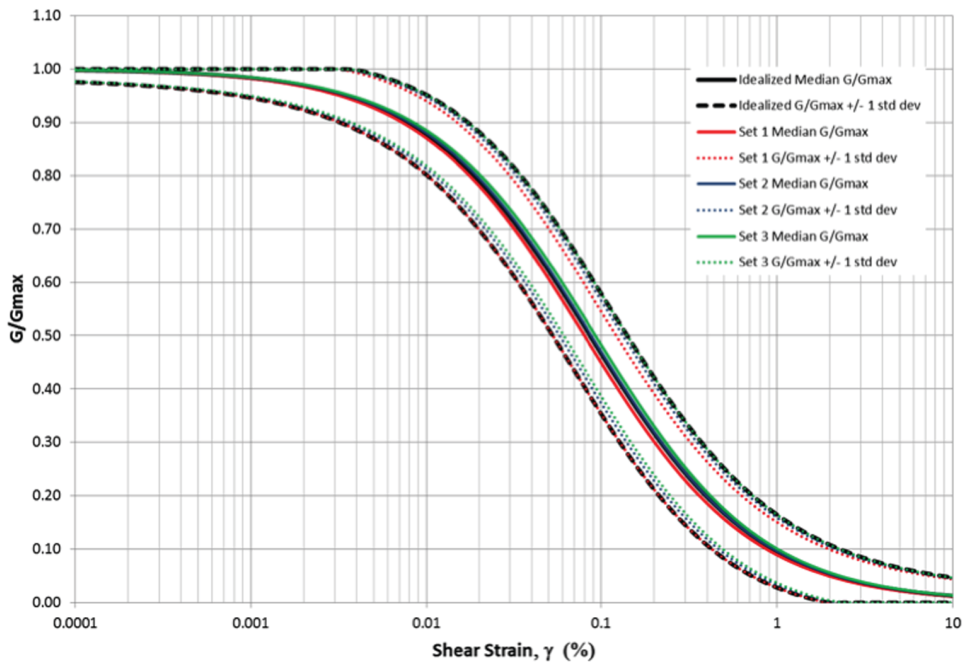
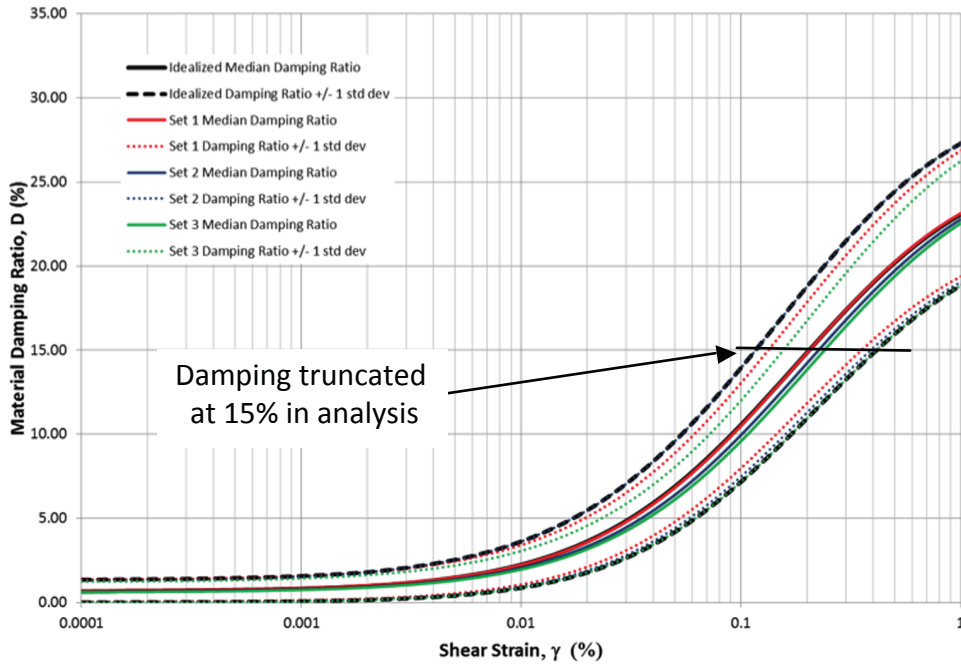
FIGURE 2.5.2-80 Rev 0

G/Gmax and Material Damping  
Curves for Soil Layers 9A and 9B
