# WOLF CREEK NUCLEAR OPERATING CORPORATION

March 29, 2013  
ET 13-0012

Subject: Docket No. 50-482: Request for Review of Information to Support Resolution of Example 2 of Non-cited Violation 05000482/2011007-03, "Failure to Ensure Post-Fire Safe Shutdown Components Remain Free of Fire Damage"

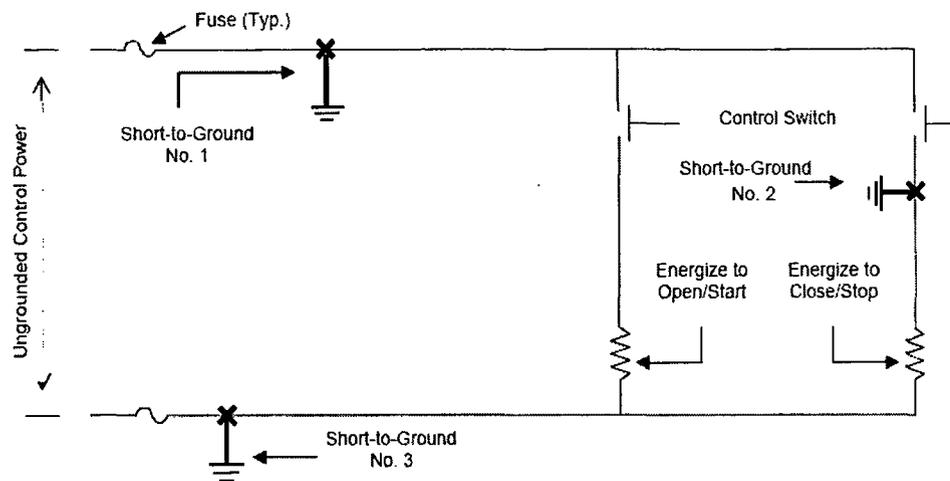
Figure 3.5.2-3: Short to Ground  
(Ungrounded Control Circuit)

Figure 3.5.2-3 in NEI 00-01 illustrates how a short to ground fault may impact an ungrounded circuit.

#### "Short-to-ground No. 1

#### "Short-to-ground No. 2

A short-to-ground at location No. 2 will have no effect on the circuit until the close/stop control switch is closed. Should this occur, the effect would be identical to that for the short-to-ground at location No. 1 described above. Should the open/start control switch be closed prior to closing the close/stop control switch, the equipment will still be able to be opened/started. If multiple grounds can occur in a single fire area, they should be assumed to occur simultaneously unless justification to the contrary is provided. Note that a simultaneous short-to-ground at locations No. 1 and No. 2 could result in a spurious close/stop. This condition is identical to that portrayed in Figure 3.5.2-5 should a hot short occur on the ungrounded circuit shown in Figure 3.5.2-5 at location No. 1."

From the guidance in NEI 00-01, for "important to safe shutdown" components (i.e., the pressurizer PORVs), multiple shorts to ground are to be evaluated for their impact on ungrounded circuits as explained in Figure 3.5.2-3. Figure 3.5.2-3 (see page 7 below) shows examples of the effects of shorts to ground on ungrounded DC circuits and illustrates that a single short to ground anywhere in the circuit will not cause a loss of control power to the circuit. In order for control power to be lost, another short to ground would have to exist somewhere in the circuit.

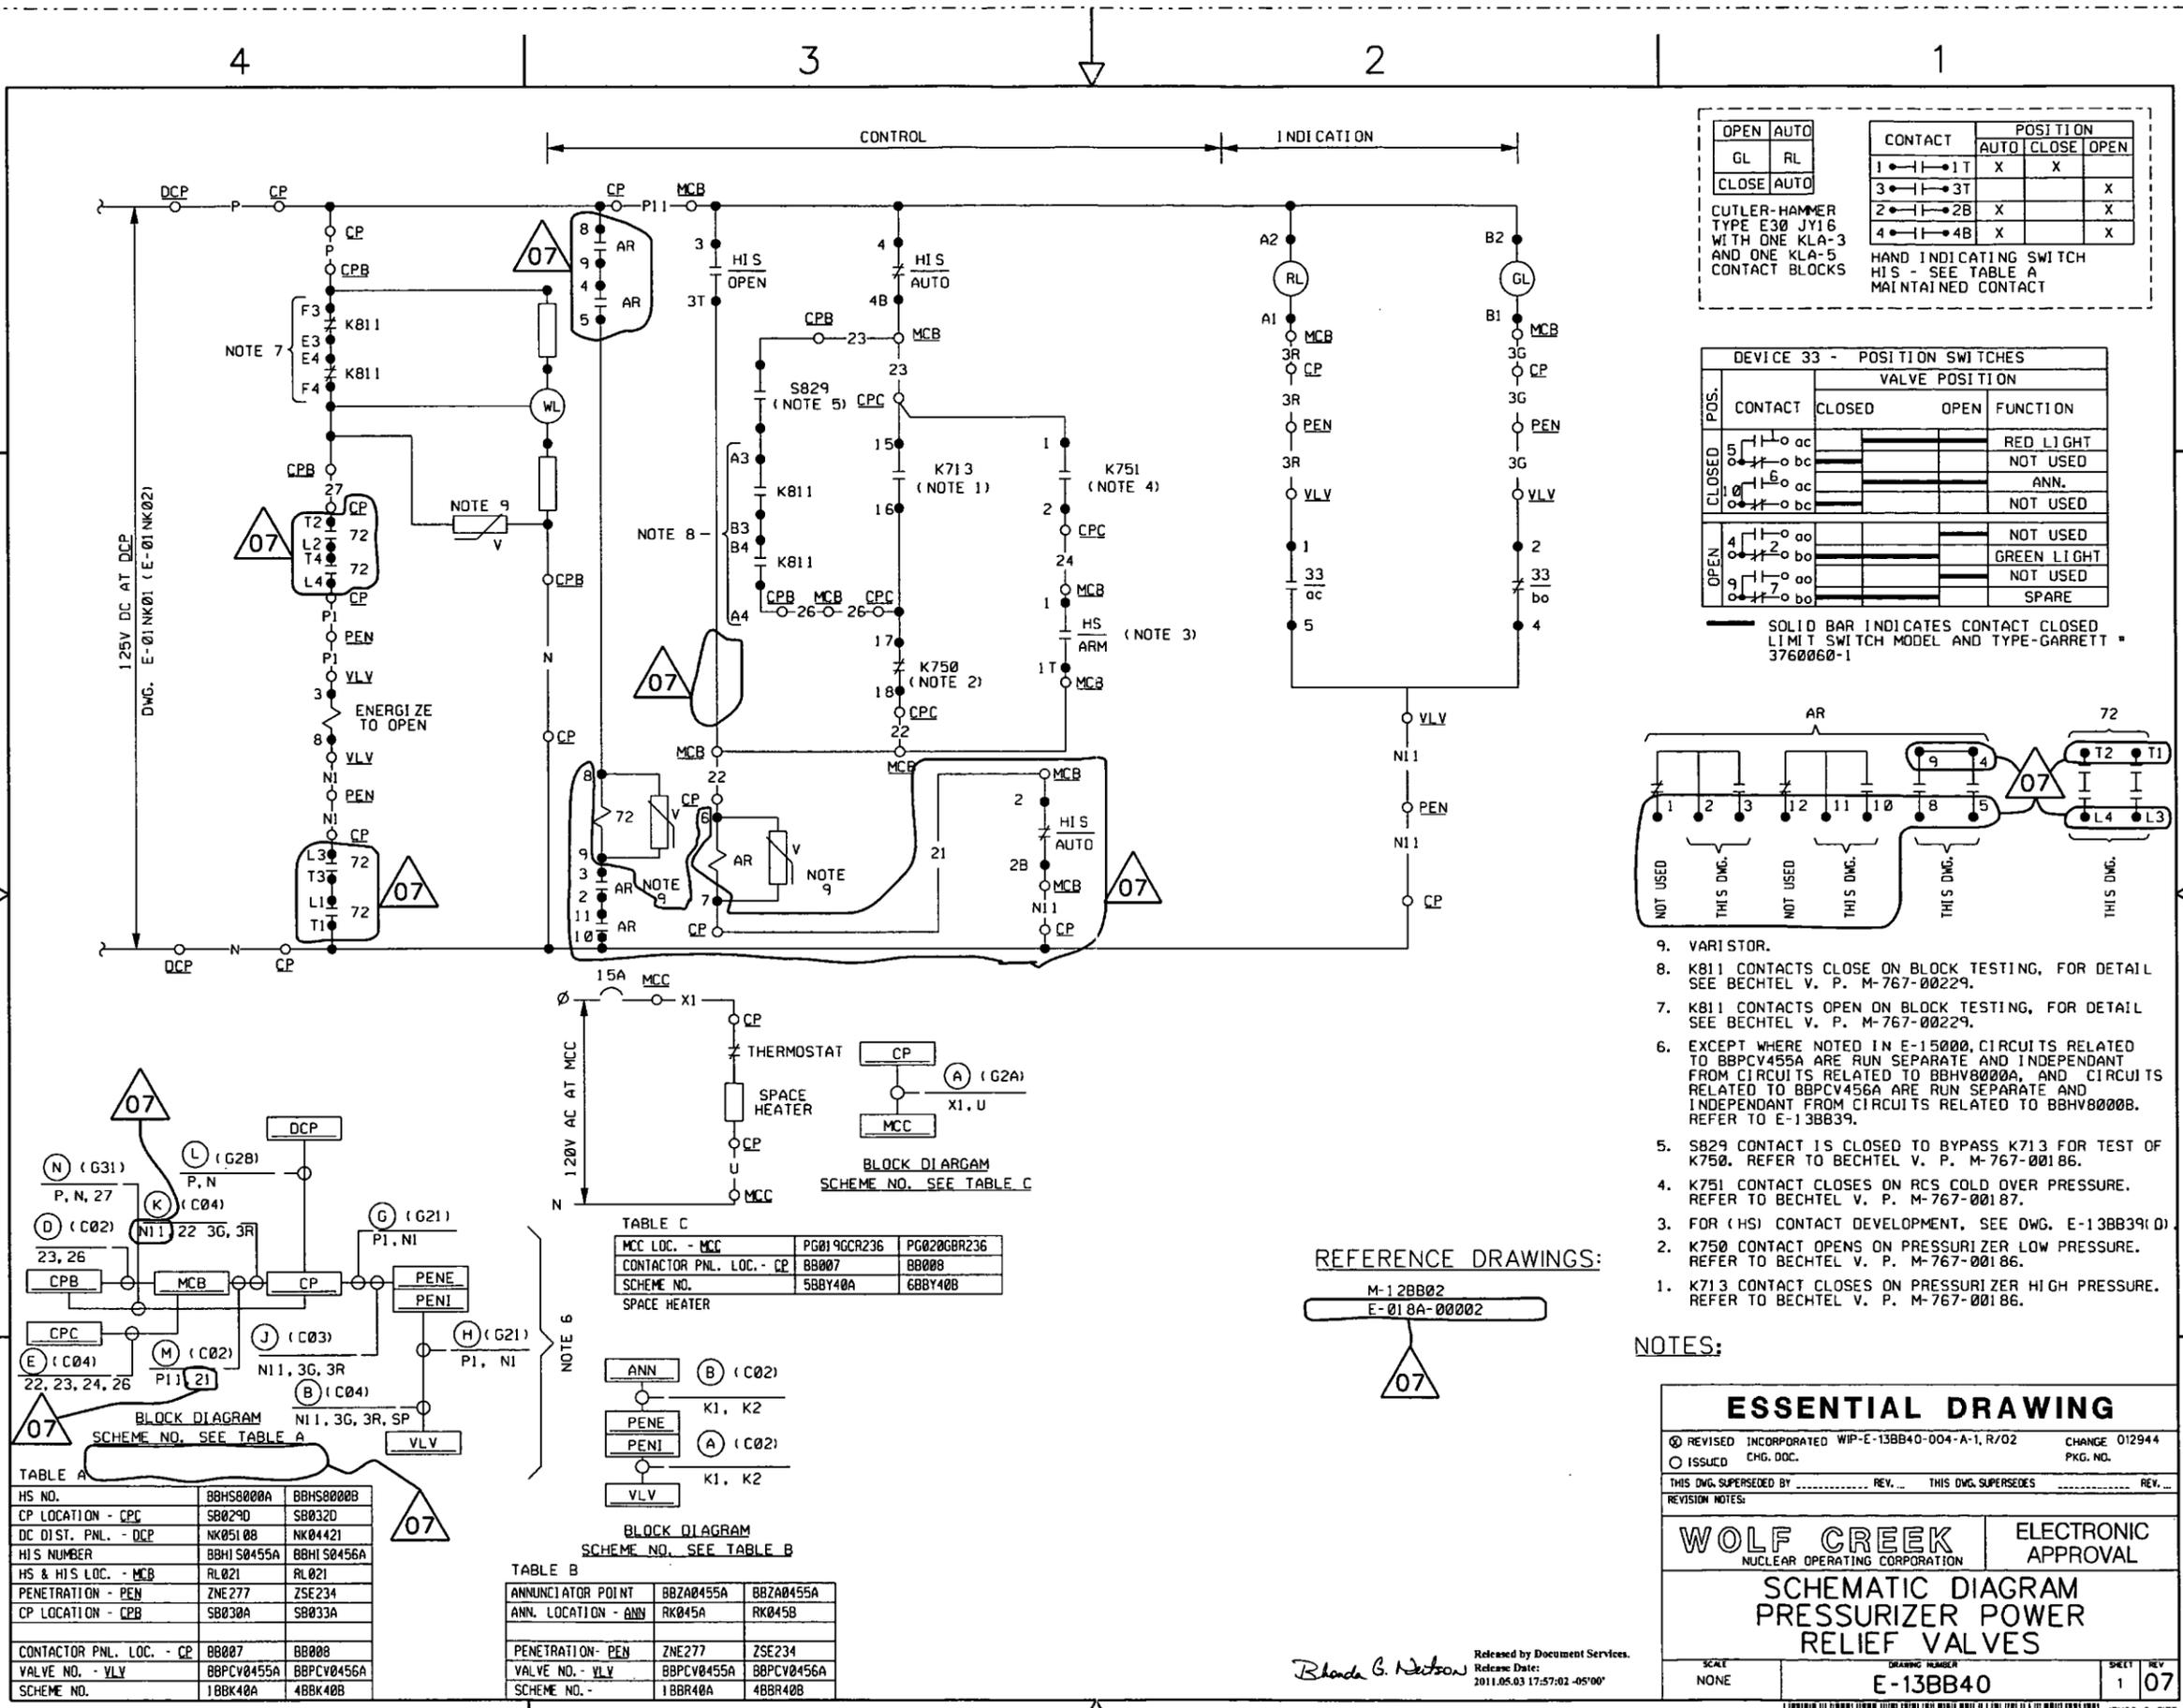
**Drawing E-13BB40**  
**Schematic Diagram Pressurizer Power Relief Valves**  
(1 page)

OPEN	AUTO	CONTACT			POSITION		
GL	RL	1	1T	X	X		
CLOSE	AUTO	3	3T			X	X
		2	2B	X			
		4	4B	X			X

CUTLER-HAMMER TYPE E30 JY16 WITH ONE KLA-3 AND ONE KLA-5 CONTACT BLOCKS  
HAND INDICATING SWITCH HIS - SEE TABLE A MAINTAINED CONTACT

DEVICE 33 - POSITION SWITCHES				
VALVE POSITION				
POS.	CONTACT	CLOSED	OPEN	FUNCTION
CLOSED	5	ac		RED LIGHT
	6	bc		NOT USED
	7	ac		ANN.
OPEN	4	oo		NOT USED
	2	bo		GREEN LIGHT
	1	oo		NOT USED
	3	bo		SPARE

SOLID BAR INDICATES CONTACT CLOSED  
LIMIT SWITCH MODEL AND TYPE-GARRETT 3760060-1

The pressurizer PORV circuits are not sealed in or latched. In the modified PORV circuit design shown in the Enclosure, consideration was given for multiple fire-induced circuit failures in at least two separate cables, consistent with the guidance in RG 1.189. The WCNO design considers any number of intra-cable hot shorts combined with a single proper polarity inter-cable hot short on cables located in the fire area of concern. Therefore, WCNO meets the guidance specified in RG 1.189, Section 5.3.
