## **Plan for Future Seismic Walkdown of Inaccessible Equipment**

Fifteen (15) items could not be walked down during the 180-day period following the issuance of the 10CFR50.54(f) letter since they are located in areas that are normally inaccessible. The items will be walked down during a unit outage or time when the equipment is accessible, as appropriate. Table E-1 summarizes the reasons each item is inaccessible during normal plant operation and notes the Dresden Station Issue Report (IR) that has been written to track completion of the Seismic Walkdowns (and Area Walk-bys) for these items. It is noted that SSCs identified on Table E-1 require a complete inspection including, as applicable, internal inspections of electrical cabinets for other adverse seismic conditions, as required.

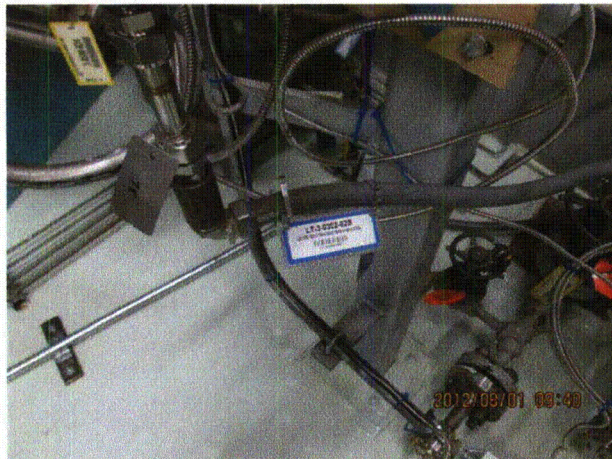
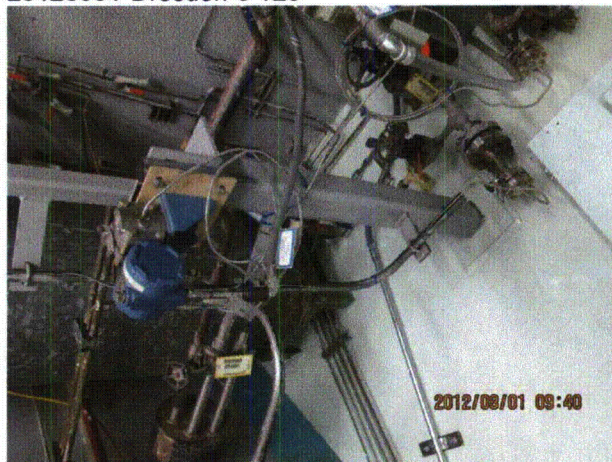
Equipment Description: CRD/ East Bank SDV Tank Level Transmitter

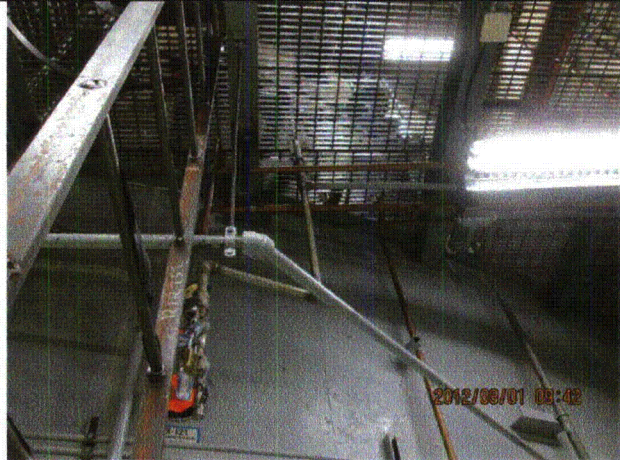
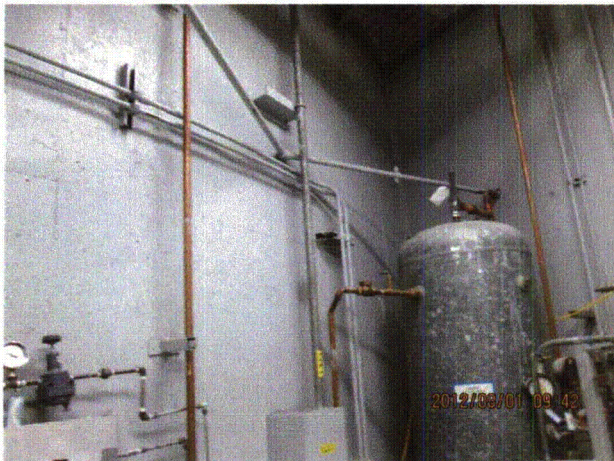
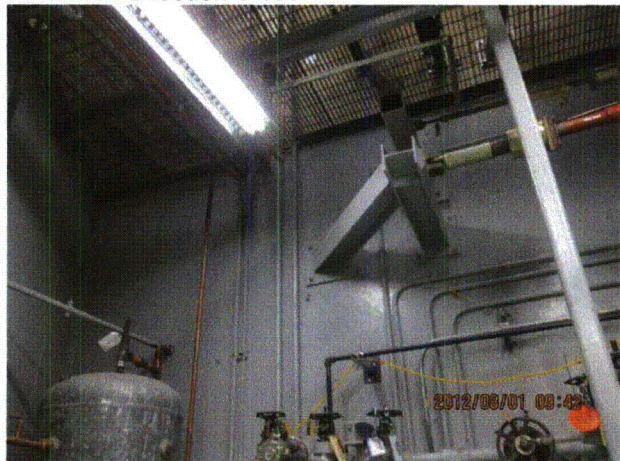
Equipment Description: CRD/ East Bank SDV Tank Level Transmitter

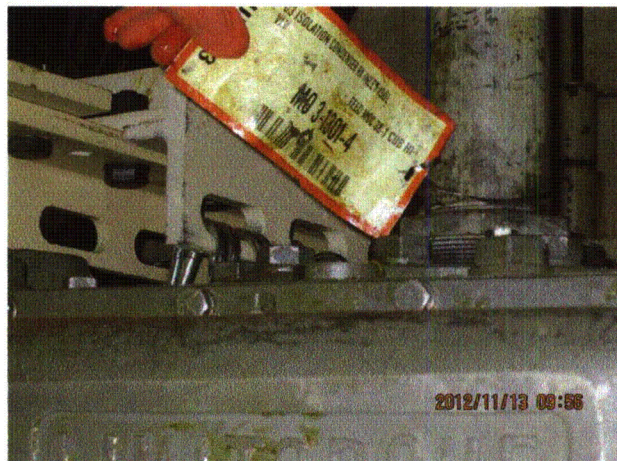
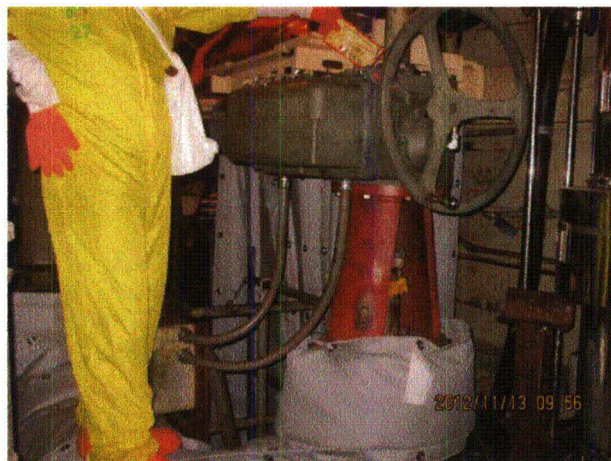
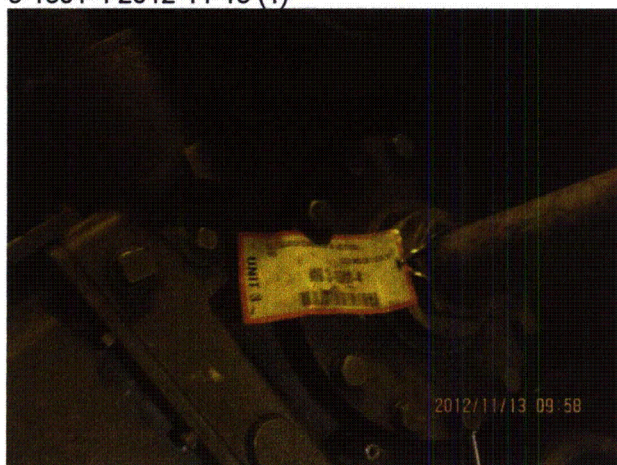
3-1301-4 2012-11-13 (1)

Equipment Description: ISOLATION CONDENSER/ Steam Return Line Isolation Valve

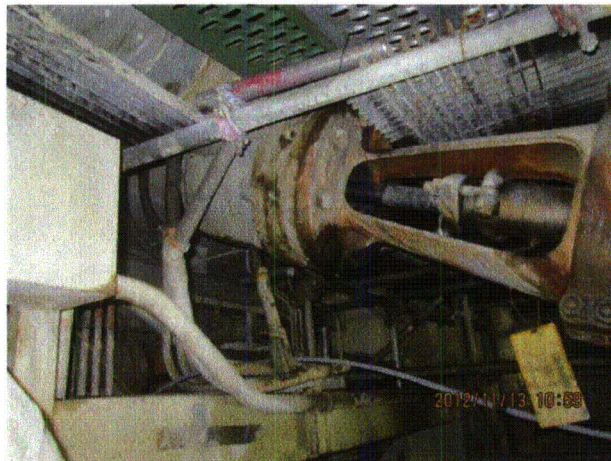
3-2301-8 2012-11-13 (1)

Equipment Description: HPCI/ HPCI Pump Injection Line Valve

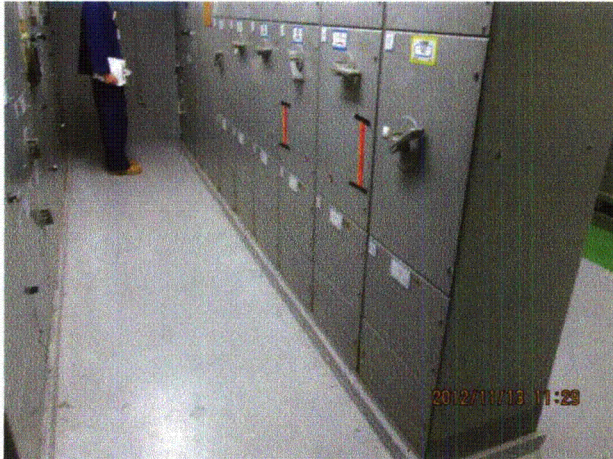
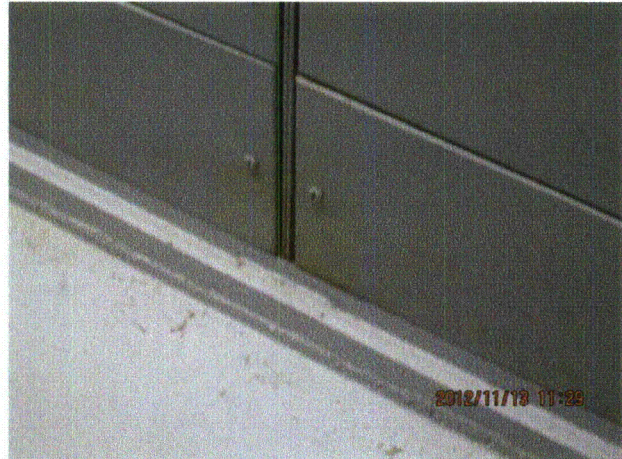
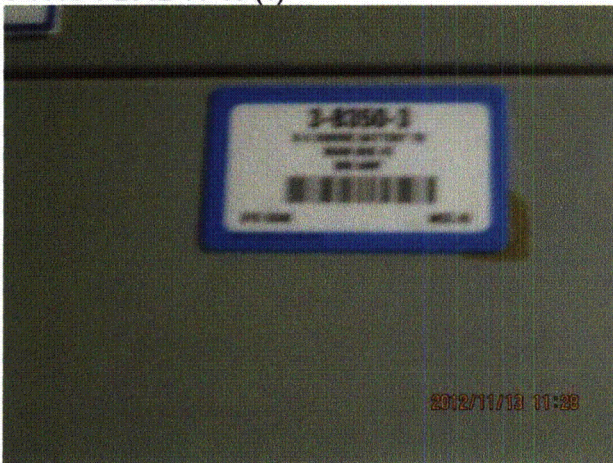
3-8350-3 2012-11-13 (1)

Equipment Description: 250V DC/ Breaker to TB MCC #3 (ROB-Battery #3)

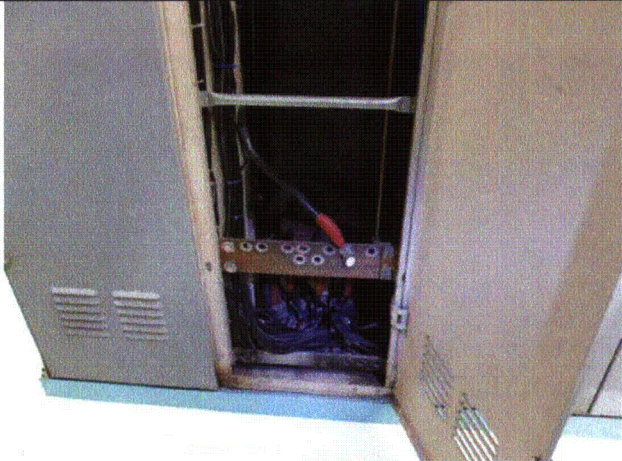
Equipment Class: (02) Low Voltage Switchgear

Equipment Description: 480V AC/ Switchgear 38

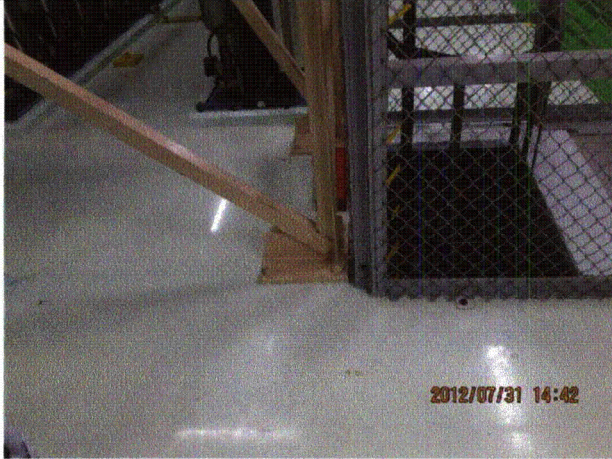
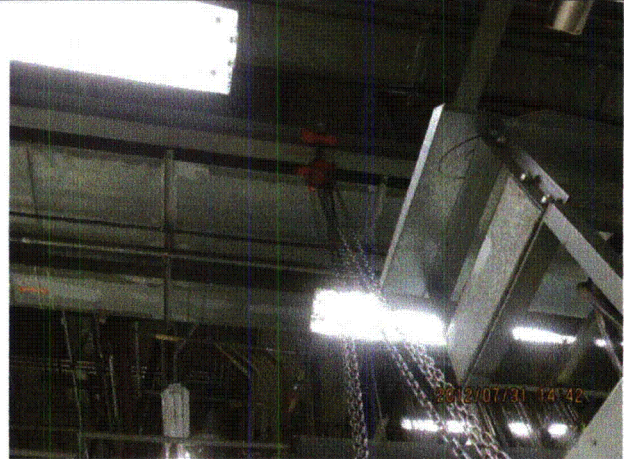
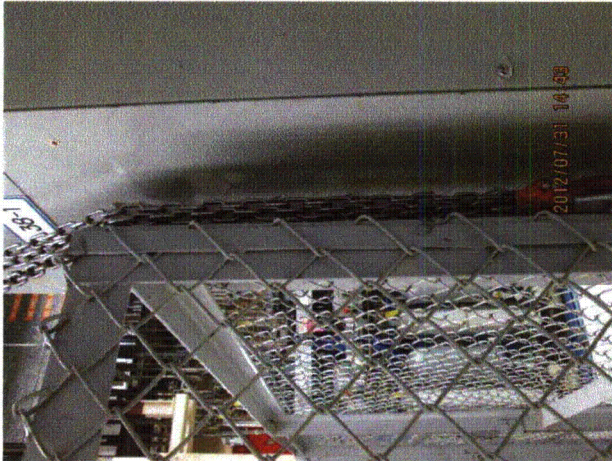
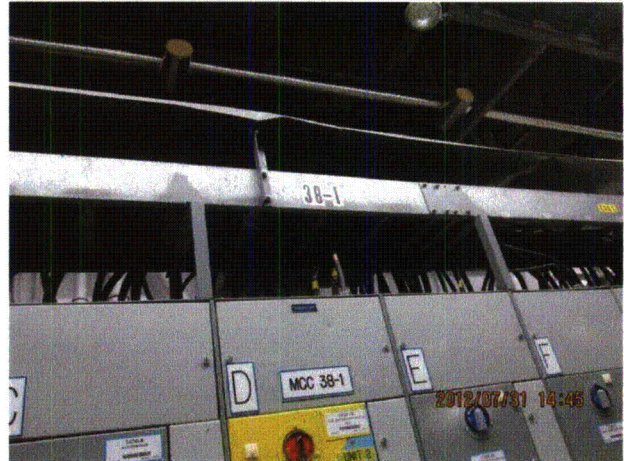
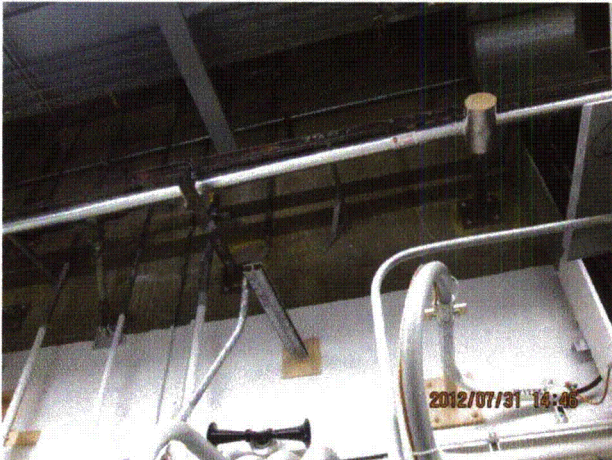
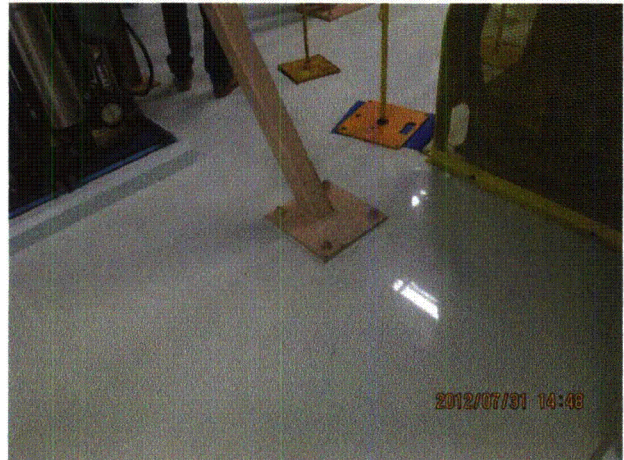
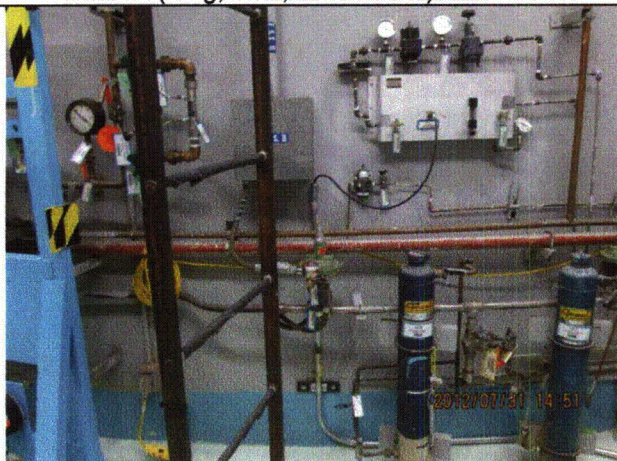
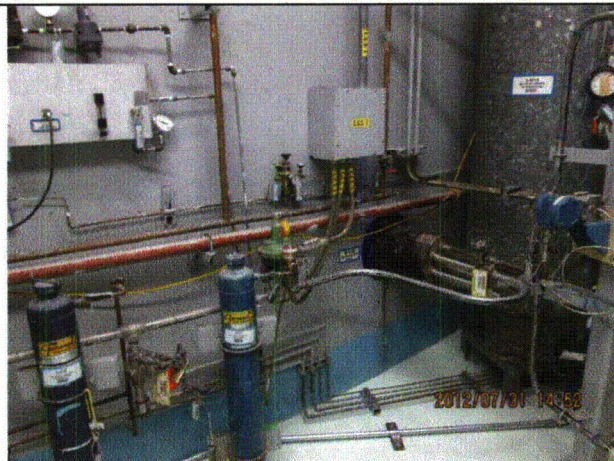
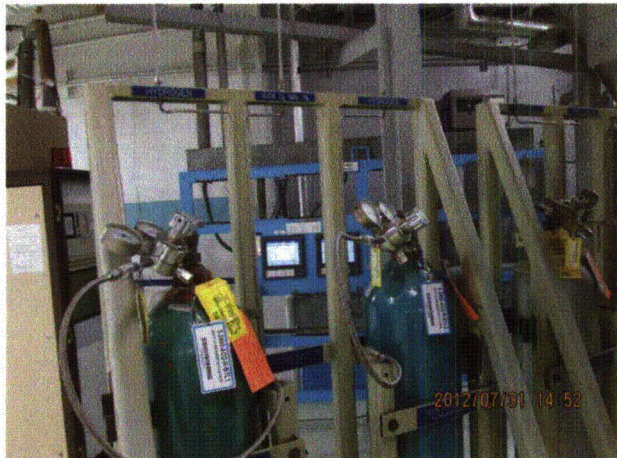
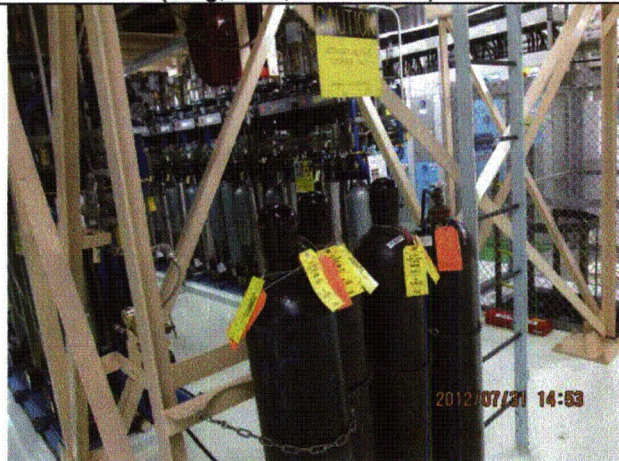
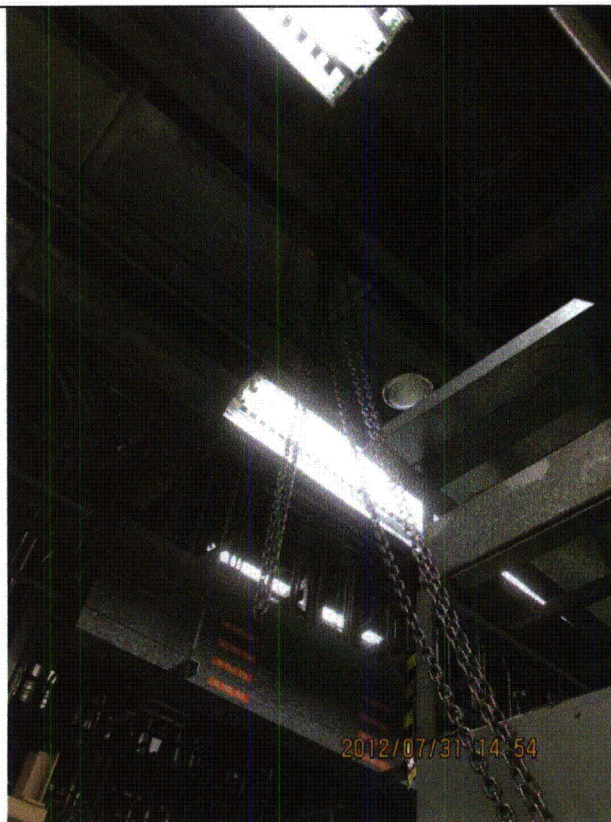
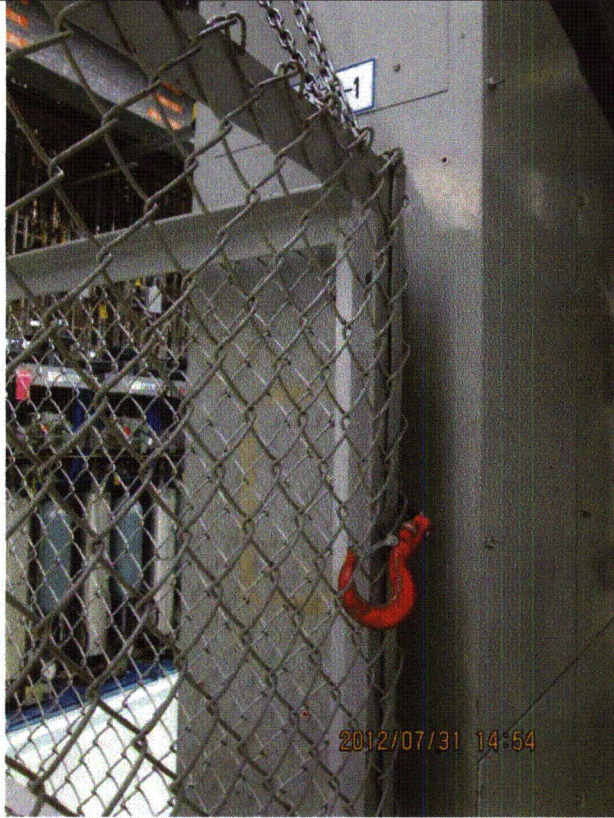
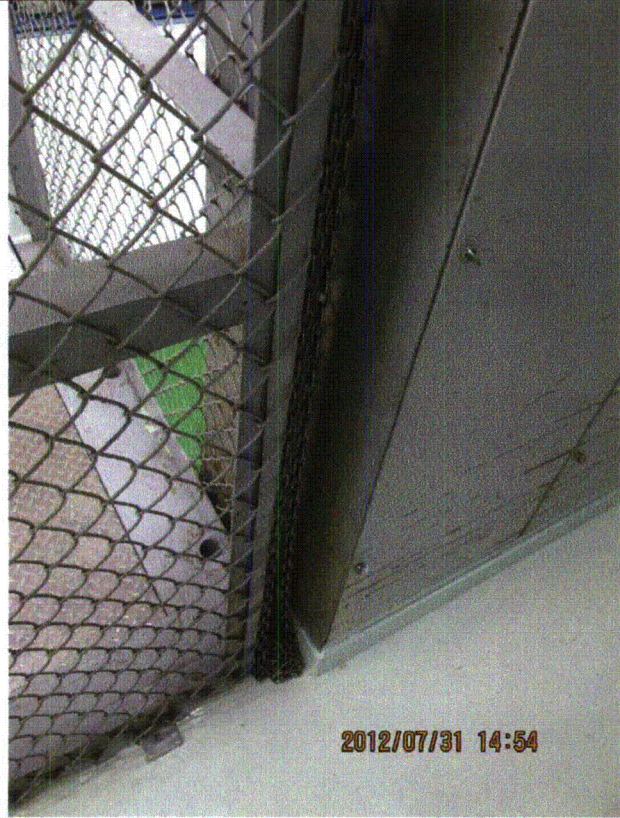
Location (Bldg, Elev, Room/Area): AWC-U3-12

1. Does anchorage of equipment in the area appear to be free of potentially adverse seismic conditions (if visible without necessarily opening cabinets)? Yes  
*Abandoned light fixture support is skewed. Support judged acceptable because it is trapped between pipes and cannot fall, and because it is anchored to the wall.*

5. Does it appear that the area is free of potentially adverse seismic interactions that could cause flooding or spray in the area? Yes  
*Piping is welded and/or well-supported and judged to be acceptable.*

6. Does it appear that the area is free of potentially adverse seismic interactions that could cause a fire in the area? Yes  
*Gas bottles chained adequately.*
