SUBJECT: COMANCHE PEAK NUCLEAR POWER PLANT, UNITS 3 AND 4
DOCKET NUMBERS 52-034 AND 52-035
RESPONSE TO REQUEST FOR ADDITIONAL INFORMATION 275 (7099)
(SECTION 3.4.1)

Attachment: Response to Request for Additional Information 275 (7099)

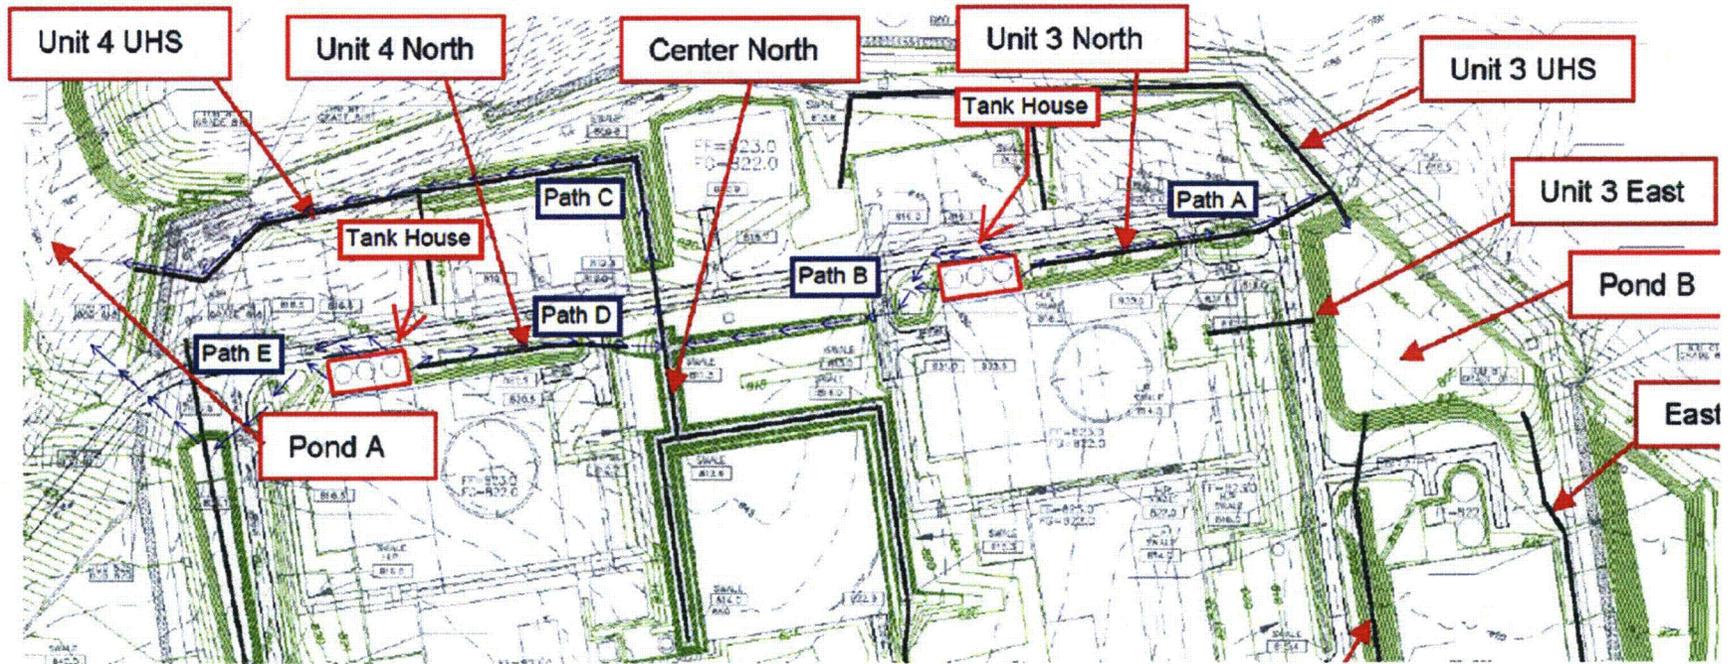
Flow Paths from Tank Houses

As shown in FSAR Figure 1.2-1R (Sheet 2 of 2), two PMWTs and one RWSAT are located inside each Tank House, which is located north of the auxiliary building. The capacities of one PMWT and the RWSAT are 140,000 gallons and 220,000 gallons, respectively. The PMWTs and RWSAT are surrounded by concrete curbs inside the Tank House that are designed to retain the entire water volume of all three tanks. Therefore, failure of two PMWTs and the RWSAT in a unit does not jeopardize any safety-related equipment. However, since the concrete curbs are not seismically qualified, they cannot be credited for a seismic event, although they can be credited for tornado/hurricane missiles. As depicted in FSAR Figure 2.4.2-202 and Figure 2.4.2-206, there are several grading and drainage features in the area of the Tank Houses. See Attachment 1 for the flow paths from the Tank Houses. If the curb is not credited due to a seismic event, the flow path from the Unit 3 PMWTs and RWSAT could be Path A and/or Path B. Path A flows to Drainage Pond B, while Path B merges into Path C and flows to Drainage Pond A. Also, the flow path from Unit 4 PMWTs and RWSAT could be Path D and/or Path E. Path D merges into Path C and flows to Drainage Pond A, while Path E flows directly to Drainage Pond A. Therefore, even if the concrete curbs inside the Tank Houses are non-functional due to a seismic event, the released water would be directed to Drainage Pond A or Drainage Pond B.

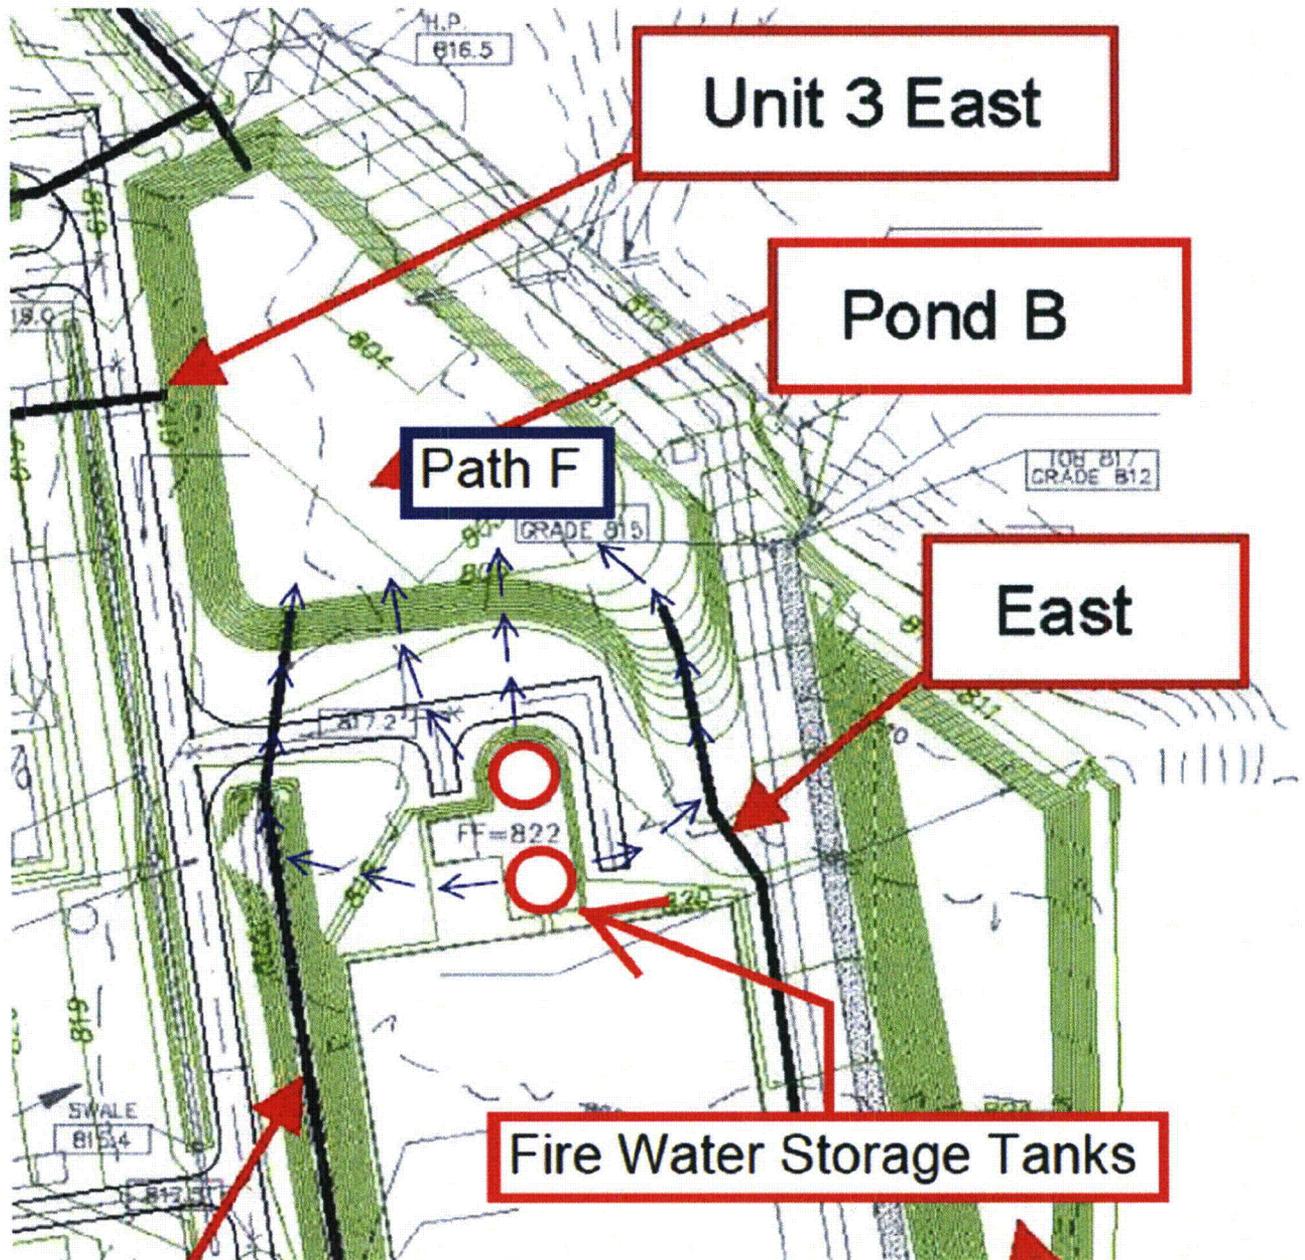
Attachment 2

Flow Paths from Fire Water Storage Tanks

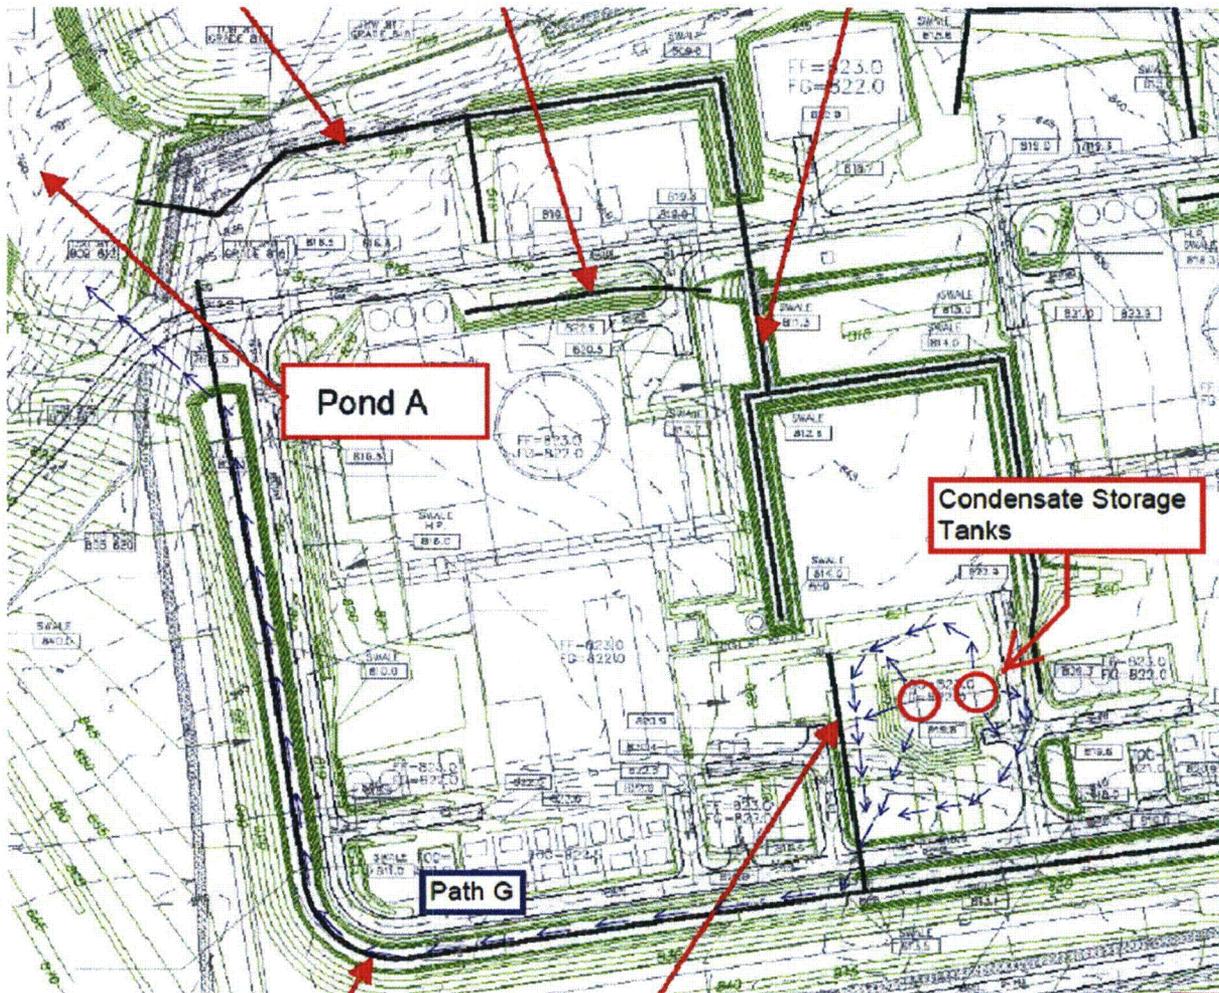
Flow Paths from Condensate Storage Tanks

Two CSTs are located at an elevation of 822 ft msl between the Unit 3 and Unit 4 Turbine Buildings. The CSTs are approximately 280 ft west of the Unit 3 PSFSV and approximately 300 ft east of the Unit 4 PSFSV, which are the nearest safety-related structures. The capacity of a CST is 750,000 gallons. As depicted in FSAR Figure 2.4.2-202 and Figure 2.4.2-206, the grade is sloped downhill around the CSTs, directing leakage from the CST to the nearest valley located southwest of the CSTs. Overflow from this valley will ultimately discharge into Drainage Pond A via a 620 ft by 30 ft swale. See Attachment 3 for the flow path from the CSTs, which is Path G. The capacity of Drainage Pond A is much greater than 7,300,000 gallons as presented above. Therefore, the entire water volume from the CSTs can be retained within Drainage Pond A even if

the runoff feeder of Drainage Pond A is postulated to be non-functional. Thus, the failure of the CSTs does not jeopardize safety-related equipment.

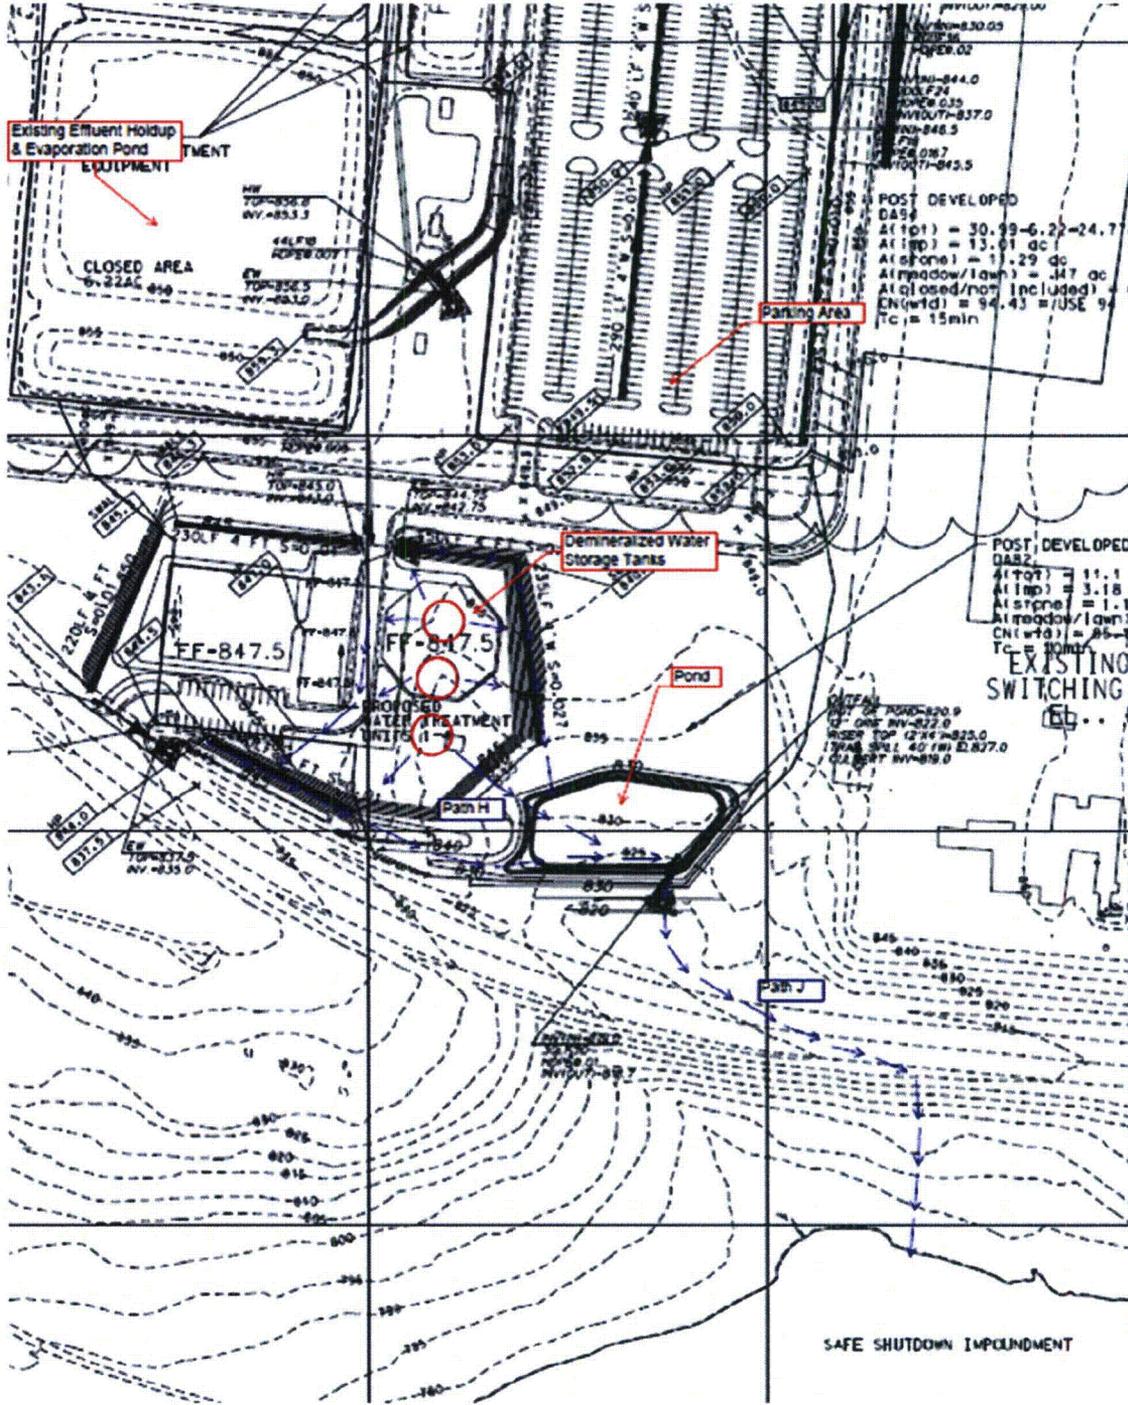
Attachment 4

Flow Paths from Demineralized Water Storage Tanks
