Tennessee Valley Authority, 1101 Market Street, Chattanooga, Tennessee 37402

Sequoyah Nuclear Plant, Units 1 and 2
Facility Operating License Nos. DPR-77 and DPR-79
NRC Docket Nos. 50-327 and 50-328

**Subject: Response to NRC Request for Additional Information Regarding
the Review of the Sequoyah Nuclear Plant, Units 1 and 2, License Renewal
Application, Set 4 (TAC Nos. MF0481 and MF0482)**

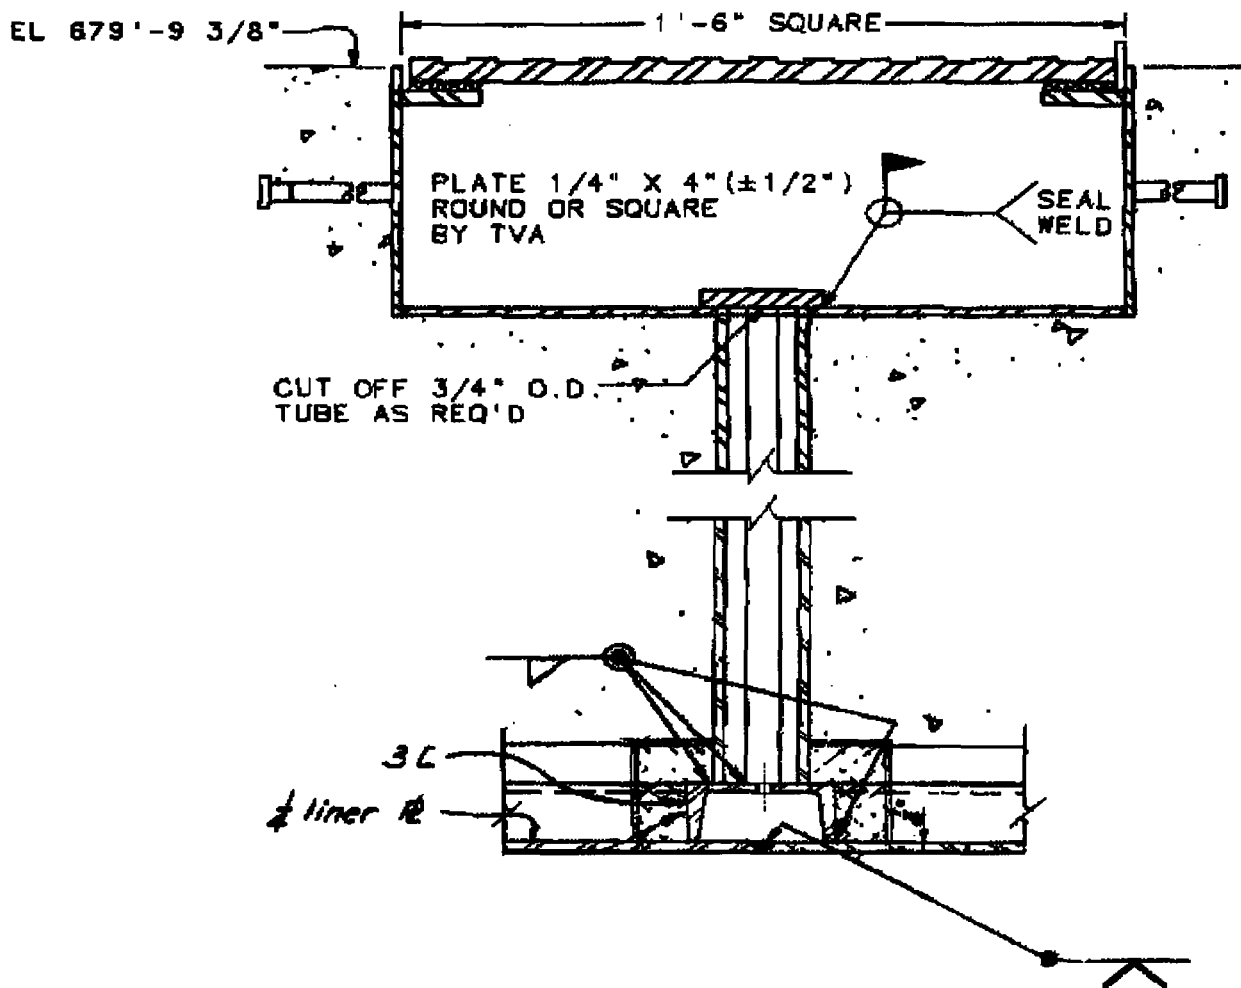
EXHIBIT A
TYPICAL TEST CONNECTION DETAIL

The leak test (leak chase) channel is a channel enclosing the SCV bottom steel liner plate welds on the containment side, which was designed to allow pressurization of the welds for post-installation pressure testing. The leak test channel and associated leak test connection are shown in Exhibit A "Typical Test Connection Detail" below. The potential paths for moisture into the leak test channel are through the $\frac{3}{4}$ inch diameter (dia) test connection tubing directly into the channel or through the annulus between the 2-inch dia pipe sleeve and the $\frac{3}{4}$ inch dia test connection tubing and then entering the channel through a flaw, if one exists. SQN plans to modify the configuration of the test connection access boxes to prevent moisture from entering the $\frac{3}{4}$ -inch dia test connection tubing or the annulus between the $\frac{3}{4}$ -inch tubing and the 2-inch dia pipe sleeve that encloses the tubing, thus preventing corrosion of the pressure test tubing, containment liner plate, including the full penetration welds in the base slab, and the associated embedded leak test channels. The design modification requires cutting the $\frac{3}{4}$ inch dia test connection tubing at the bottom of the access box and welding a steel cover plate over the opening as shown in Exhibit A below. This modification has already been installed in SQN Unit 2, and plans are in place to install a similar modification in SQN Unit 1. Prior to installing this design modification in SQN Unit 2, remote visual examinations were performed, to the extent possible, inside the leak test channels by inserting a borescope video probe into the test connection tubing. Similar inspections will also be performed prior to installation of the modification on Unit 1. Based on the satisfactory examination results to date, following installation of the design modification SQN has no plans to perform future visual examinations of the embedded SCV liner plate or embedded leak test channels.

TVA will modify the configuration of the SQN Unit 1 test connection access boxes to prevent moisture intrusion to the leak test channels. Prior to installing this modification, TVA will perform remote visual examinations inside the leak test channels by inserting a borescope video probe through the test connection tubing.
