Reactor Oversight Process Task Force FAQ Log – June 26, 2013

FAQ Log Entering ROP Public Meeting on June 26, 2013

NRC Final Response
FAQ 12-04, HRA Related Occurrences (Generic)

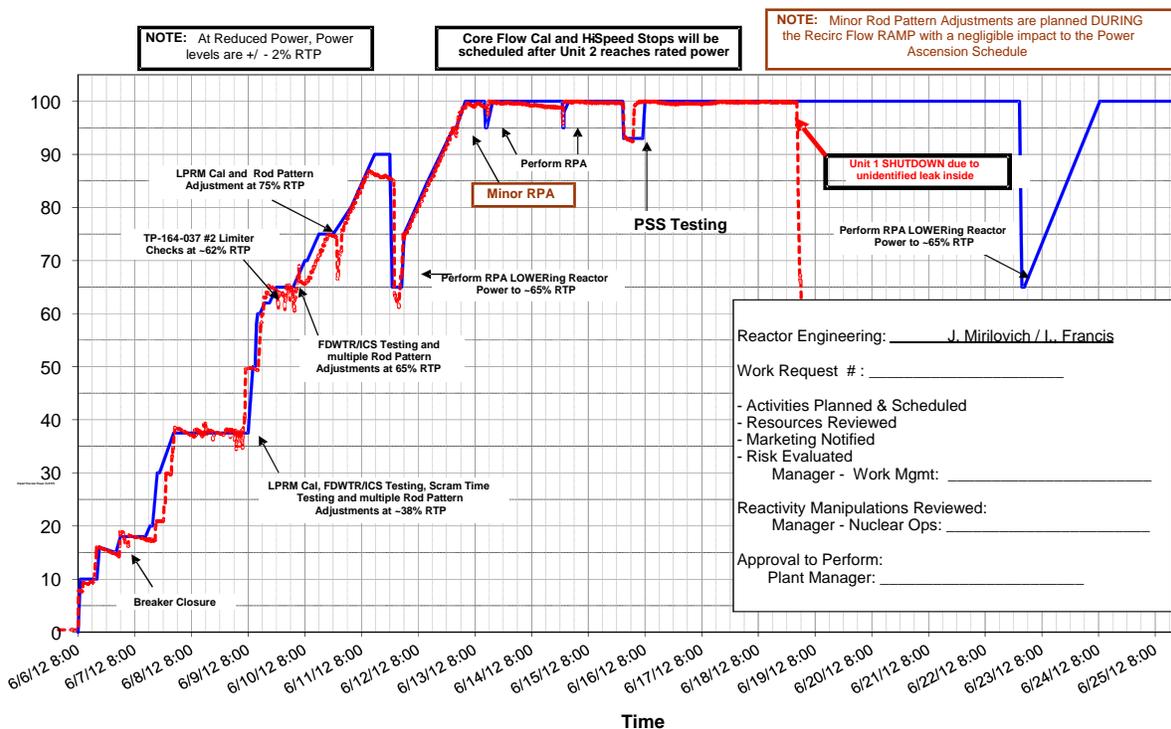
U1C18 BOC Startup Load Profile

Susquehanna Unit 1 was in the process of reducing power on 6/11/2014, at 21:35, for a planned rod pattern adjustment. See the load profile below for a comparison of the predicted power changes in blue and the actual power changes in red.

PPL Susquehanna concluded that this was not an unplanned power change because:

- The power reduction was greater than 20% and was planned greater than 72 hours in advance of the rod pattern adjustment. The planned reduction was from approximately 90% power to approximately 65% power.

- The emergent condenser area issue was resolved quickly and operators completed the planned rod pattern adjustment. Although the planned evolution was briefly delayed it was completed. If the planned evolution had been canceled (not just briefly delayed) because of the emergent condition, this would be considered an unplanned power change.
