From: MP Whalen (Generation - 3) [mp.whalen@dom.com]
Sent: Wednesday, August 07, 2013 3:59 PM
To: Sreenivas, V
Subject: Relief Request RAI from NRC Conference Call August 2 2013
Attachments: 2013-08-07 RAI Response Update .docx

Friday, 8/2/13, NRC conference call regarding weld SW41. In our 2010 submittal on page 44 we discuss Weld SW41 and only getting 35% coverage. In the last sentence we take credit for one other weld on the segment with complete coverage that provides an acceptable alternative. The NRC is looking for two items:

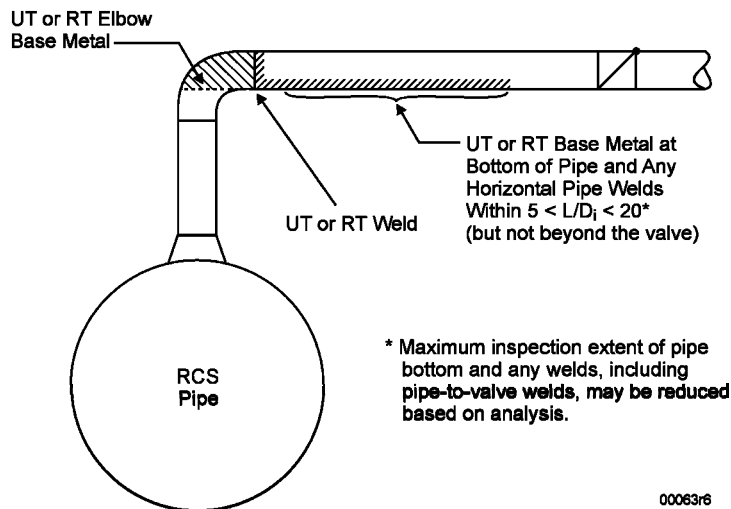
EPRI developed MRP-146, "Materials Reliability Program Management of Thermal Fatigue in Normally Stagnant Non-Isolable Reactor Coolant System Branch Lines," in order to provide screening, evaluation, monitoring, inspection, operations, maintenance, and modification guidance to enable utilities to avoid thermal fatigue cracking due to valve in-leakage or turbulence/swirl penetration effects in affected lines. Although weld SW-41 is classified in the Risk-Informed ISI Program as R-A / R1.11, subject to thermal fatigue, this branch connection weldolet at the top of the RCS pipe is not considered for evaluation under the MRP-146 guidelines.

Figure 2-12
Examination Zones for Butt-Welded Lines Vertically Upward from RCS Piping
