Charlissa C. Smith  
(Denial of Senior Reactor Operator License)

CCS-099

Compare the way Scenario 6 was administered to the other crews for FIC 121 and PT508

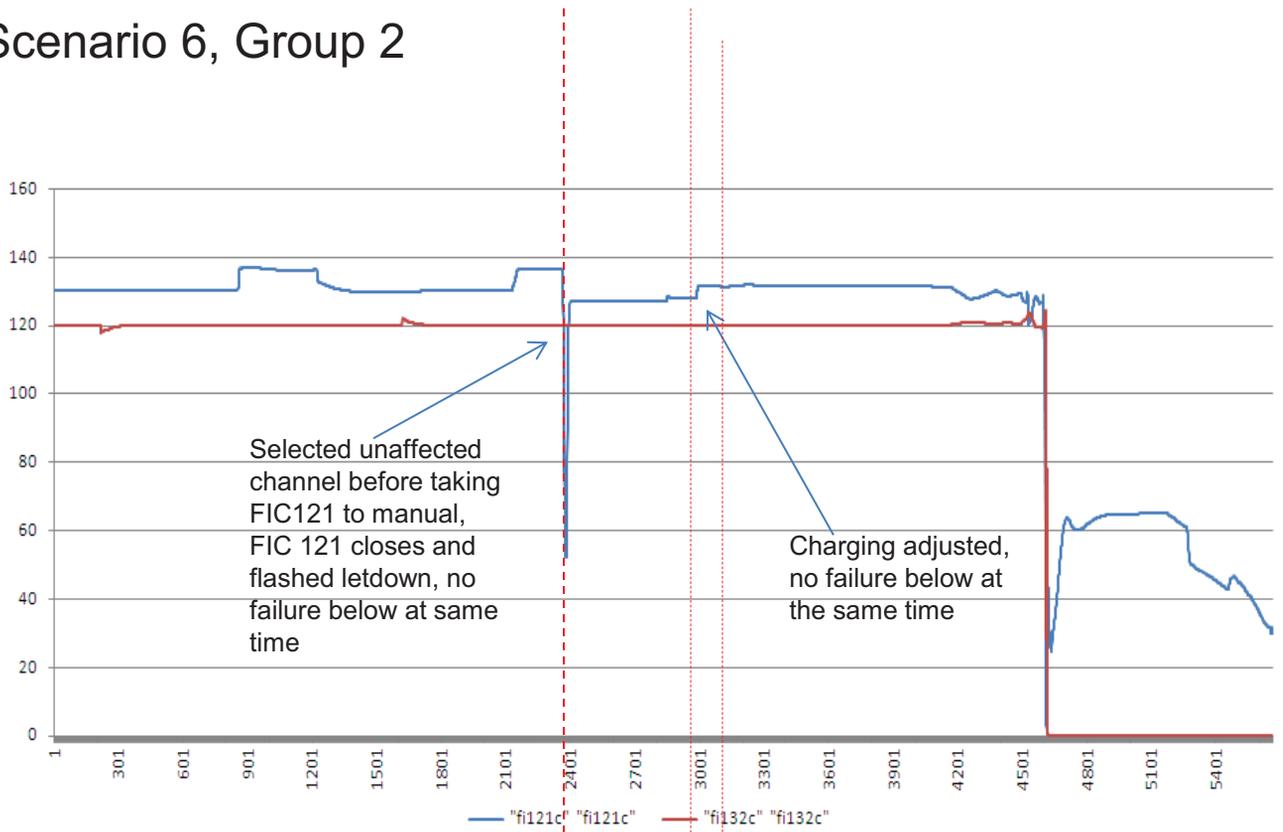
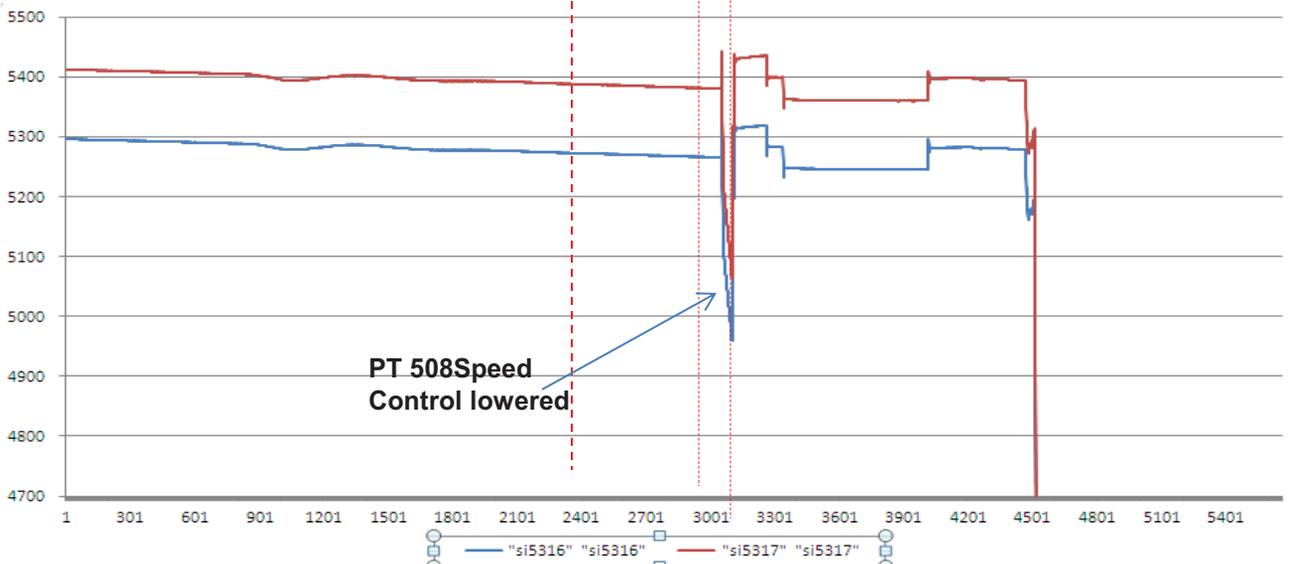
# Scenario 6, Group 2

Looking at the data this crew never took FIC 121 to automatic. Notice that prior to the MFP PT508 failure that charging was still being adjusted. Exam team likely moved on and put in the next failure. The controller was in manual for ~11 minutes. The arrow shows the last adjustment made. If our crew left the controller in manual for 18 minutes and group 3 left in manual for 8 minutes, then the same thing would have occurred if this crew would have returned the controller to auto (after 11 minutes). No simultaneous action or failures occurred here. **Notice the spacing between actions and failures (indicated by red dotted lines).** This crew received the failure before taking FIC 121 back to automatic, so the opportunity to test their knowledge was not challenged due to the timing of the failure. No penalty was applied (yet penalty was applied to C. Smith's crew when the PZR heaters were not returned to auto in another scenario).

12 minutes – \*\*it was never taken to automatic

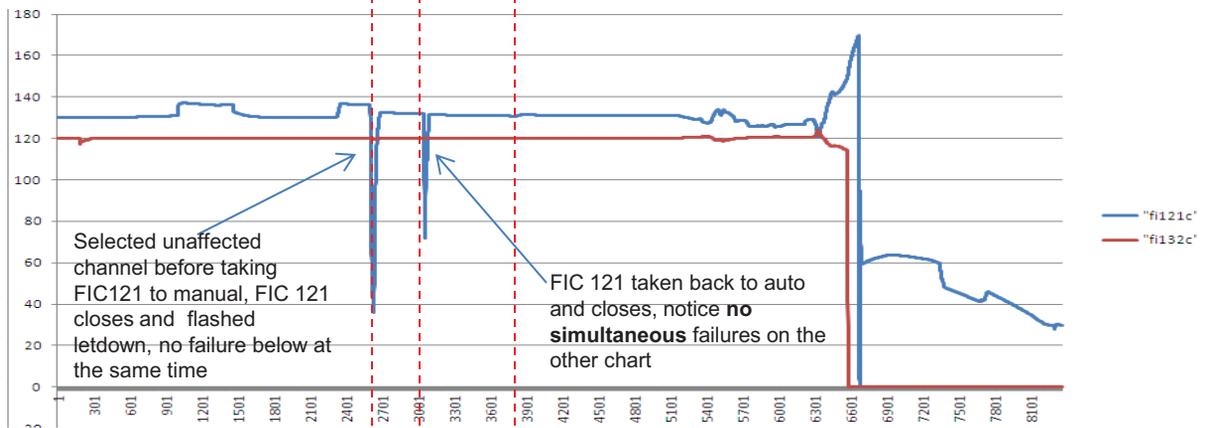
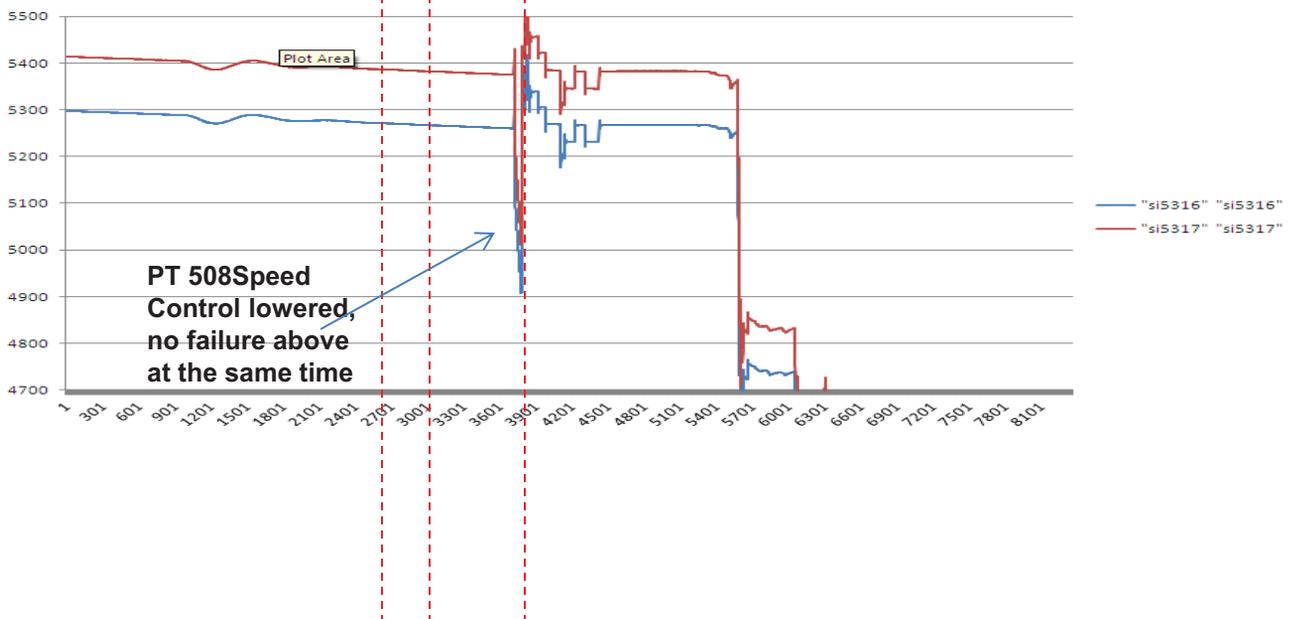
# Scenario 6, Group 3

This crew selected the unaffected channel before taking FIC 121 to manual causing charging to lower PZR level (first red dotted line) and flashing. Then the crew took FIC 121 to automatic and it caused charging to lower as it did with my crew (second red dotted line). But notice that the PT 508 failure does not come in at the same time that the crew was dealing with the lowering of charging. (third dotted line). Although this crew performed the exact same actions they only received a comment for selecting the unaffected channel before taking FIC 121 to manual – no separate comment was given for the FIC 121 being taken back to auto and closing due to saturation ( two different errors). One of the applicants received one comment with both errors in the same comment. Personnel on my crew received a separate comment for each error even if it was in the same event. In addition the timing of the failure allowed the crew the opportunity to assess the issue and determine the cause, where my crew was dealing with two issues at the same time.

8 minutes
