SUBJECT: Technical Specification 5.6.8 – IP3 Steam Generator Tube Inspection Report -
Spring 2013 Refueling Outage
Indian Point Unit No. 3
Docket No. 50-286
License No. DPR-64

The scope of the inspection included all four steam generators, which are Westinghouse Model 44F with thermally treated Alloy 690 tubes. At the time of the inspection, the steam generators had approximately 205 effective full power months of operation since the first inservice inspection performed in 1990. All four steam generators were found to be in compliance with condition monitoring requirements. The previous inspection was performed during the spring 2007, Refueling Outage 3R14 (reference 1).

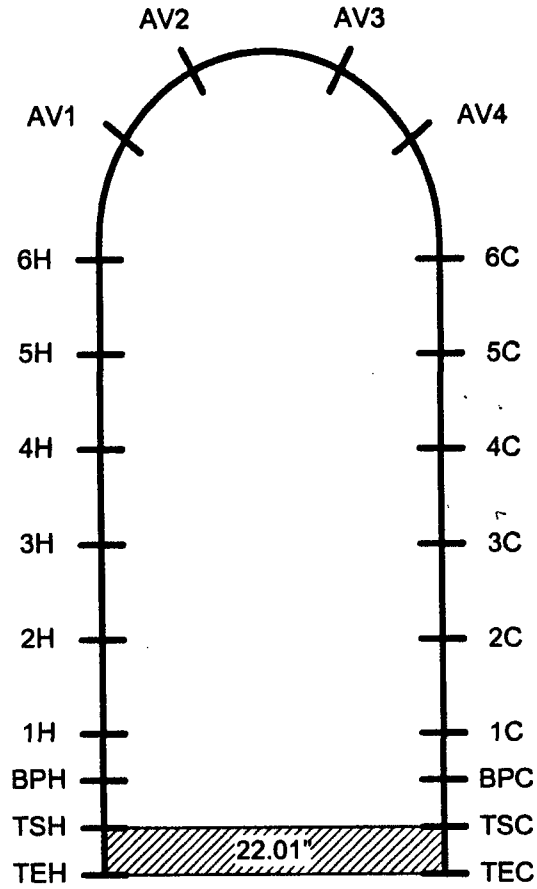
**Indian Point
Steam Generator
Location Landmarks**

Westinghouse Model 44F
Steam Generator

- a) SG Tubesheet Map
- b) SG Landmark Information
