Subject: Docket No. 50-206  
Effects of Non-Category A Equipment Failure  
San Onofre Nuclear Generating Station  
Unit 1

ENCLOSURE 1

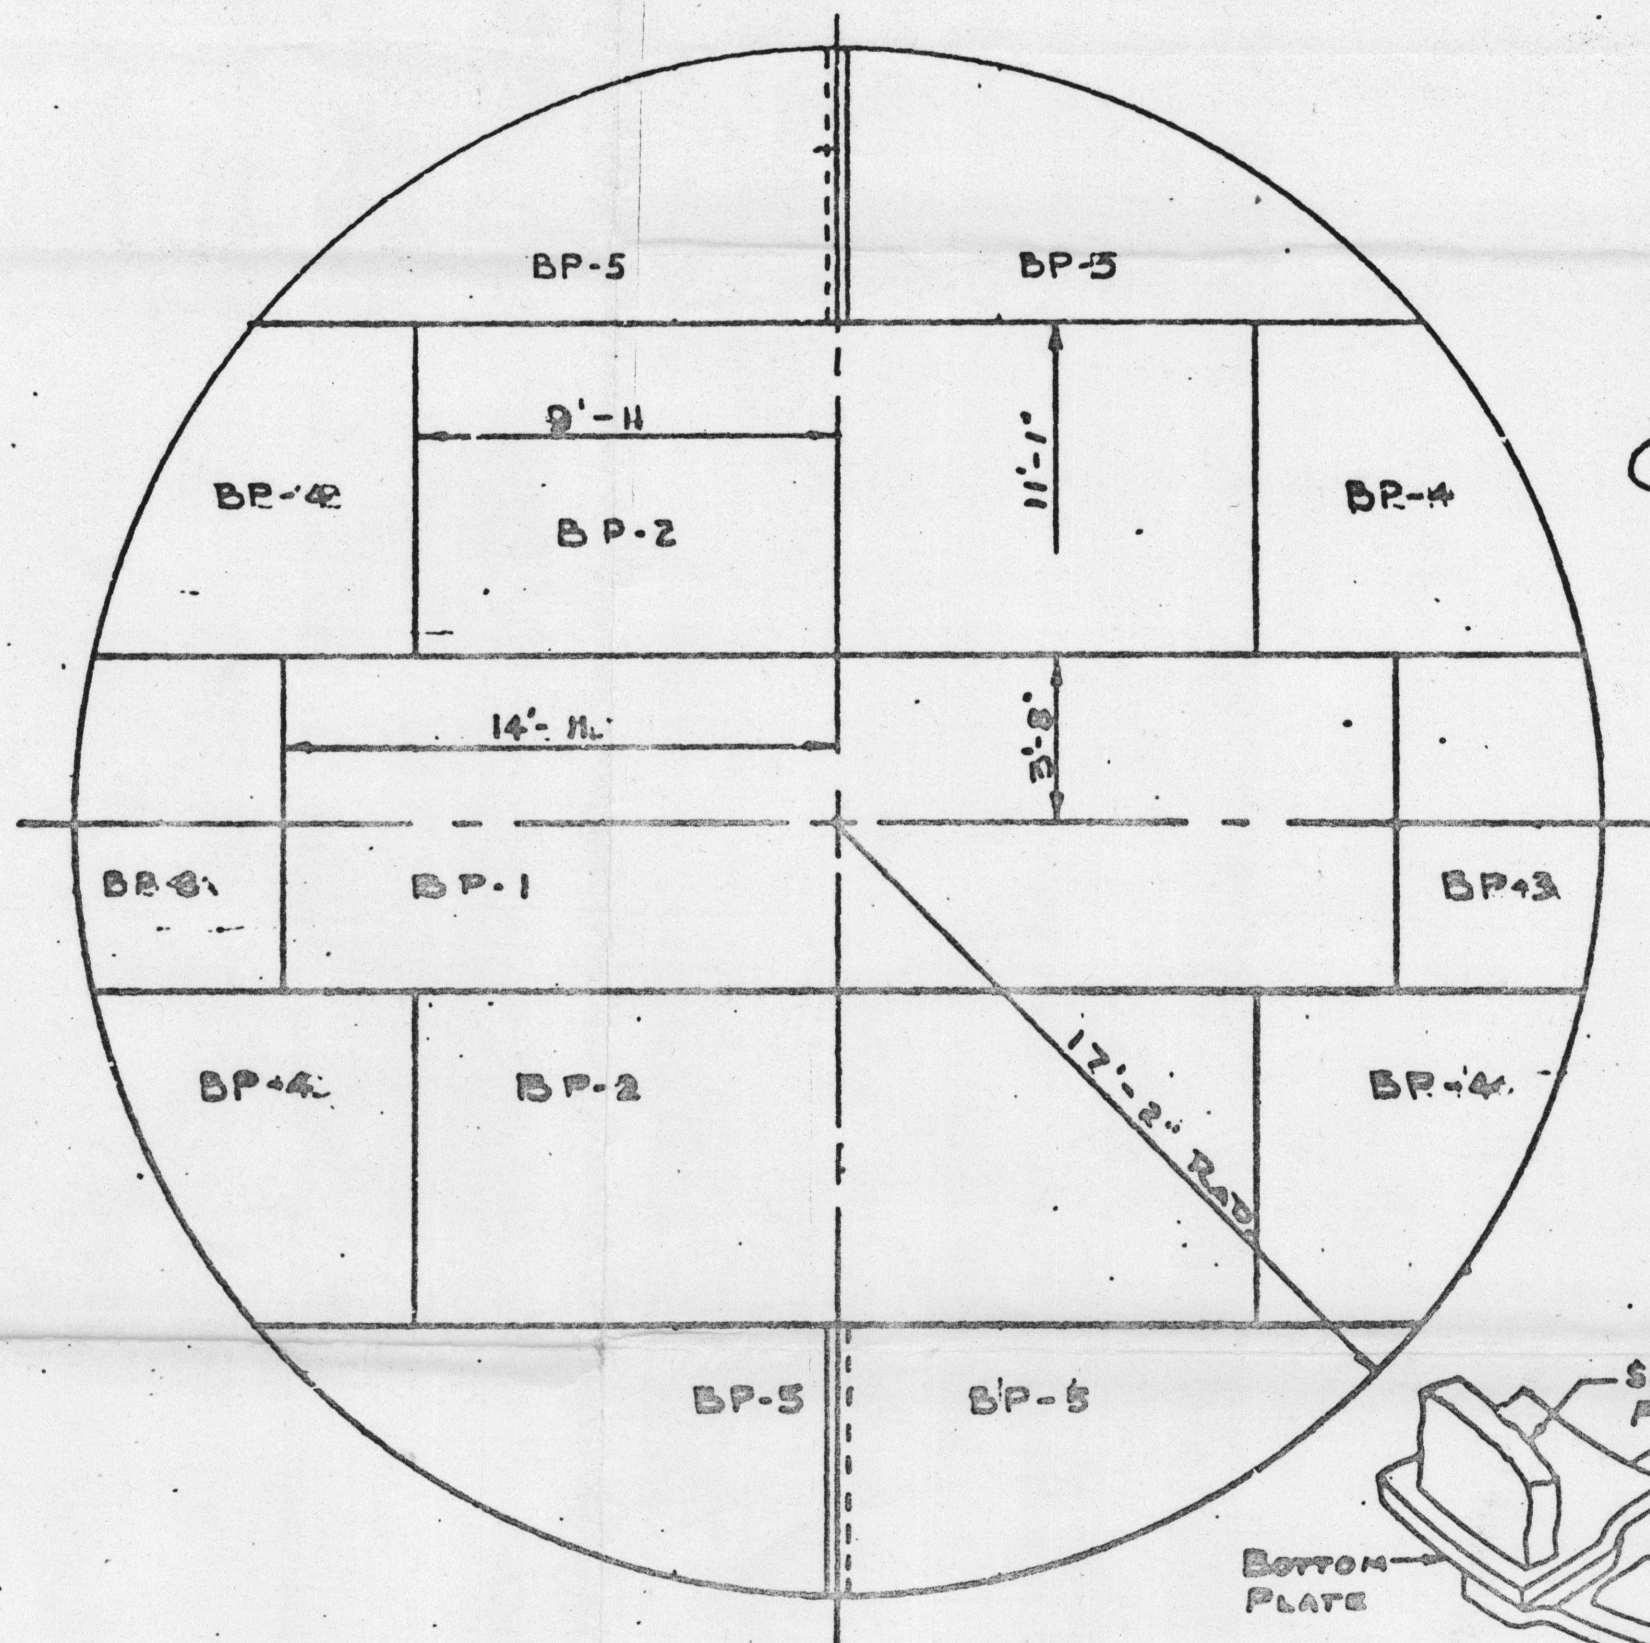
BOTTOM LAYOUT

BREAK DOWN BOTTOM PLATES  
UNDER SHELL AS SHOWN TO  
FORM A SMOOTH BEARING  
SURFACE.

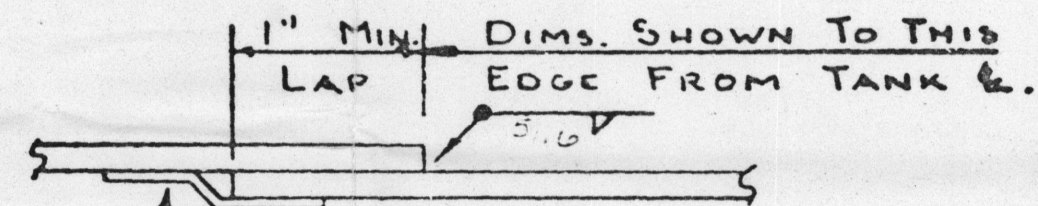
## TYPICAL SEAM

DEARBORN CHEMICAL COMPANY'S NO-OXIDIZED  
#3 WRAPPER 6" x .025" (BP-6) UNDER ALL SEAMS AND  
ALSO UNDER SHELL CHIME WELD. FIELD CUT TO  
SUIT.
