**Reactor Oversight Process Frequently Asked Questions – November 20, 2013**

**FAQ Log Entering ROP Public Meeting November 20, 2013**

**FAQ 13-03**  
**Quad Cities Animal Intrusion**

FAQ 13-05  
Oyster Creek Downpower

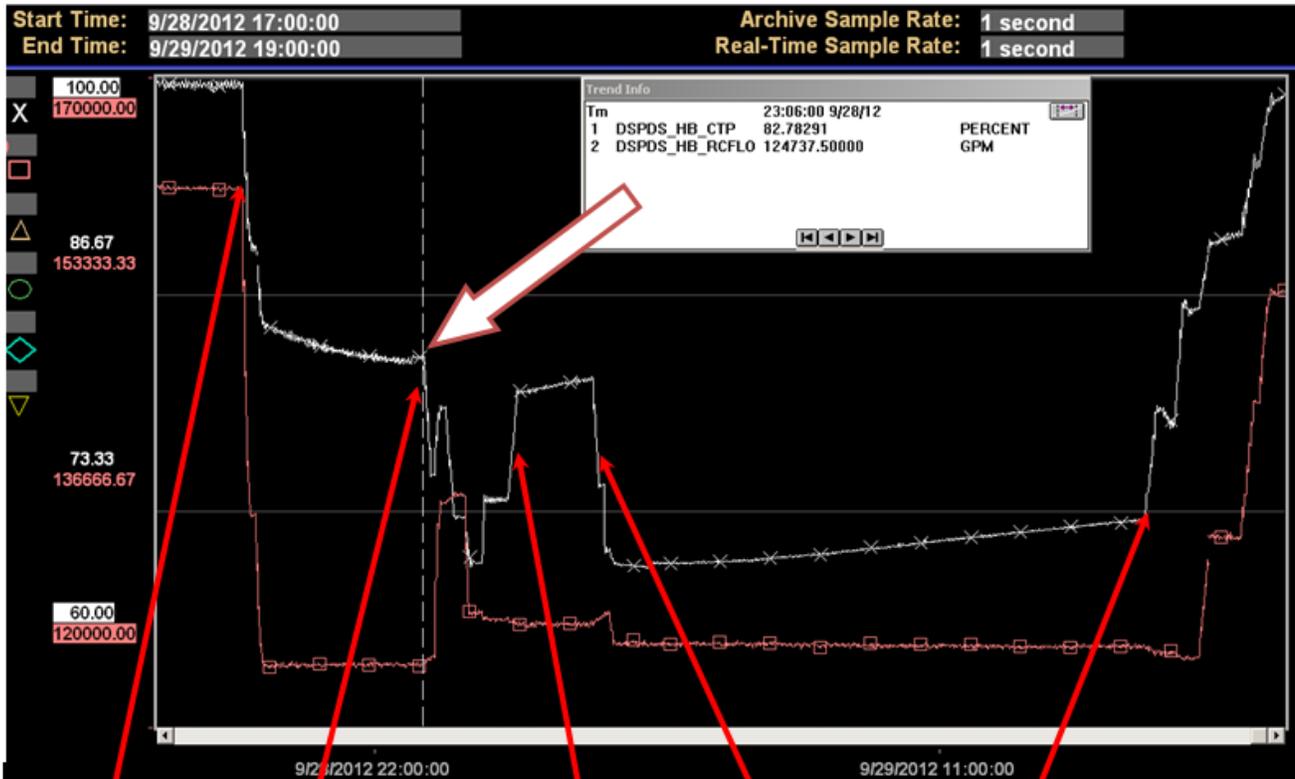
Attachment 1 - Reactor Power vs Time

Lowered Power due to a leak in the Circulating Water system (unplanned)

Lowered power as part of a planned (>72 hours) rod pattern adjustment

Lowered power due to need to continue Circulating Water pipe repair

Completed Circulating Water pipe repair and raised power

An emergent downpower to 85% was initiated to address circulating water piping leak. The emergent downpower was scheduled to coincide with a planned downpower to 73% for End of Cycle Rod Maneuvers (rod pattern adjustments). Repairs commenced during the emergent downpower and continued into the planned power reduction significantly reducing the leakage (to approximately 1 gpm). The emergent downpower was < 20 and therefore outside the scope of the performance indicator.

During power ascension from the planned power reduction for rod pattern adjustments, a decision was made to halt the power ascension at 80%, reduce power to 70%, and perform additional repairs to further reduce or eliminate leakage from the circulating water piping repair prior to returning to 100% power.

- The power reduction to 70% was outside of the preplanned evolution which ended at 0033 on 9/29/12
- The power reduction to 70% was < 20% below the previous power level of 80%
- A power reduction to 70% was not required for the additional repairs
- Power level had not been restored to 100% following completion of the planned power reduction.
