Reactor Oversight Process Task Force FAQ Log – January 15, 2014

FAQ Log Entering ROP Public Meeting January 15, 2014

**NRC Final Response
FAQ13-05
Oyster Creek Downpower**

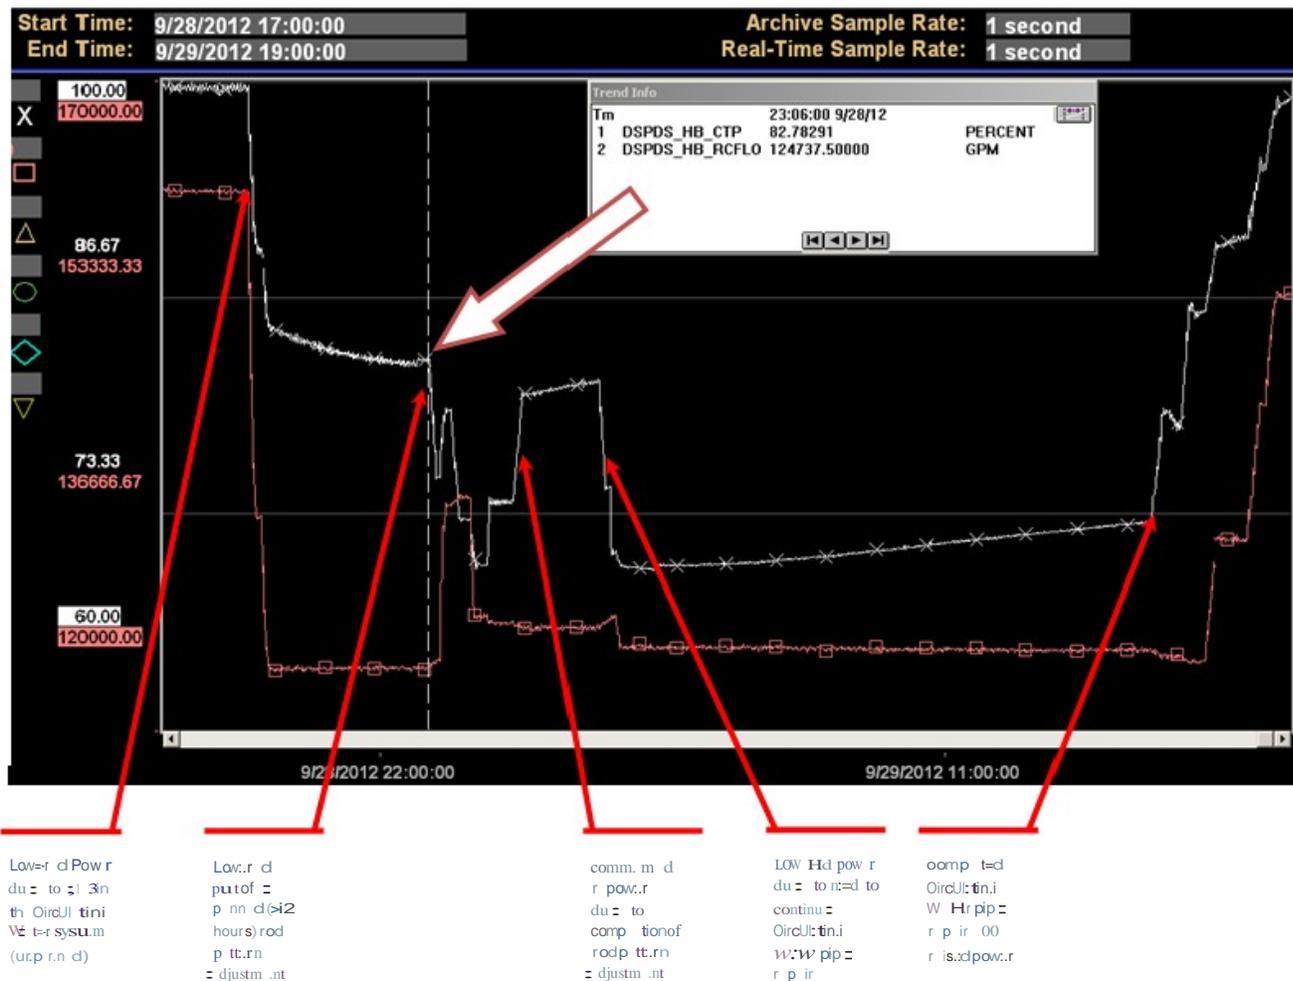
Attachment 1 - Reactor Power vs Time

During power ascension from the planned power reduction for rod pattern adjustments, a decision was made to halt the power ascension at 80%, reduce power to 70%, and perform additional repairs to further reduce or eliminate leakage from the circulating water piping repair prior to returning to 100% power.

- The power reduction to 70% was outside of the preplanned evolution which ended at 0033 on 9/29/12
- The power reduction to 70% was < 20% below the previous power level of 80%
- A power reduction to 70% was not required for the additional repairs
- Power level had not been restored to 100% following completion of the planned power reduction.

The NRC staff concludes that this event meets the first part of the definition of unplanned changes in reactor power since the downpower was initiated less than 72 hours following the discovery of a circulating water leak and resulted in a total power reduction of 30% (100% to 70%) of full power to fully resolve.
