Industry and NRC Coordination Meeting Materials Programs Technical Exchange

Clevis Insert Bolt Update

Bryan Wilson, Westinghouse

June 2014

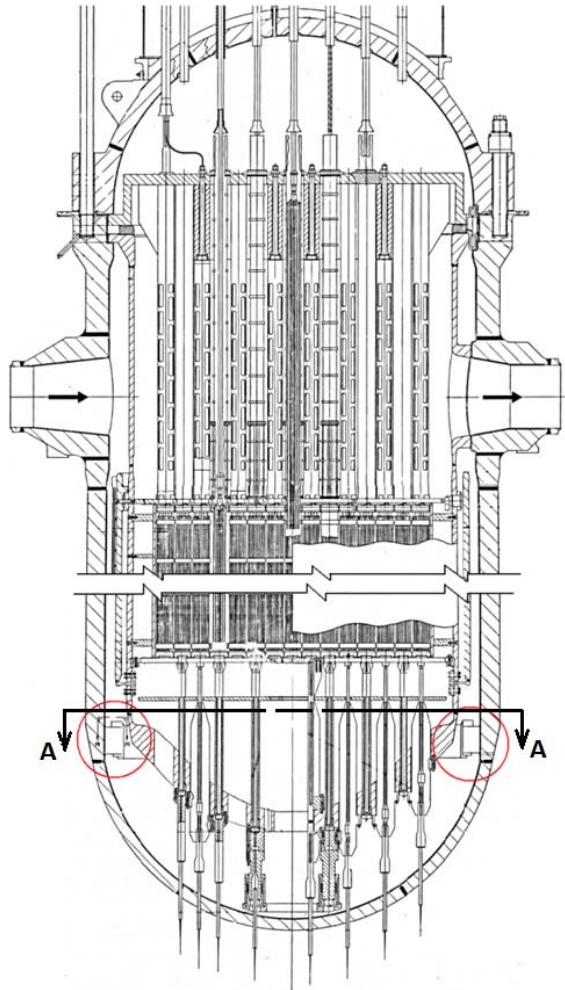
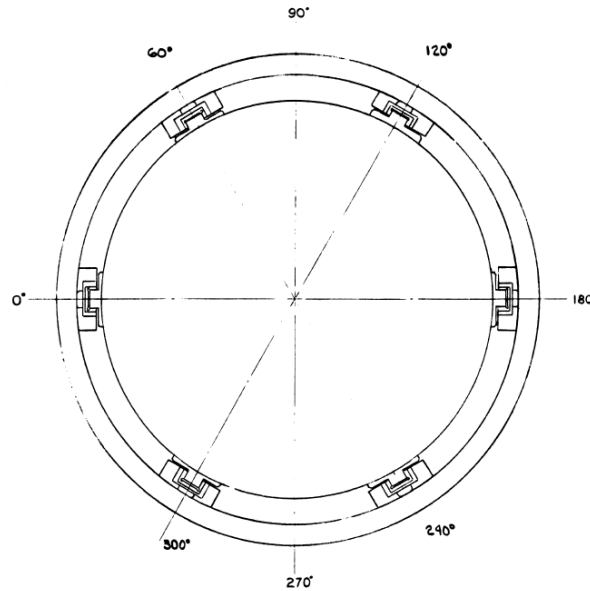
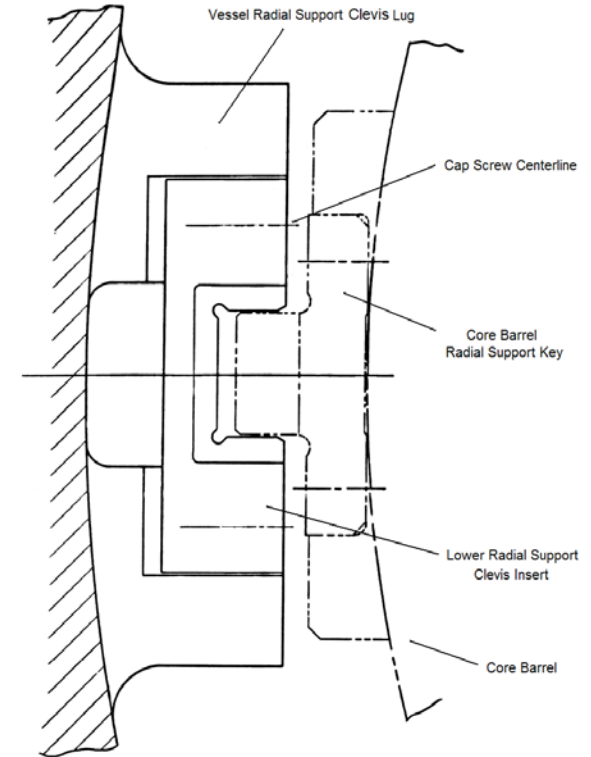
Industry and NRC Coordination Meeting Materials Programs Technical Exchange Clevis Insert Bolt Update - Background

Section A-A
(Internal Details Removed for Clarity)
