NUREG/CR-5833  
PNL-7907

# Auxiliary Feedwater System Risk-Based Inspection Guide for the H. B. Robinson Nuclear Power Plant

Prepared by  
N. E. Moffitt, R. C. Lloyd, B. F. Gore, T. V. Vo/PNL  
L. W. Garner/NRC

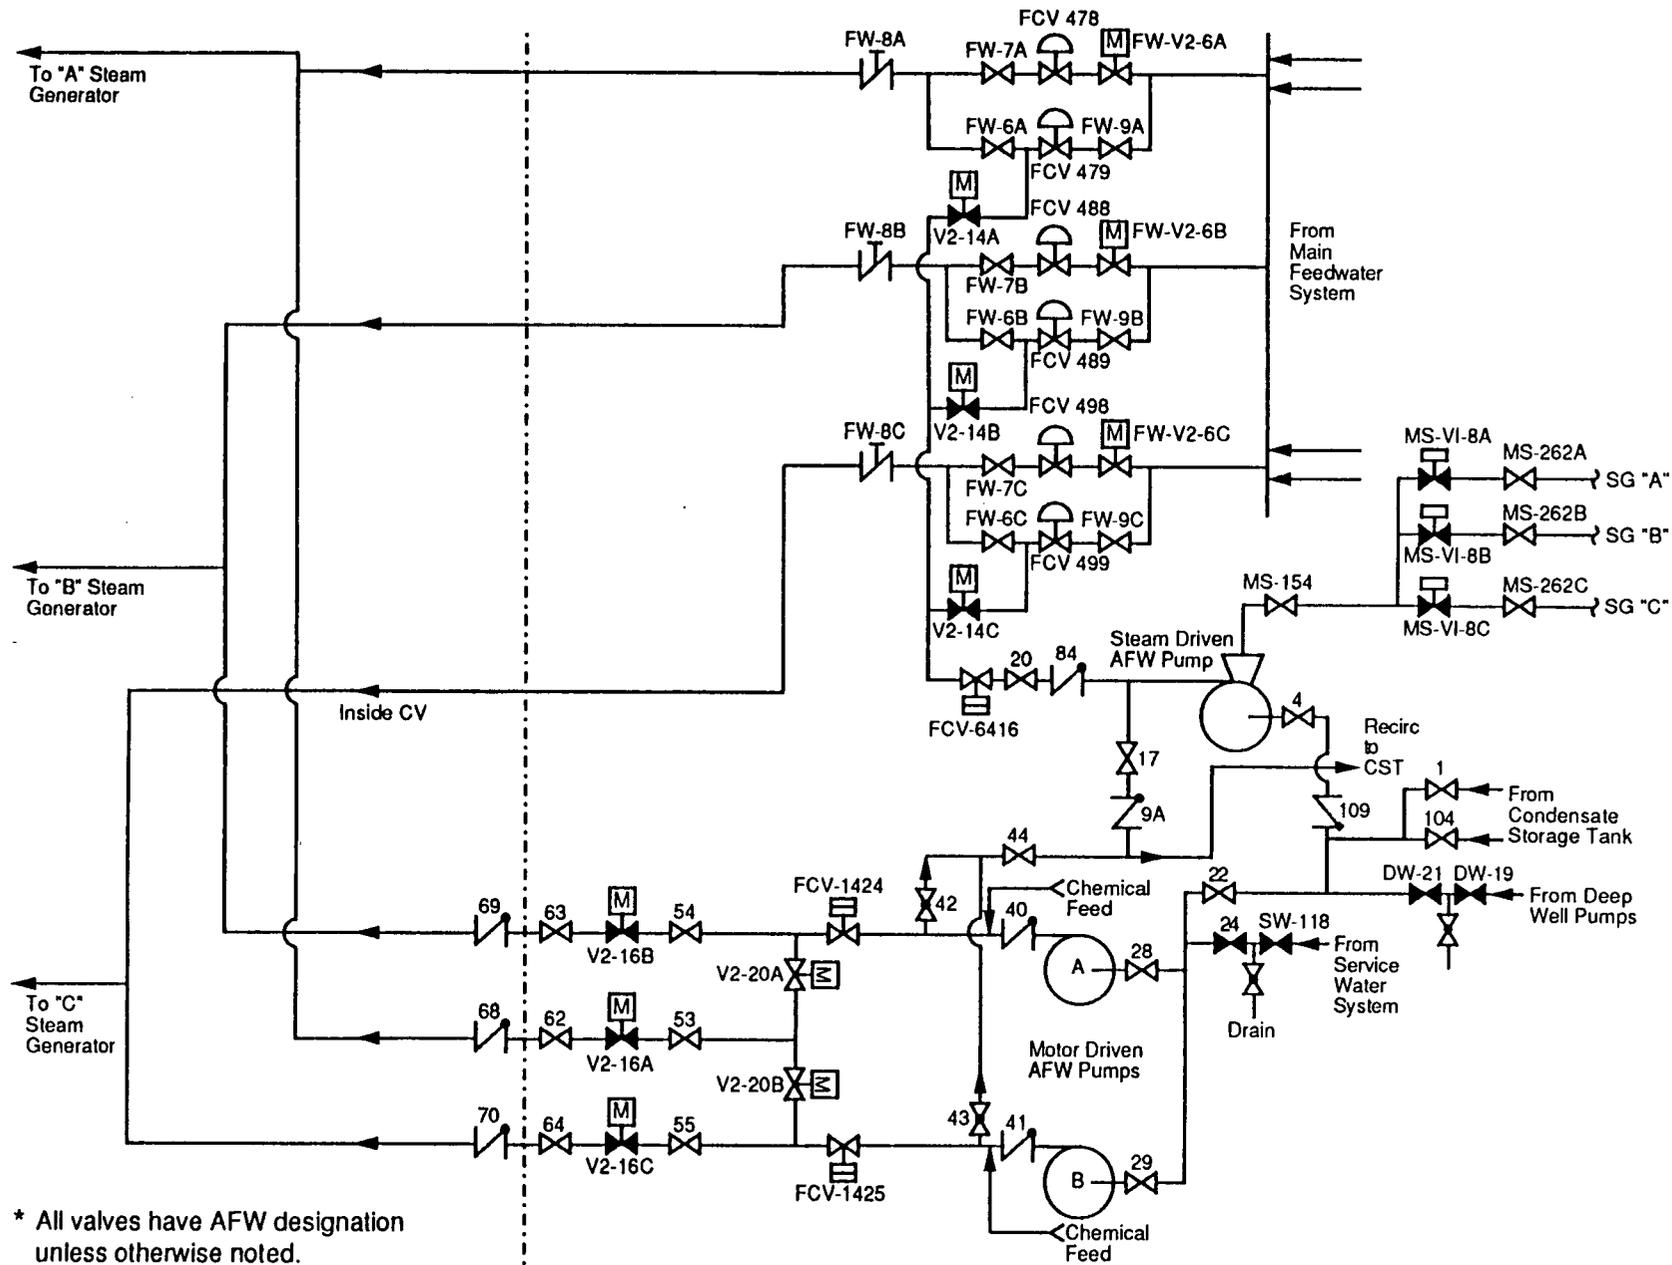
Figure 2.1 H. B. Robinson Auxiliary Feedwater System

The AFW system provides feedwater to the steam generators (SG) to allow secondary-side heat removal from the primary system when main feedwater is unavailable. The system is capable of functioning for extended periods, which allows time to restore main feedwater flow or to proceed with an orderly cooldown of the plant to where the residual heat removal (RHR) system can remove decay heat. A simplified schematic diagram of the H. B. Robinson AFW system is shown in Figure 2.1.
