PLANT NAME:
H. B. ROBINSON #2

RESPONSE TO QUESTIONS ON SPENT FUEL SHIPPING CRANE

CP&L RESPONSES TO NRC REQUESTS
FOR ADDITIONAL INFORMATION ON THE
SPENT FUEL CASK HANDLING SYSTEM
H. B. ROBINSON UNIT NO. 2, DOCKET NO. 50-261

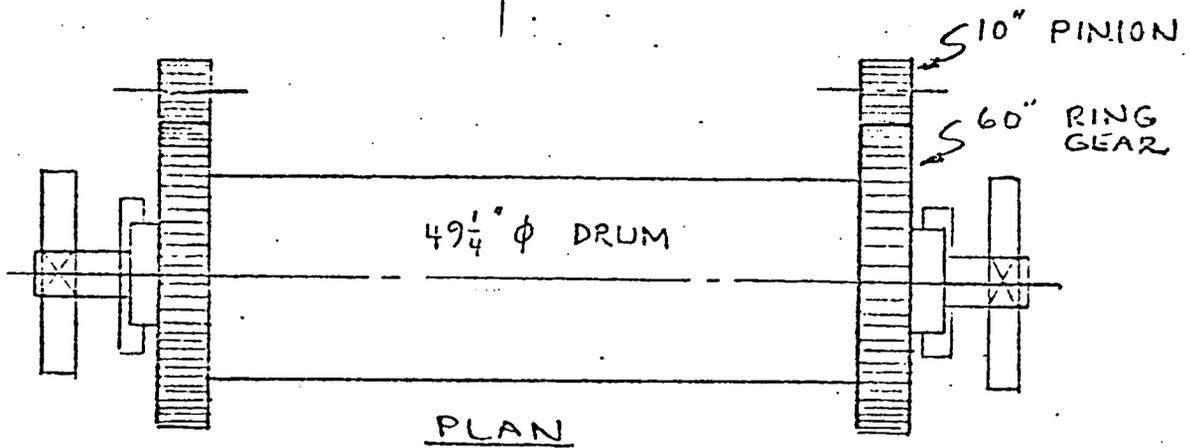
ASSUME SHAFT FAILS
AND DRUM FALLS 1/8"
TO SAFETY LUG

Response - Each end of the drum is provided with a hub which is concentric with the drum shaft. A safety lug, (receptacle) is built into the trolley frame on both ends of the drum. The safety lug has a surface which is concentric with the drum hub and is located 1/8" under the drum hub. In the event of failure of a drum shaft or support, the drum hub comes into contact with the safety lug which prevents the drum from falling. An analysis shows that the misalignment on the gear train opposite the failed shaft, or support, as a result of the drum dropping is within the design limits of the gearing, and that the combination of misalignment and added friction of the drum hub on the safety lug will not cause excessive loading on the gearing during emergency lowering of the load. The analysis is attached for information.

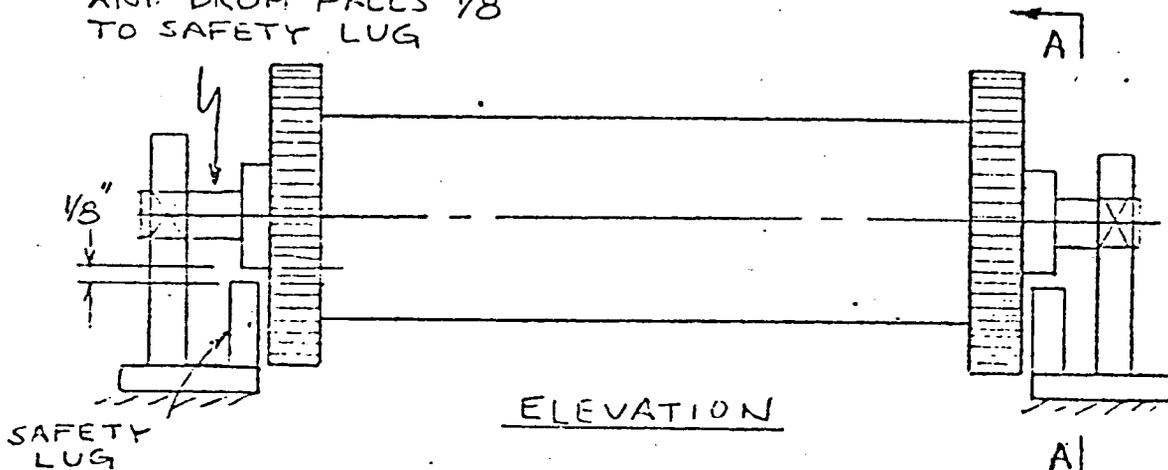
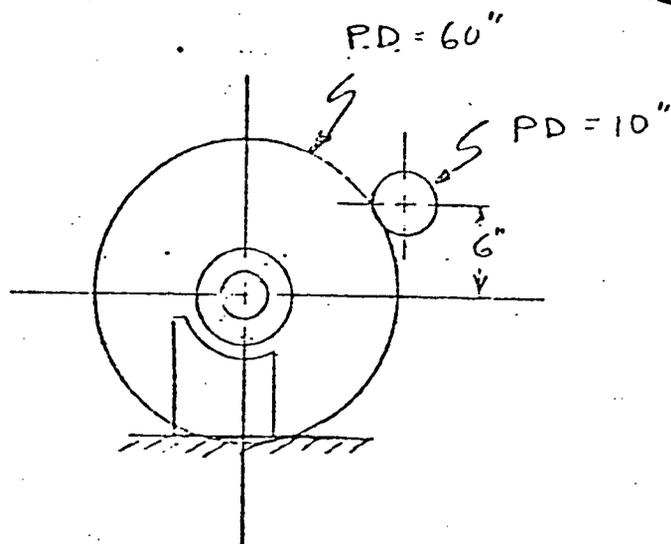
MISALIGNMENT OF GEARING DUE TO
SHAFT FAILURE

$$\theta = \sin^{-1} \frac{.125}{208.5}$$

$$\theta = .035^\circ$$

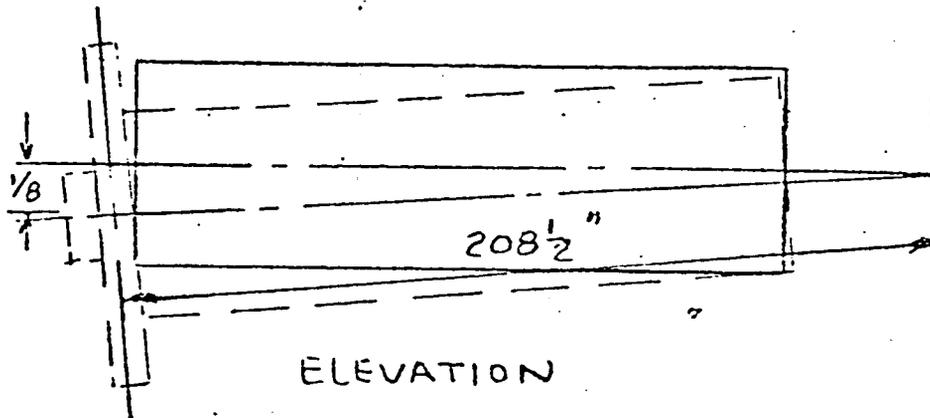
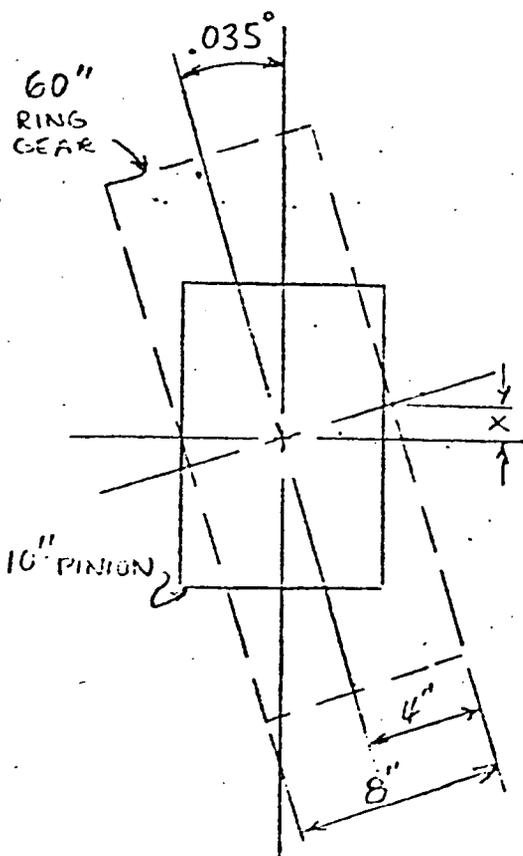
$$x = 4 \sin \theta = 0.0024 \text{ in}$$

$$e = \text{ALLOWABLE BACKLASH BETWEEN GEARS} = \frac{.040}{\text{D.P.}}$$

THEREFORE, THE ROTATION OF THE RING GEAR IS STILL WITHIN THE BACKLASH LIMITS.

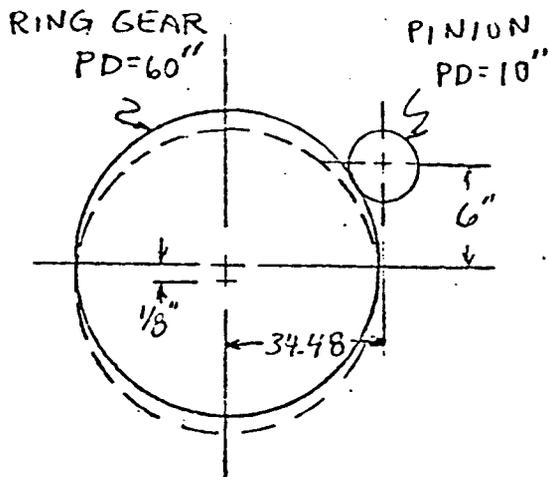
SEPARATION OF GEARS DUE TO 1/8" FALL OF RING GEAR

BEFORE FAILURE
 ϕ RG TO ϕ P = 35"

$$\begin{array}{r} 35.022 \\ - 35.000 \\ \hline 0.022 \text{ in} \end{array}$$

THE RING GEAR MOVES 0.022 in. AWAY FROM PINION.

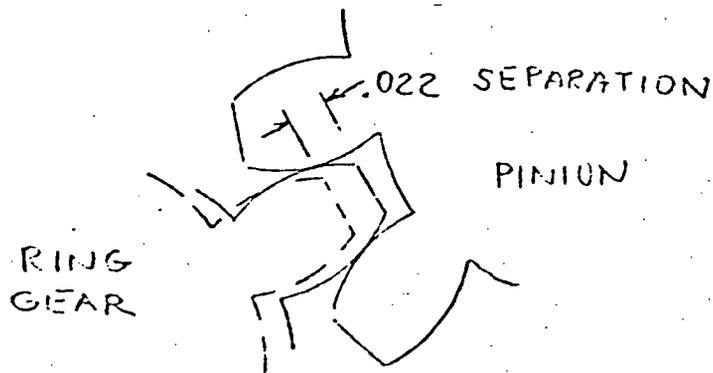
BENDING MOMENT IN GEAR TOOTH

$$\text{WORKING DEPTH OF TOOTH} = \frac{1.6}{PD} = \frac{1.6}{1.5} = 1.067 \text{ in}$$
