Subject: Steam Generator Examination Program Results 2014 Refueling Outage (2R21)  
Indian Point Unit No. 2  
Docket No. 50-247  
License No. DPR-26

Attachment 1: Steam Generator Examination Program Results, 2014 Refueling Outage (2R21)

ATTACHMENT 1 TO NL-14-113

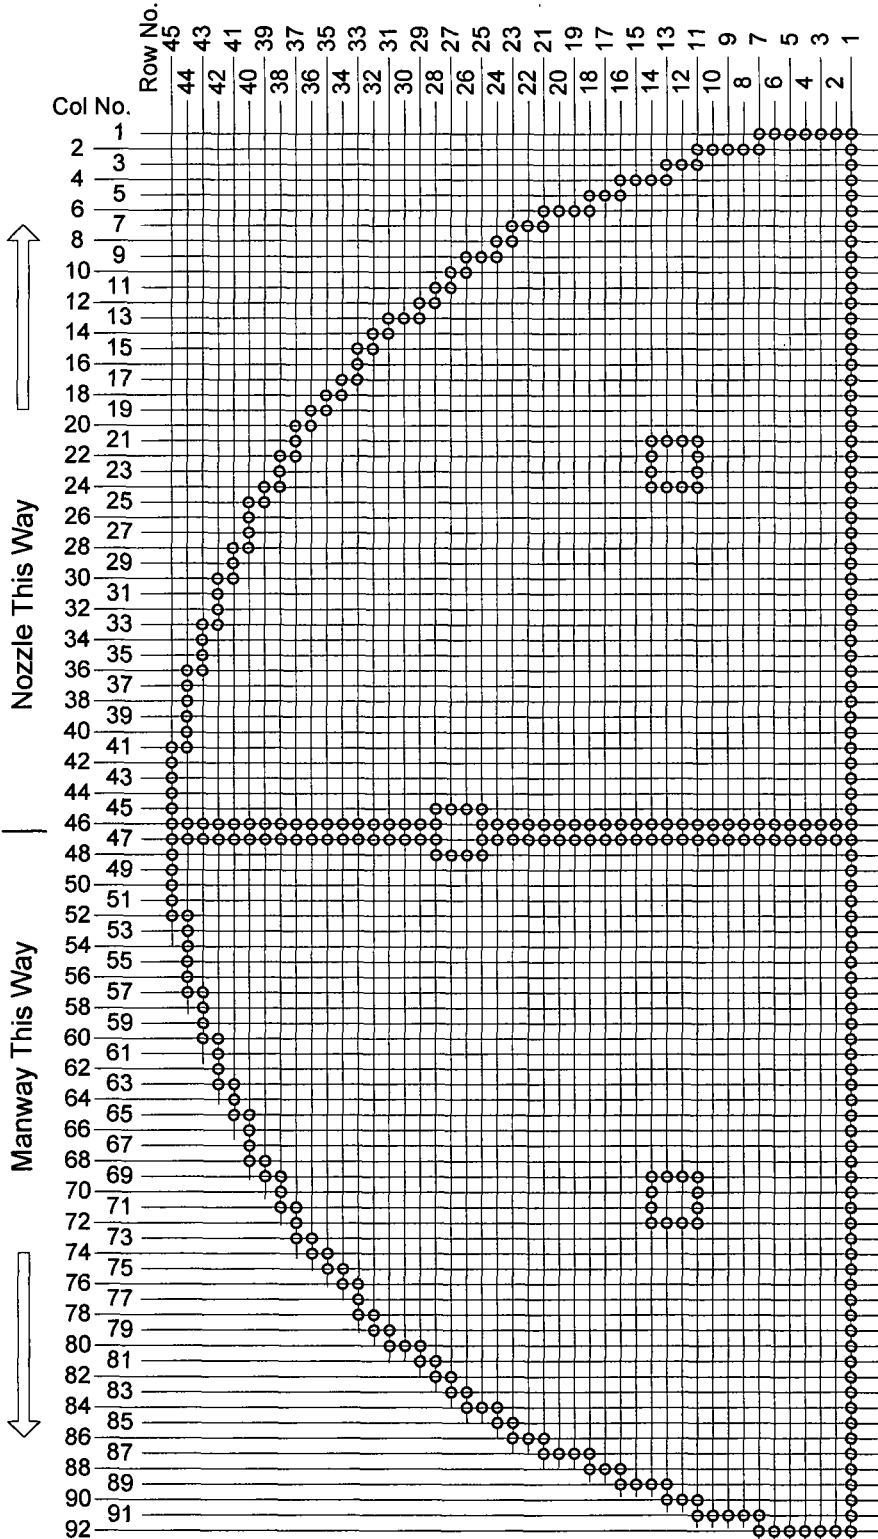
### Indian Point 2 Steam Generator Tubesheet Map

Steam Generator Tubesheet Map

Attachment 1-C: Steam Generator Tubesheet Map

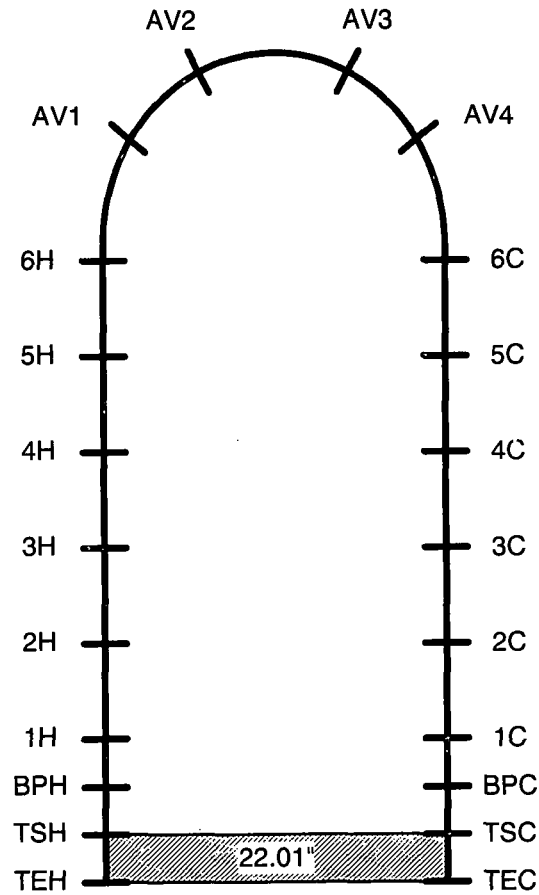
### Indian Point 2 Steam Generator Location Landmarks

Steam Generator Landmark Information

Westinghouse Model 44F  
Steam Generator

Attachment 1-D: Steam Generator Landmark Information
