**SUBSECTION 2.5.3: SURFACE FAULTING  
TABLE OF CONTENTS**

Turkey Point Units 6 & 7  
COL Application  
Part 2 — FSAR

### 2.5.3 SURFACE FAULTING

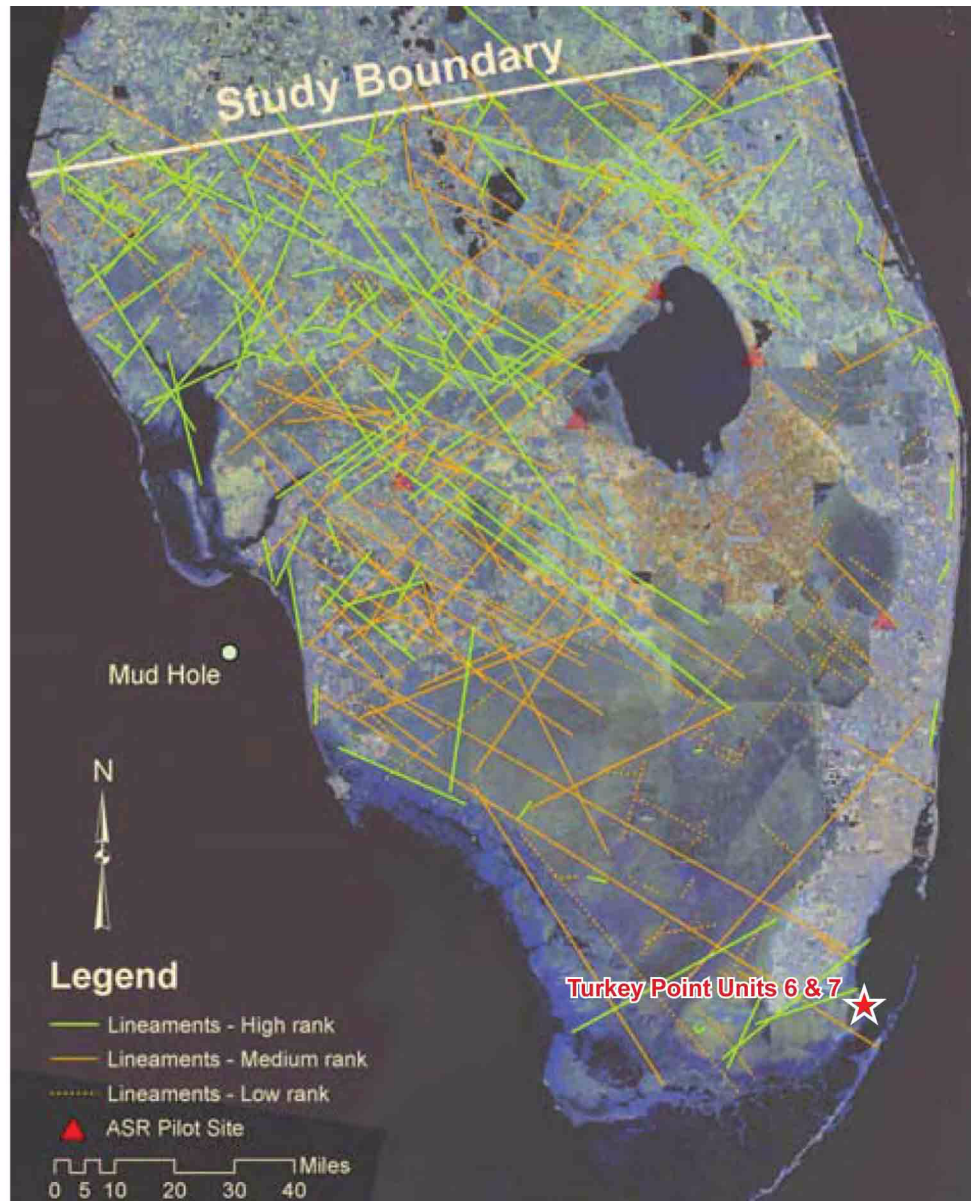
Figure 2.5.3-204 Lineament Analysis of South Florida for ASR Regional Study

Source: Reference 232
