W3F1-2014-0041

SUBJECT: 180 Day Steam Generator Tube Inspection Report
for the 19TH Refueling Outage
Waterford Steam Electric Station, Unit 3
Docket No. 50-382
License No. NPF-38

1. 180-Day Steam Generator Tube Inspection Report for the 19TH Refueling Outage

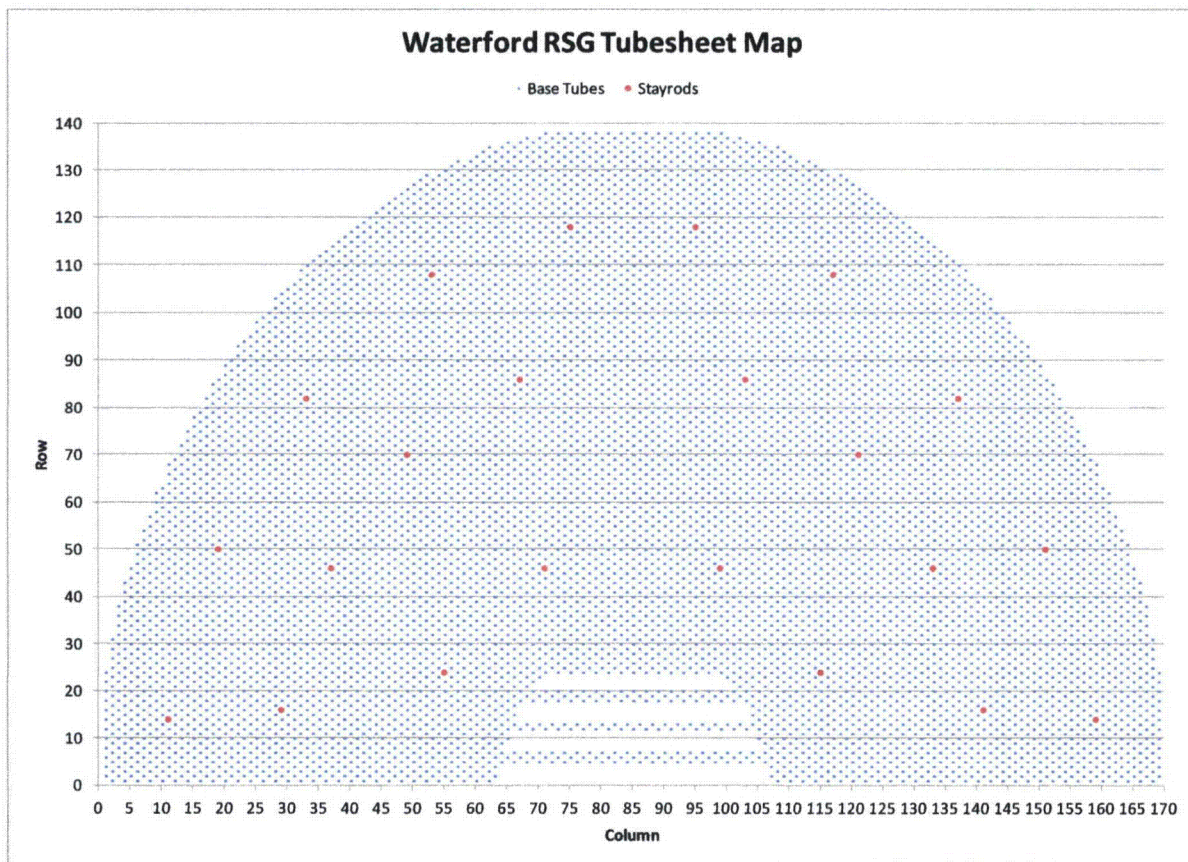
FIGURE 2
**Waterford-3 Delta 110
Steam Generator Tubesheet**
