Industry Response to Recent Thermal Fatigue Operating Experience

**NRC-Industry Materials Workshop
Washington, DC**

June 2, 2015

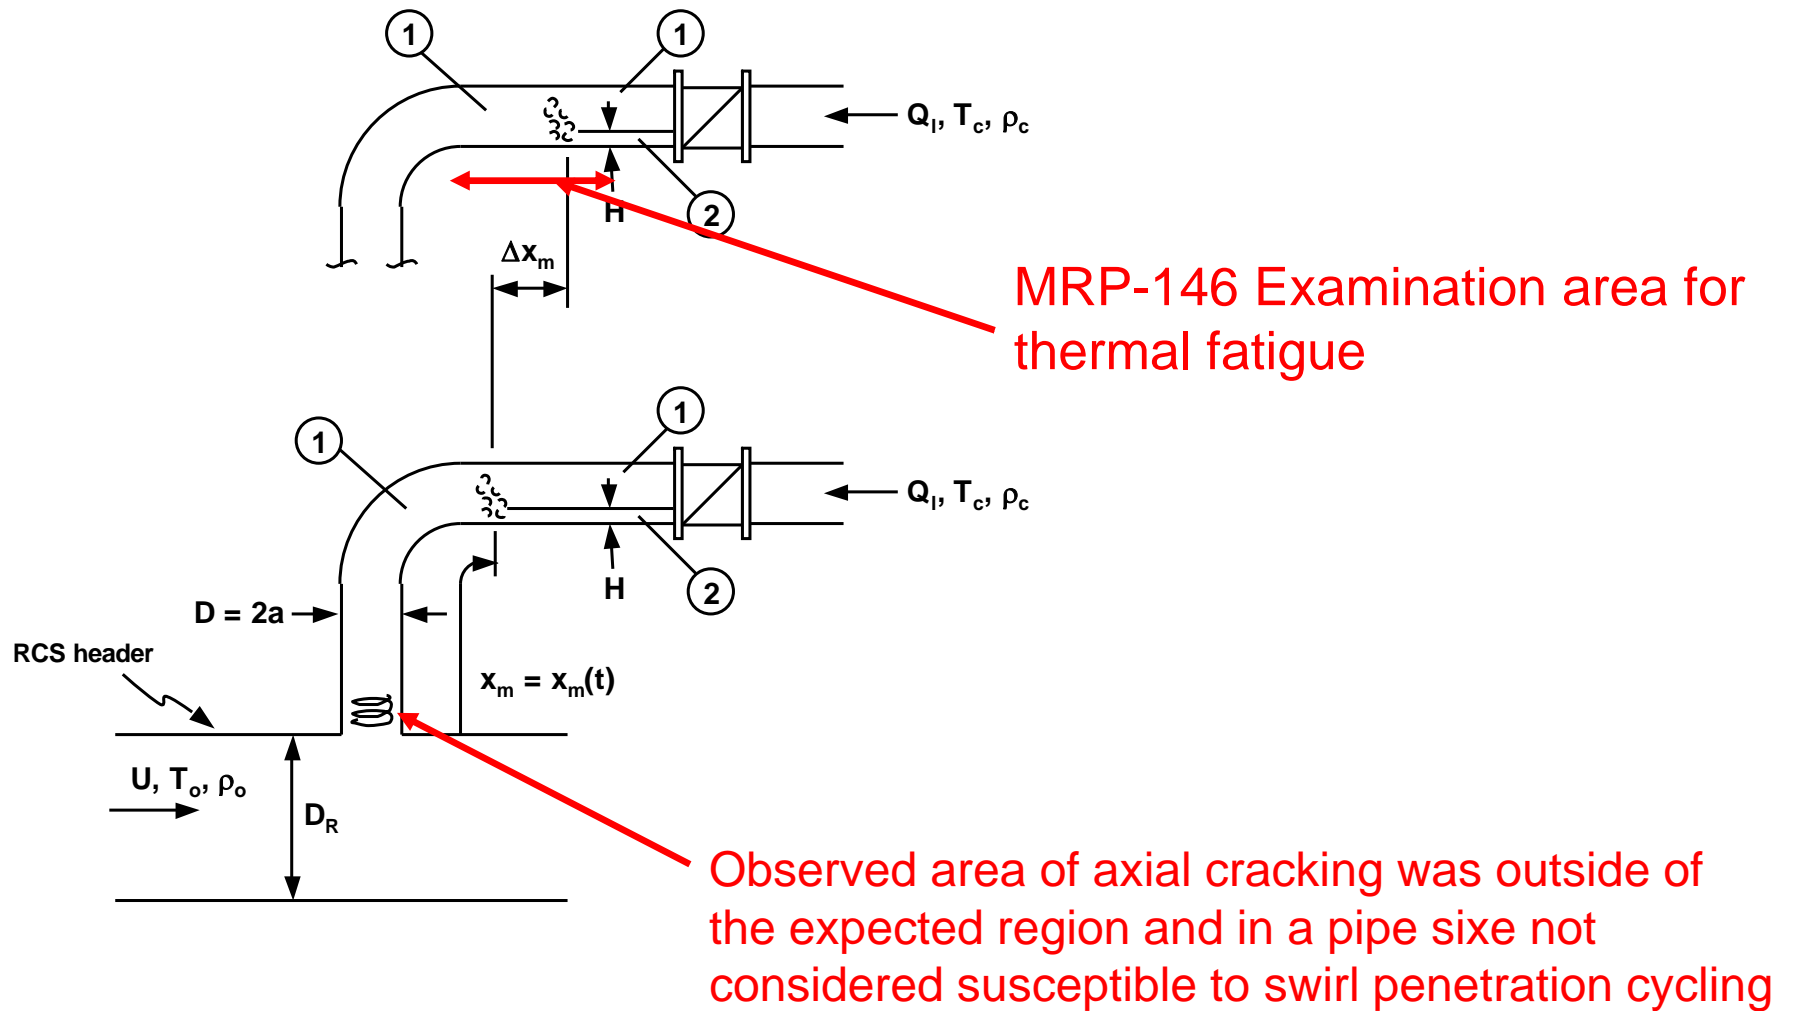
An Example: Small-Diameter UH Branch Line September 2014

An Example: Small-Diameter UH Branch Line September 2014

Analysis Process	Result
Identify Conditions Deviating From Expectations	Cracks were detected in exempted line <2 NPS Cracking in vertical pipe not previously observed
Identify Potential Causes	Cyclic thermal interface w/o swirl penetration Cyclic breakup of cold laminar in-leakage Significant construction repairs in butt weld
Determine Mitigation Alternatives	Emphasize prevention of inleakage Impose examinations to detect new fatigue mode
Candidate Thermal Fatigue Guidance Change	Eliminate small diameter exemption, >1 NPS Examine vertical section of small D piping Remind program owners of construction repair risk
Identify Knowledge Gaps	Behavior of cold inleakage with RCS in small diameter UH branch lines is not understood Sensitivity to key variables not known
Propose Research	Construct physical mockups Benchmark Computational simulations Investigate International approaches

Cracks were located near bottom of vertical pipe. Not in expected zone	Hot-cold fluid cyclic interface relocated to where turbulent breakup resumed	Perform a one-time examination of vertical pipe in comparable UH geometries not later than the first RFO after 6-1-16
		Significant rework performed in safe end welds may have predisposed weld to cracking	Discuss this risk factor in the letter, suggest program owners review and understand fabrication history
