Certificate of Compliance Renewal Application for the VSC-24 Ventilated Storage Cask System
(Docket No. 72-1007),
Document No. LAR 1007-007, Revision 4, June 26, 2015

VSC-24 Ventilated Storage Cask System

(Docket No. 72-1007)

Document No. LAR 1007-007

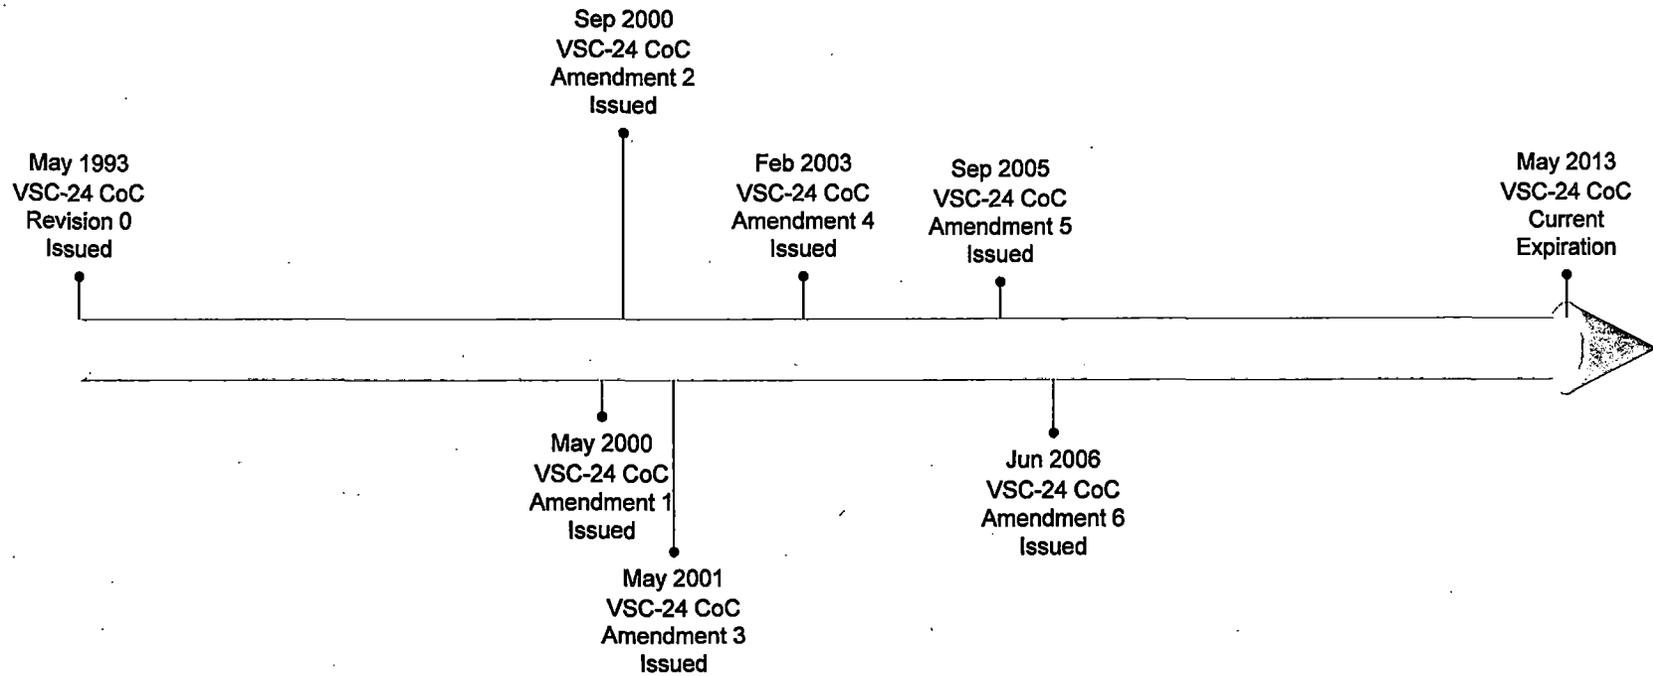
Figure 1 - VSC-24 Storage System CoC Amendment Timeline

The initial VSC-24 Storage System CoC was issued on May 7, 1993, corresponding to Revision 0 of the VSC-24 Storage System Safety Analysis Report (SAR) [1.2]. Subsequently, six (6) amendments were issued to the VSC-24 Storage System CoC. A description of the certification basis for the VSC-24 Storage System CoC initial issue and amendment history is provided in the following paragraphs. General descriptions of the changes and reasons for each amendment are provided, including the dates of the applications and associated supplements, the date of CoC issuance, and the corresponding FSAR revisions in which the changes were incorporated. An overall timeline of the VSC-24 Storage System CoC amendments history is shown in Figure 1.

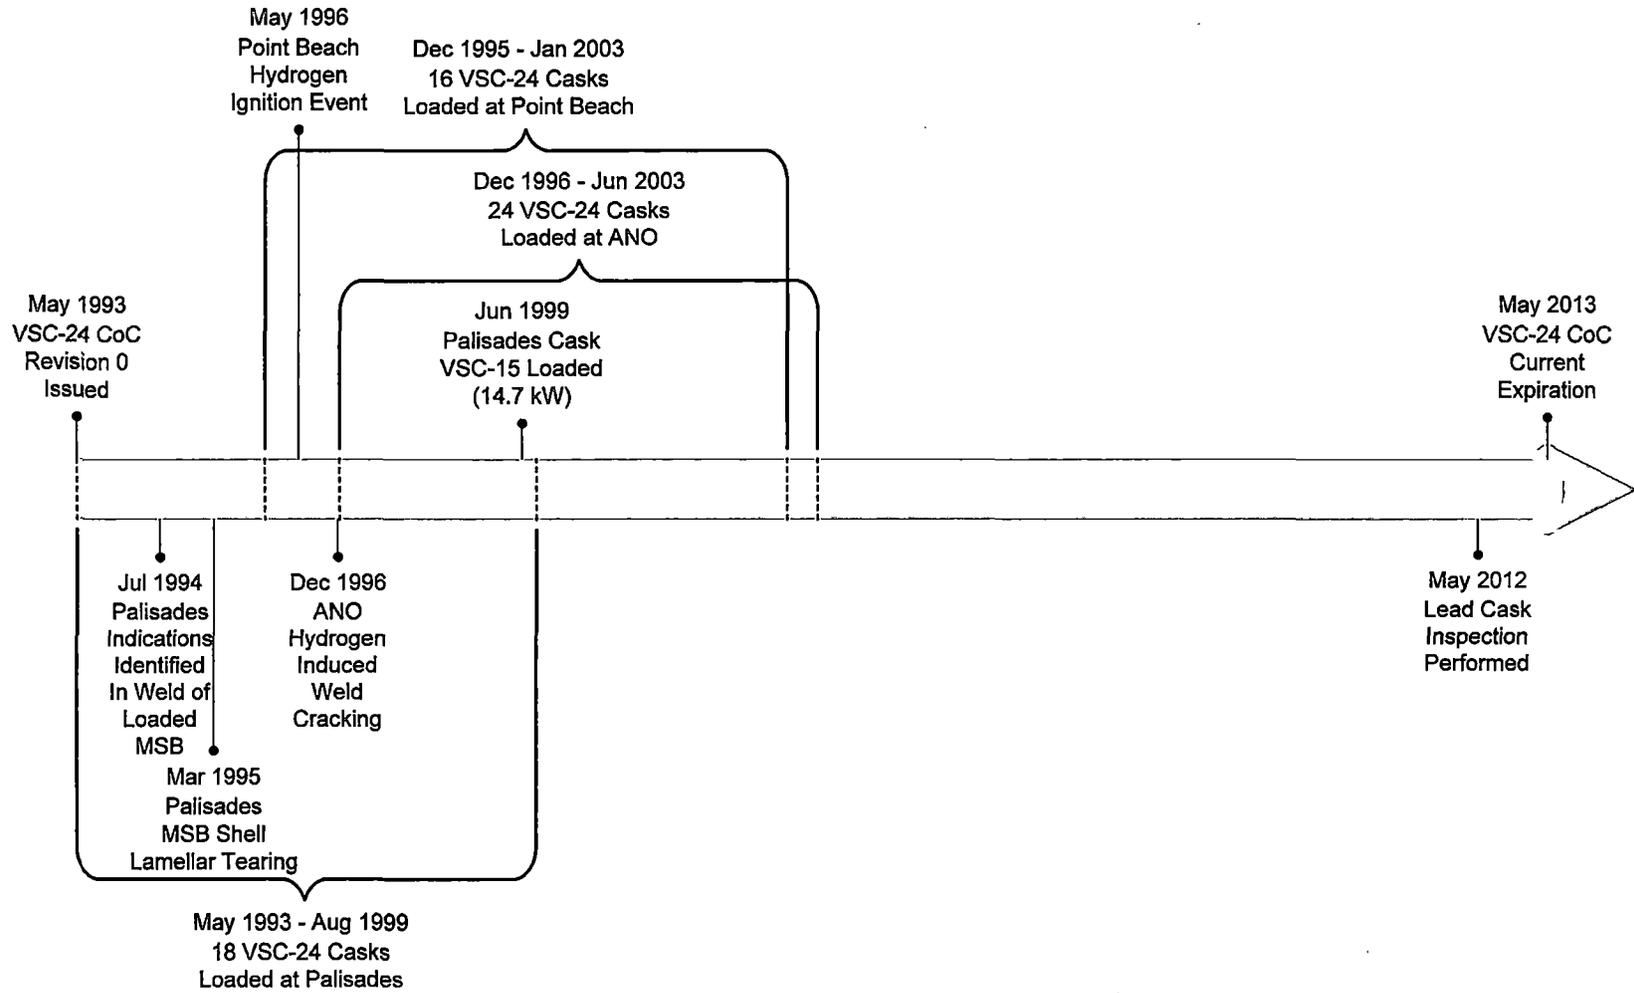
Figure 2 - VSC-24 Storage Cask Loading Timeline

In accordance with the guidance of NUREG-1927 [1.11], a discussion of the experience gained during the early VSC-24 storage cask loading operations is provided in Sections 3.4.3.2 through 3.4.3.4. The discussion focuses on significant events that occurred, and the corrective actions taken to assure continued safe operation and prevent recurrence of the conditions. The events discussed include several instances of MSB closure weld leaks that were identified and corrected during the MSB loading operations at all three sites, identification of flaws in the MSB longitudinal seam weld of an MSB (Palisades MSB-04) that had already been loaded and placed in storage, and a hydrogen ignition event at Point Beach. A general timeline of these events is provided in Figure 2, which shows that these events occurred relatively early in the cask loading

An overall timeline of the VSC-24 casks loaded to date is provided in Figure 2. The VSC-24 cask with the longest time in service is Palisades Cask Number VSC-01, which was loaded in May 1993. Although this cask has approximately six (6) more years in service than Palisades Cask Number VSC-15, it was not selected for the lead cask inspection since it is already inspected on the exterior every year, as discussed in Section 3.4.2.1, and on the interior at a 5-year frequency, as discussed in Section 3.4.2.2. Rather, the cask with the highest heat load was selected for the initial lead cask inspection to gain additional operating experience.
