**ANNUAL REPORT**

**WASHINGTON STATE UNIVERSITY**

**TRIGA REACTOR**

**Facility License R-76 for the Reporting Period of  
July 1, 2014 to June 30, 2015**

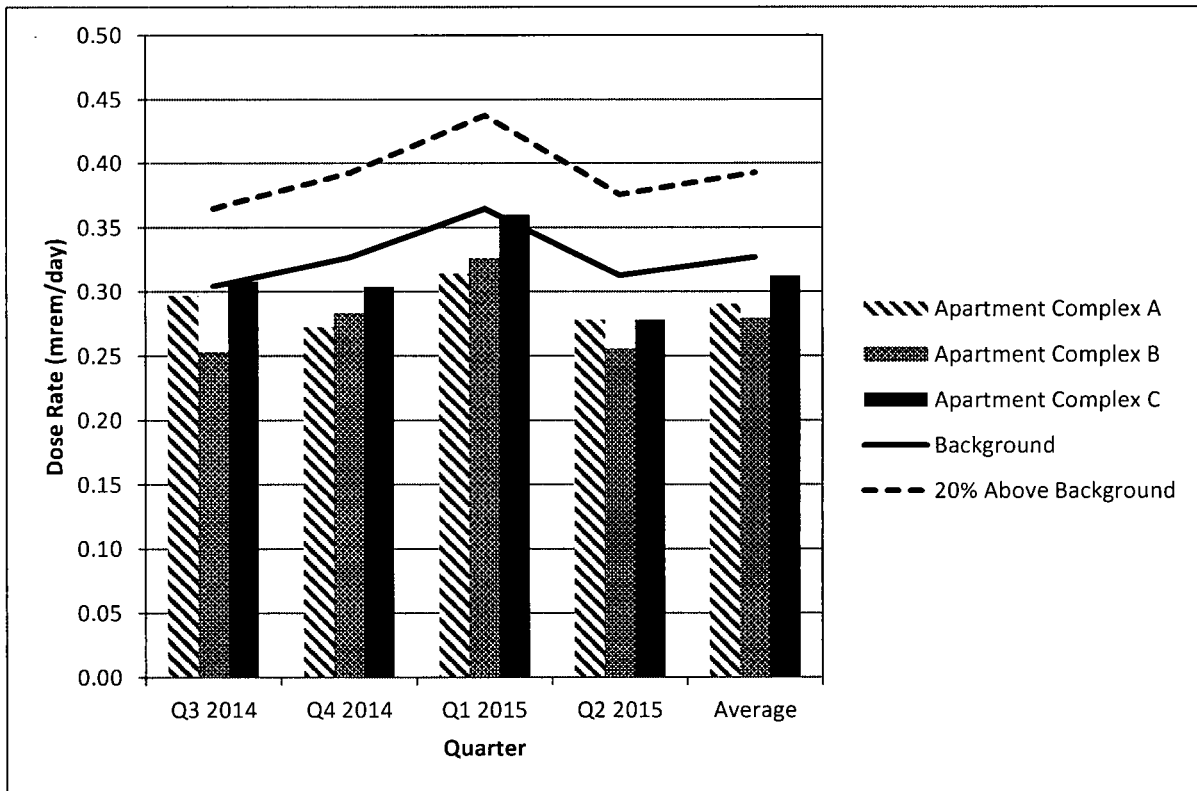
**Chart I**  
 Environmental Radiation Levels for the Closest Off-site Point of Extended Occupancy as Compared to Background Radiation Levels and 20% Above Background Radiation Levels

The dose rate for the closest offsite points of extended occupancy can be found in Table X. In Chart I the closest offsite points of extended occupancy are compared to both the background radiation levels and the 20% above background radiation levels from Table XI. Technical Specifications describing ALARA effluent releases in 3.5.2(3) specify annual radiation exposure due to reactor operation, at the closest offsite extended occupancy, shall not, on an annual basis, exceed the average offsite background radiation by more than 20%. For the reporting period, the average background radiation dose rate for off-site locations was 0.33 mrem/day, while the average radiation dose rate at the closest extended occupancy area 600 meters away was 0.29 mrem/day. This result indicates that no exposure level above normal background radiation was found. While Chart I indicates TLD 36 was higher than background radiation levels for Q3 2014 and Q1 2015, TLD 36 was still well below the 20% above background radiation levels required by the Technical Specifications. This result shows that no dose levels exceeded Technical Specifications requirements for an offsite area of extended occupancy.
