UNITED STATES  
NUCLEAR REGULATORY COMMISSION

March 26, 1997

SUBJECT: RESOLUTION OF PEER REVIEW COMMENTS ON AEOD DRAFT REPORT,  
"OCONEE ELECTRICAL SYSTEM DESIGN AND OPERATION"

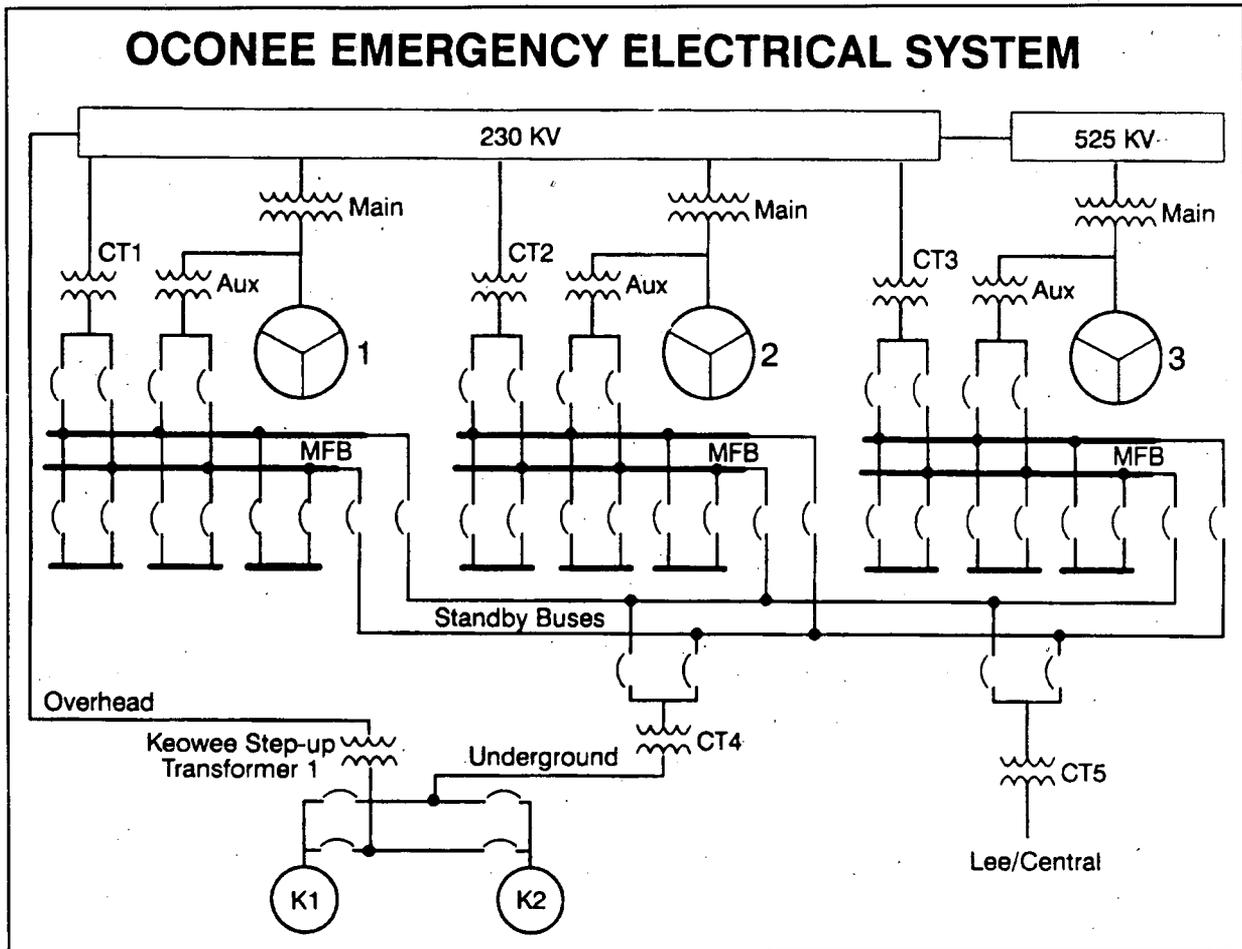
Emergency ac power is provided to the three Oconee nuclear units by two Keowee hydroelectric units rather than by the typical diesel generator systems. Figure 1 represents a simplified diagram of the power sources and connections. Upon a LOOP at any Oconee unit, both Keowee hydroelectric units start automatically, with one Keowee hydroelectric unit connected to the underground path, capable of feeding the Oconee main feeder buses through transformer CT4 and the standby buses, and the other Keowee hydroelectric unit connected to the overhead path, capable of feeding the Oconee main feeder buses through the startup transformer CT3 (for Oconee Unit 3, CT2 for Oconee Unit 2, and CT1 for Oconee Unit 1). The overhead path connections are through the 230 kV switchyard and connected with circuits which are also used for normal power generation. Initial information provided to the Nuclear Regulatory Commission's Office of Analysis and Evaluation of Operational Data (AEOD) staff indicated that both Keowee units were used several hours a day for generating power to the grid. However, in their peer review comments (Ref. 1), Duke Engineering indicated that review of Keowee operating data showed that the Keowee units were actually used for commercial power generation (to the grid) approximately six percent of the year — with dual unit grid generation approximately three percent of the year.

Following a LOOP, emergency power to all Oconee nuclear units may be supplied either through the underground path or the overhead path; and in some cases, a single Keowee hydroelectric unit could supply power to all emergency loads. Most nuclear plant emergency power systems provide power to one safety division from one diesel and to the second safety division from a second diesel.

**Figure 1** Oconee Emergency Electrical System

Since the overhead path for emergency power is through the switchyard, a LOOP event which originates in the switchyard can disable the overhead path as a source of emergency power. Operating experience at Oconee, as well as other U.S. nuclear plants, shows that this is the most likely LOOP scenario. Thus, the overhead path is more likely to be lost than the underground path.

The source of power for the main feeder buses is chosen by automatic auctioneering of the available power sources; if the startup transformer loses power and the standby buses are energized, the main feeder buses are automatically connected to the standby buses, and if the standby buses lose power and the startup transformer is energized, the main feeder buses are automatically connected to the startup transformer. The Lee Station gas turbine units and the Central substation provide additional offsite power sources via manual connection through the CT5 transformer. In this case, the Lee gas turbines must be separated from the grid. In addition, Central can be used as a maintenance source of power during Oconee unit outages for brief periods of time. For SBO scenarios caused by LOOP and failure of Keowee hydroelectric units to start or run, the CT5 source could be available in approximately 1 hour. The main feeder buses are powered from the auxiliary transformer during normal power operation and from the startup transformer (CT1, CT2, or CT3 depending on the unit) during shutdown operation.

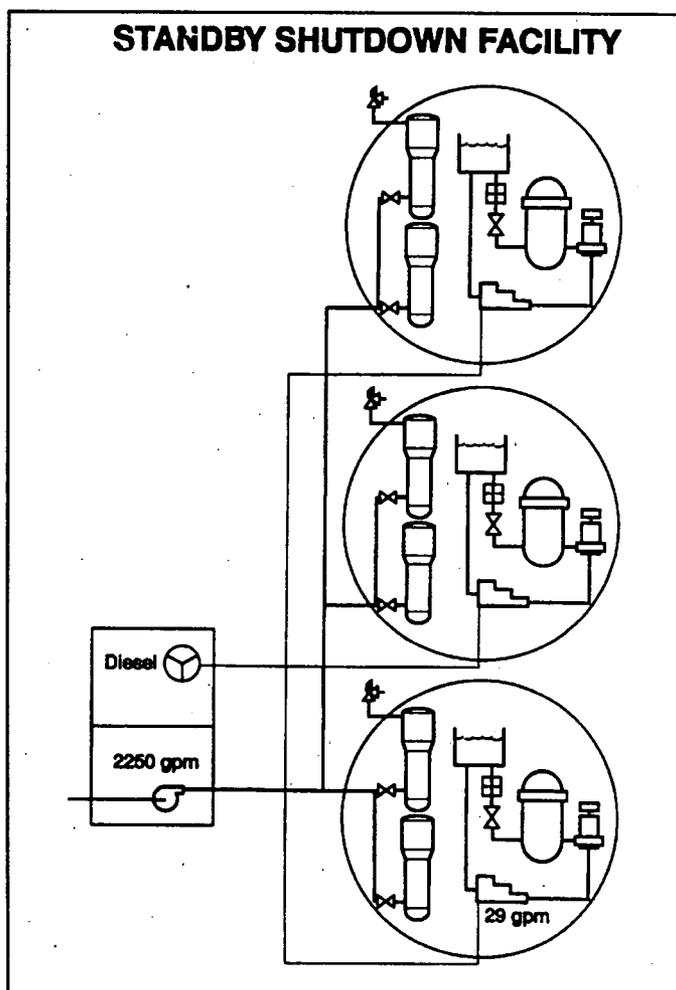
Figure 2 shows a simple schematic diagram of the SSF. Two basic functions are performed by the SSF:

**Figure 2 Standby Shutdown Facility**

(1) makeup water to the reactor coolant system through the reactor coolant pump (RCP) seals, and (2) feedwater to the steam generators. Primary system makeup water cools the RCP seals to prevent a seal loss-of-coolant accident (LOCA) and maintains primary system inventory to ensure natural circulation; feedwater to the steam generators removes decay heat. Feedwater to the steam generators of all three Oconee nuclear units is provided by a single 2250-gpm pump. The SSF water source for steam generator feedwater is raw water from the emergency condenser cooling water system. Primary system makeup water is provided by one positive displacement pump for each Oconee unit, each with a 29-gpm capacity. The water source for primary makeup water is the spent fuel pool (SFP). Electric power for the SSF is from a single diesel generator.
