Sequoyah Nuclear Plant, Units 1 and 2
Facility Operating License Nos. DPR-77 and DPR-79
NRC Docket Nos. 50-327 and 50-328

Subject: Application to Revise Technical Specification 6.8.4.h, "Containment Leakage Rate Testing Program," (SQN-TS-14-03) (TAC Nos. MF5366 and MF5367), Response to Request for Additional Information

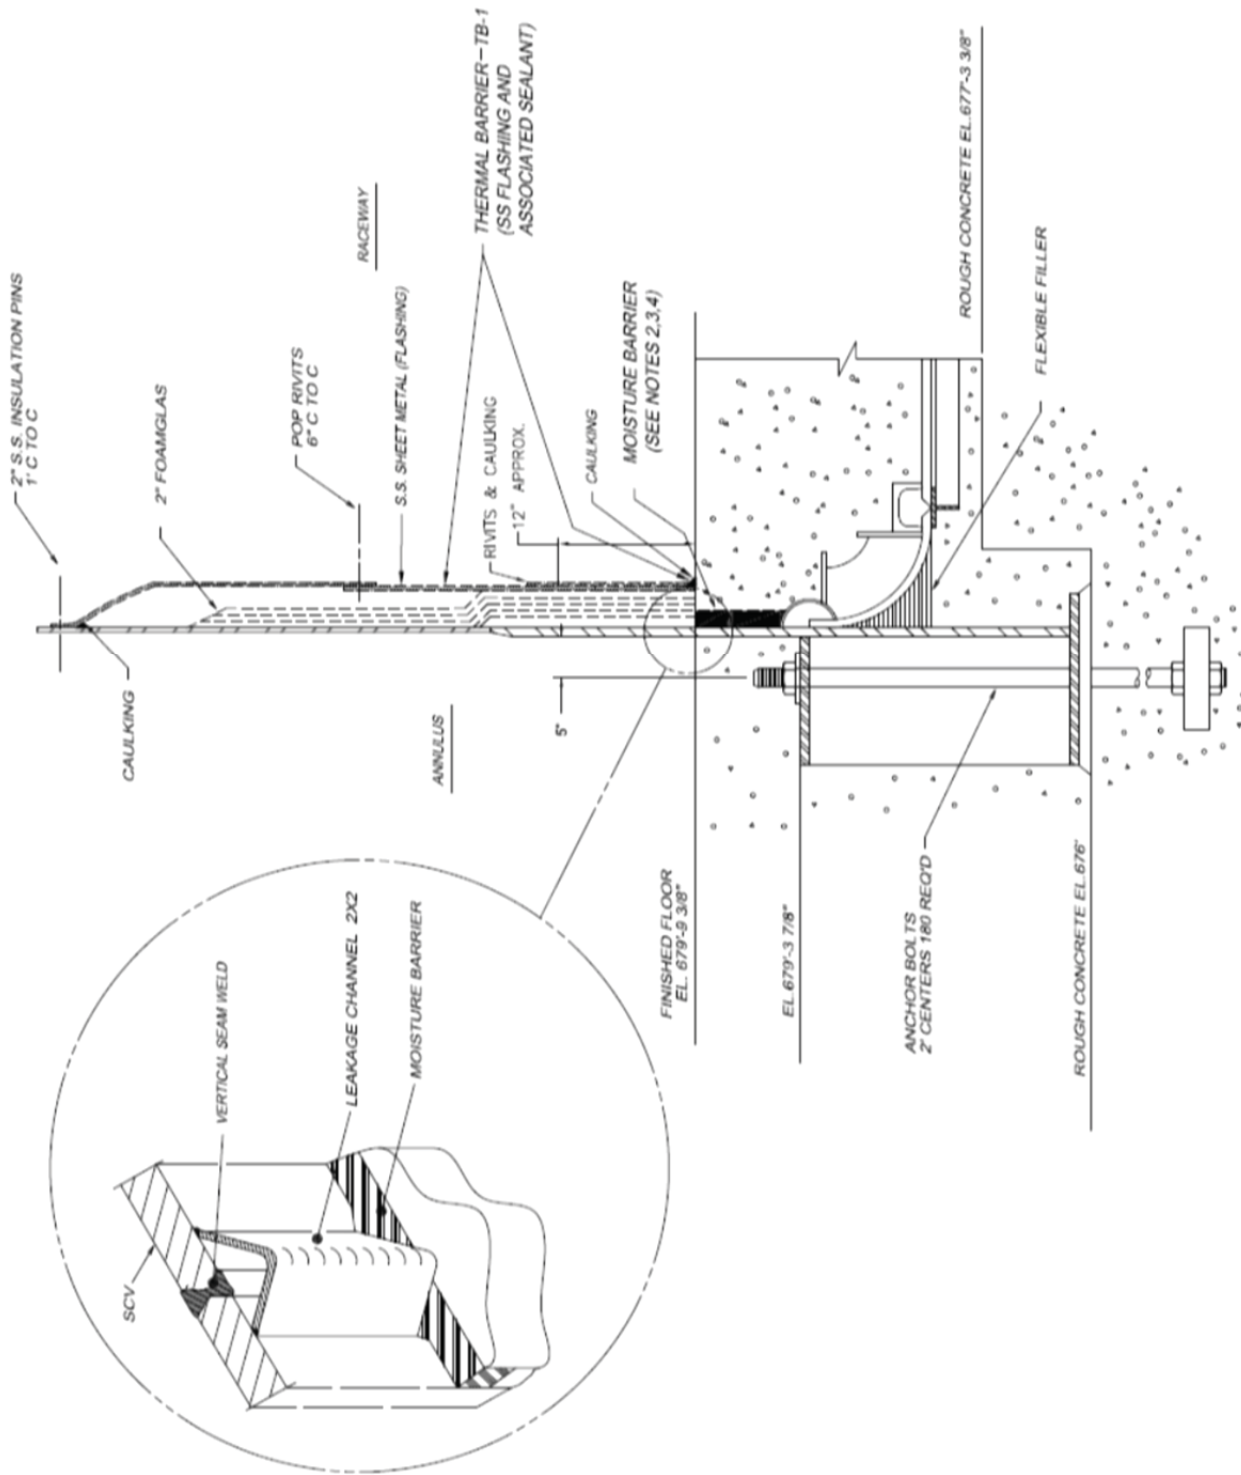
The SCV to concrete interface is visible in the Annulus. The annulus is the area in the reactor building between the SCV and the concrete shield building. No moisture barrier covers the SCV to concrete interface in the Annulus. The metal to concrete interface is examined in the Annulus each inspection period. The following detail provides a representation of the internal and external SCV to concrete interface.

The moisture barrier is intended to prevent intrusion of moisture against inaccessible areas of the pressure retaining metal containment shell or liner at concrete to metal interfaces that are not seal welded. The moisture barrier is the sealant between the concrete to metal containment interface in the raceway behind the metal flashing. The raceway is an area inboard of the SCV between the Polar Crane Wall and the SCV on the bottom elevation of containment used for access to the accumulator rooms, fan rooms, and inside the polar crane wall. An examination of the moisture barrier is performed each inspection period. The flashing covering the moisture barrier is removed to allow access for examination.
