SUBJECT: ENFORCEMENT CONFERENCE SUMMARY
(INSPECTION REPORT NOS. 50-269/90-17, 50-270/90-17 AND 50-287/90-17)

On July 12, 1990, representatives from Duke Power Company (DPC) met with the NRC in the Region II office in Atlanta, Georgia to discuss a design deficiency in Oconee's Penetration Room Ventilation System.

PENETRATION ROOM VENTILATION SYSTEM DESIGN DEFICIENCY

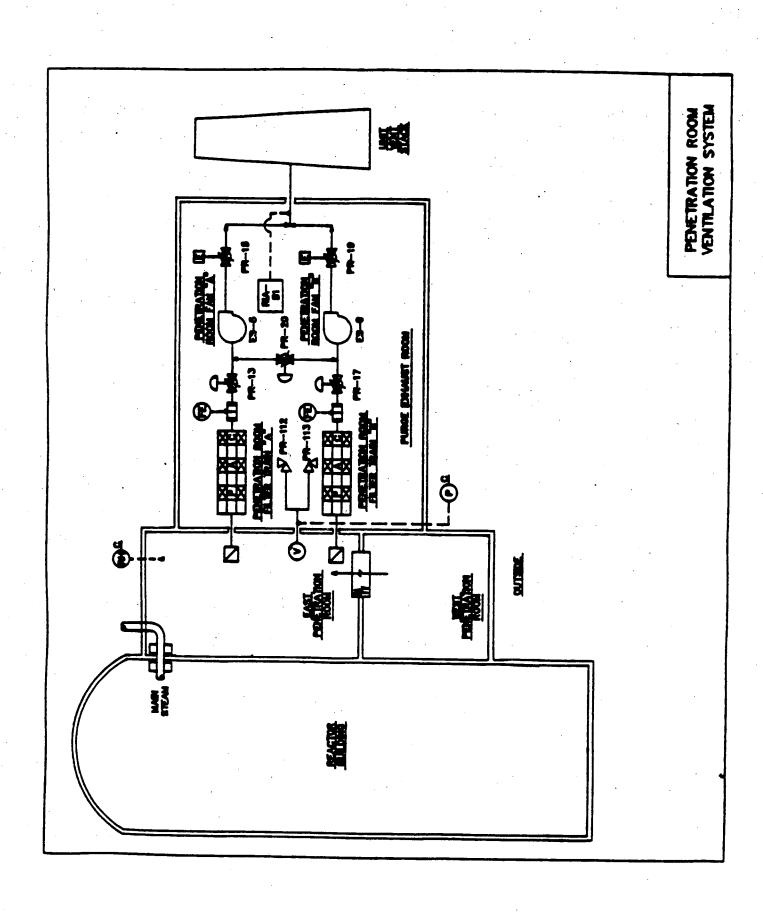
DESIGN BASIS

PROCESS CONTAINMENT LEAKAGE FOLLOWING A MAXIMUM HYPOTHETICAL ACCIDENT (MHA)

50% OF LEAKAGE IS PROCESSED BY PRVS FILTERS

FAIL CLOSED DESIGN APPARENTLY CHOSEN TO PROTECT FILTER FROM HIGH FLOW DURING LOSS OF INSTRUMENT AIR EVENT

PRESENT DESIGN IS FAIL TO THROTTLED POSITION WITH (NON-SEISMIC) REMOTE CAPABILITY FOR OPENING
