SUBJECT: Technical Specification 5.6.8 – IP3 Steam Generator Tube Inspection Report -
Spring 2013 Refueling Outage
Indian Point Unit No. 3
Docket No. 50-286
License No. DPR-64

ENCLOSURE 1 TO NL-13-032

Entergy performed a SG inspection in March 2013 during refueling outage 3R17. This inspection was the 7th in-service inspection (ISI) following SG replacement in 1989 and the 1st of 2 scheduled inspections in the 2nd inspection period. The unit initially entered MODE 4 following this inspection on March 25, 2013.

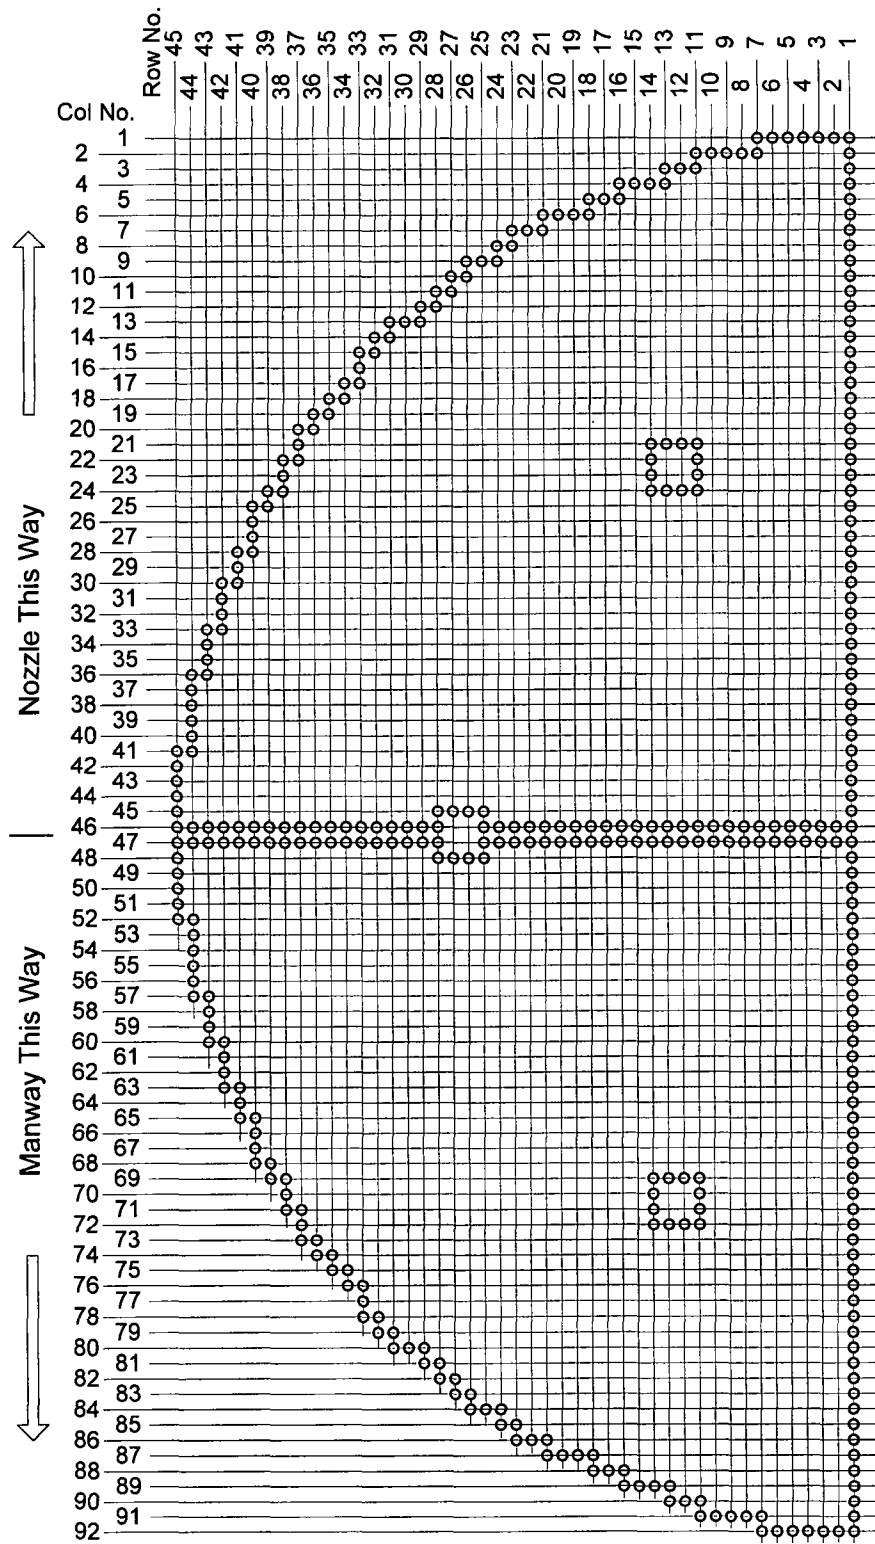
Indian Point 3 Steam Generator Tubesheet Map

The original Westinghouse Model 44 SG's at Indian Point 3 were replaced in 1989 with Westinghouse Model 44F SG's. Each SG has 3214 tubes made from thermally treated Alloy 690. The nominal OD of each tube is .875 in. and the nominal tube wall is .050 in. thick. At the time of the 2013 refueling outage (3R17) at Indian Point 3, the steam generators had accumulated approximately 205 effective full power months (EFPM) of operation since the first in-service inspection performed in 1990. Refueling outage 3R17 was the first of two refueling outages in the second inspection period of 108 EFPM as defined in section 5.5.8.d.2 of Technical Specifications and the first scheduled inspection of the period. The steam generator inspections were performed in March 2013.

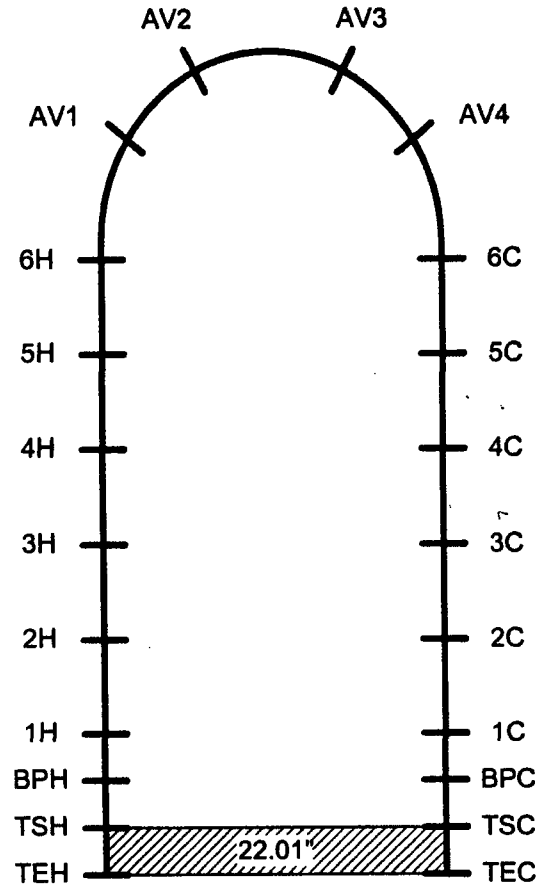
Indian Point Steam Generator Location Landmarks

Westinghouse Model 44F
Steam Generator
