Entergy Nuclear Operations, Inc.  
(Indian Point Nuclear Generating Units 2 and 3)

## 5 Laboratory Test Results

### 5.1 Fixed-Focus Camera Test Results

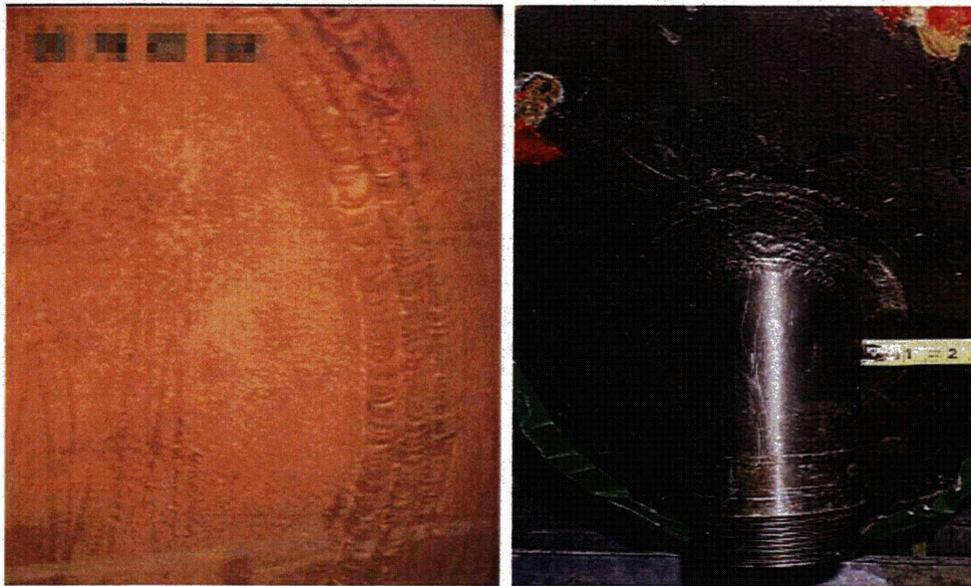
BWRs primarily have red hematite-based deposits on all internal components. In PWRs, which have magnetite-based deposits, one sees dark grey or black deposits on internal components. Examples of each are shown in Figure 6.1. The image on the left was taken during an EVT-1 inspection in a BWR during a scheduled outage and shows a component prior to any cleaning. The surface is highly diffuse and dull red. The image on the right shows the wetted side surface of a control rod drive mechanism (CRDM) that had been removed from service and sent to PNNL for examination. The CRDM has been decontaminated using a wide variety of techniques, and the surface is somewhat specular. Prior to the decontamination, the CRDM wetted surface was also very diffusely reflecting. The bottom surface in a PWR is shown in Figure 6.2. Also shown at the left of the image are a resolution target and a bottom-mounted instrument penetration. The white section of the resolution target was used to white-balance the image. The bottom of the PWR appears to be dark brown, suggesting a mix of oxides.

**Figure 6.1 Examples of Deposit Layers from BWR (left) and PWR (right)**

The red discoloration in a BWR possibly does not have a strong effect on crack detectability. The dark grey/black discoloration in a PWR could make crack detection more difficult, however. The dark color of the oxide in a PWR can be at least partially overcome with more lights and longer exposures. The largest problem encountered in remote VT on reactor components was caused by mottled surfaces. When a tight crack passes through regions that are both light and dark, finding and sizing the crack can be very difficult.

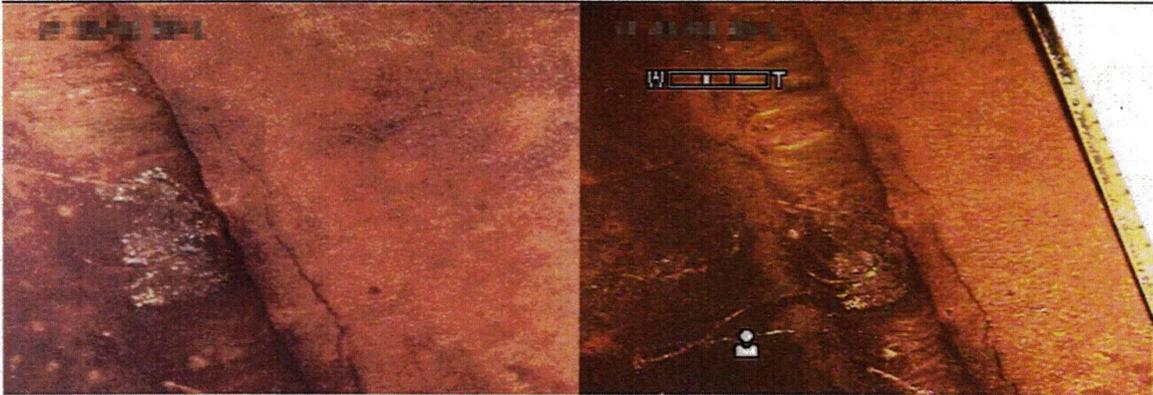
The deposits usually accumulate in two layers, an adherent layer on the metal surface and a loose layer on top of the adherent layer. The loose layer can usually be removed with a brush or water jet, while the adherent layer requires aggressive methods such as wire brushing or acid etching to remove it. For practical purposes during visual testing in a reactor, soft brushing or hydrolasing is convenient to remove the loose layer and leave the adherent layer. Also, as virtually all visual testing is performed using spot lighting, removing the adherent layer and exposing a highly specular surface would severely degrade the inspectability of the cleaned components. An example of a component in a BWR before and after light brushing is shown in Figure 6.3. The image on the left shows a cracked component before cleaning, with the loose and adherent layers present. The image on the right shows the same area after the loose

**Figure 6.3 A Crack Before (left image) and After (right image) Cleaning Loose Oxide Layer from Surface**

deposits have been brushed off, as well as part of a tape measure that has been lowered to facilitate measuring the length of the crack. The image of the area before brushing shows the layers to be almost entirely diffuse, and the spotlights provide very even illumination with no signs of glare. The cleaned image shows the adherent layer to be somewhat specular with slight glare but still less specular than the tape measure, which shows significant glare.

It should be noted that for the purposes of this study, PNNL focused on analyzing under laboratory conditions pertinent issues associated with the reliability of VT. In the course of the study, some limited information was found regarding field conditions. For example, VT practitioners have indicated that the oxide layer may sometimes be helpful in finding cracks. There is anecdotal evidence of the oxide patina being discolored around cracks, making the cracks easier to find. It was learned that a recent examination of a BWR provided two cases in which crack detection was assisted by markings and discolorations in the oxide layer. Both cracks were mechanical fatigue cracks. In the first case, the crack was very long, had a large COD, and would have been found even without the discoloration. This crack is shown in Figure 6.4. The discoloration is near the end of the crack, where it is the tightest. For the second crack, the oxide layer was disturbed near the crack, greatly enhancing the crack visibility. This crack is shown in Figure 6.5, both before and after the loose oxide layer was brushed off. The crack was, in fact, more visible before the loose oxide layer was removed.

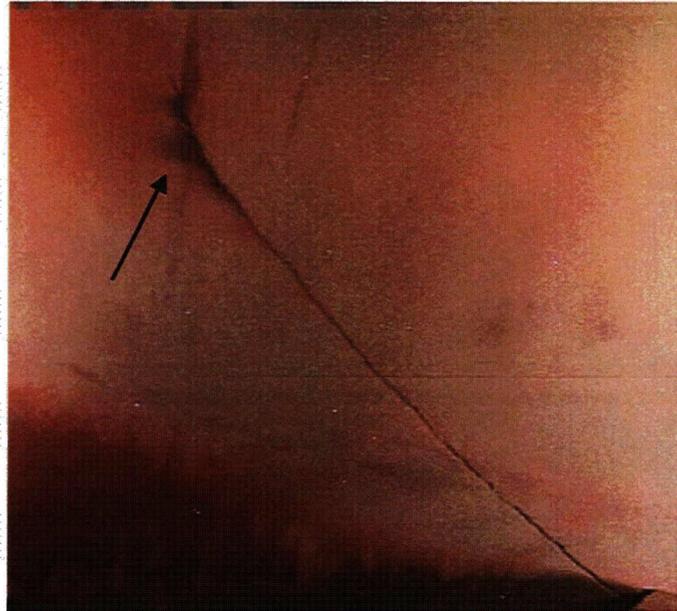
**Figure 6.4 Mechanical Fatigue Crack with Black Oxide Decorating One End of Crack**

The oxide layer can help in crack detection with the periodic decoration of the outside of the crack. This phenomenon has been observed several times, and some photographs of this are shown in Section 6.3. The cause of this decoration and the probability of it occurring are as yet unknown.

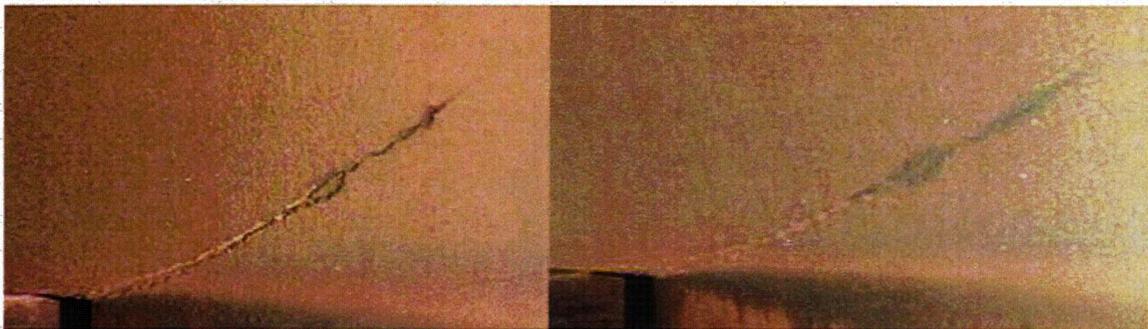
**Figure 6.5 Mechanical Fatigue Crack Made Visible by Disturbance in Loose Oxide Layer**

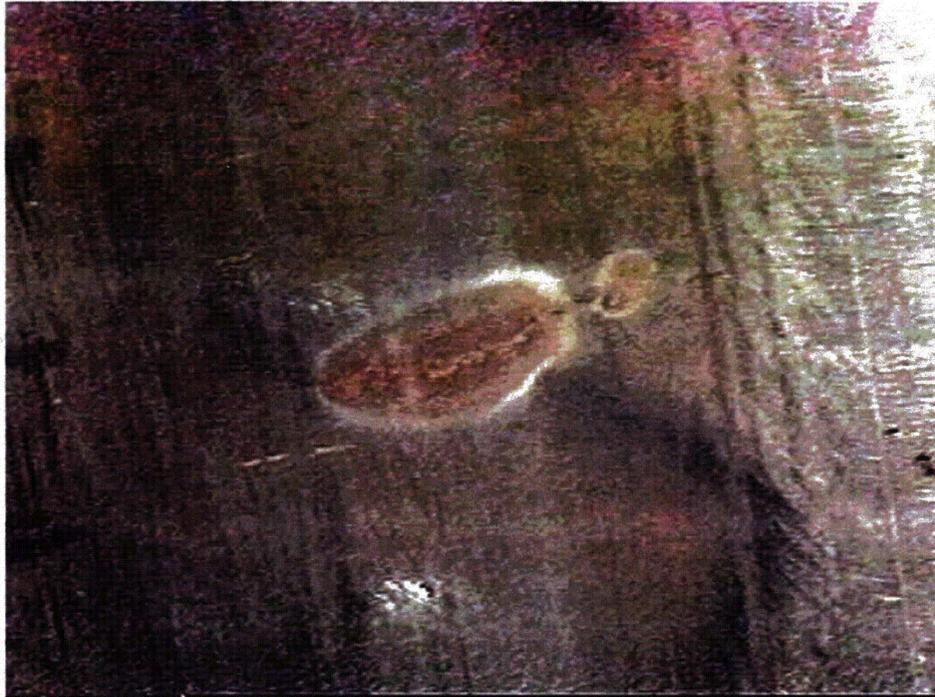
Another example of a crack that was made more visible by oxides is shown in Figure 6.6. In this case, the component had stainless steel cladding over carbon steel. When the stainless cladding cracked through, the carbon steel oxidized, and the resulting oxide bled through the crack, decorating the surface of the stainless steel. This oxide decoration draws attention to the cracked region. While the crack is faintly visible without the oxide, the oxide decoration does help in crack detection.

**Figure 6.6 Stress Corrosion Crack Through Stainless Steel Made More Visible by Oxide Decoration**

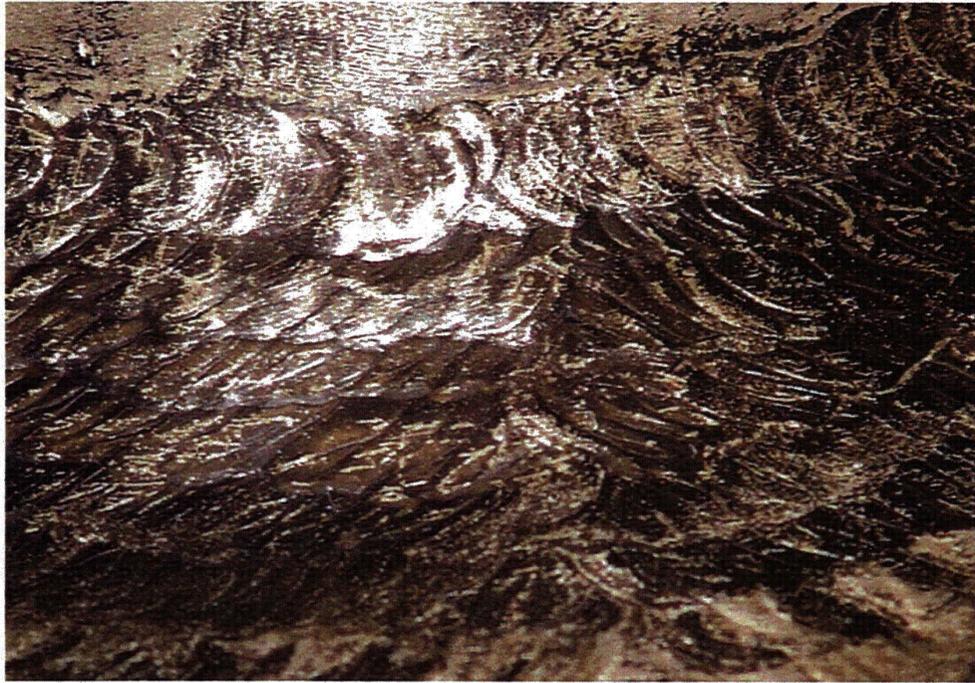
One difficulty that can be caused is uneven layer distribution. Uneven layer distribution may result in a mottled surface on a component. When one is examining a region with light and dark regions, imaging a crack is challenging. If one sets the lighting and exposure to optimize crack visibility on the lighter areas, the crack will be invisible in the dark regions; and if one sets the lighting and exposure for the darker regions, the image will be overexposed in the lighter regions. Also, a mottled distribution can result in very different specularities levels across the imaged area. Parts covered will be dull, and any bare metal may be highly specular. A weld region removed from a PWR with a mottled and uneven buildup is shown in Figure 6.7.

**Figure 6.7 Mottled Surface with Varying Color and Specularity Across Surface**

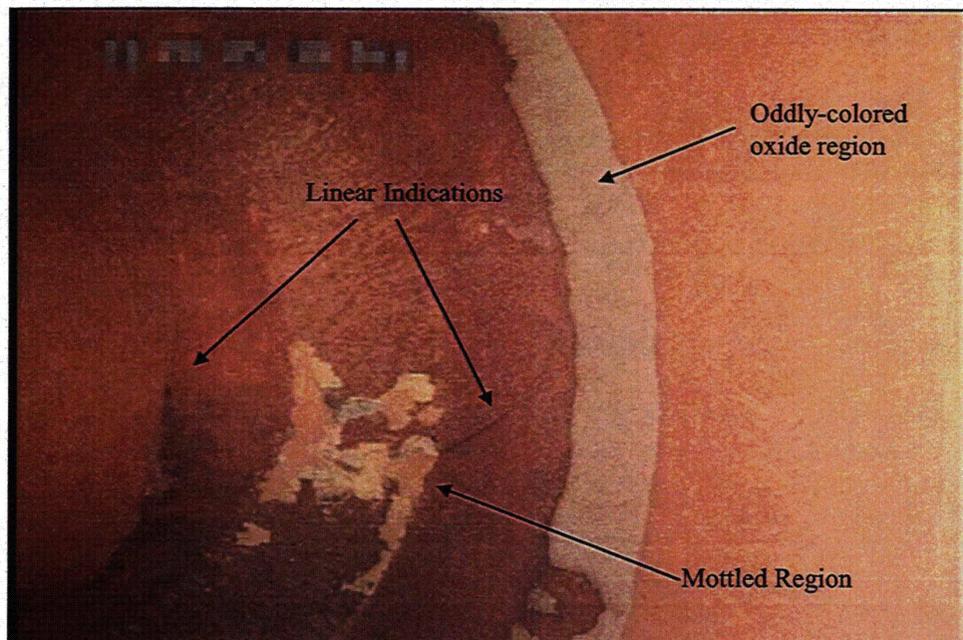
In addition to being covered in oxides, reactor components are often not flat plates and have a variety of textures and configurations. Figure 6.8 shows a pipe coming out of a larger component, and one can see pipe, ground weld, clad plate, and the transition regions clearly. The deposits have not accumulated evenly over these surfaces, and there is more than one place for a crack to hide on such a surface. There are two linear indications that were not called as cracks shown in Figure 6.8. The transition between the pipe and the plate shows an oddly colored deposit region that could potentially hide a crack along the boundary. There is also a mottled region of deposits that presents a challenge to crack detection. All these features occur close to welds, which put them in regions that should be highly scrutinized.

**Figure 6.8 Complex Surface Geometry and Deposit Layering on BWR Component**

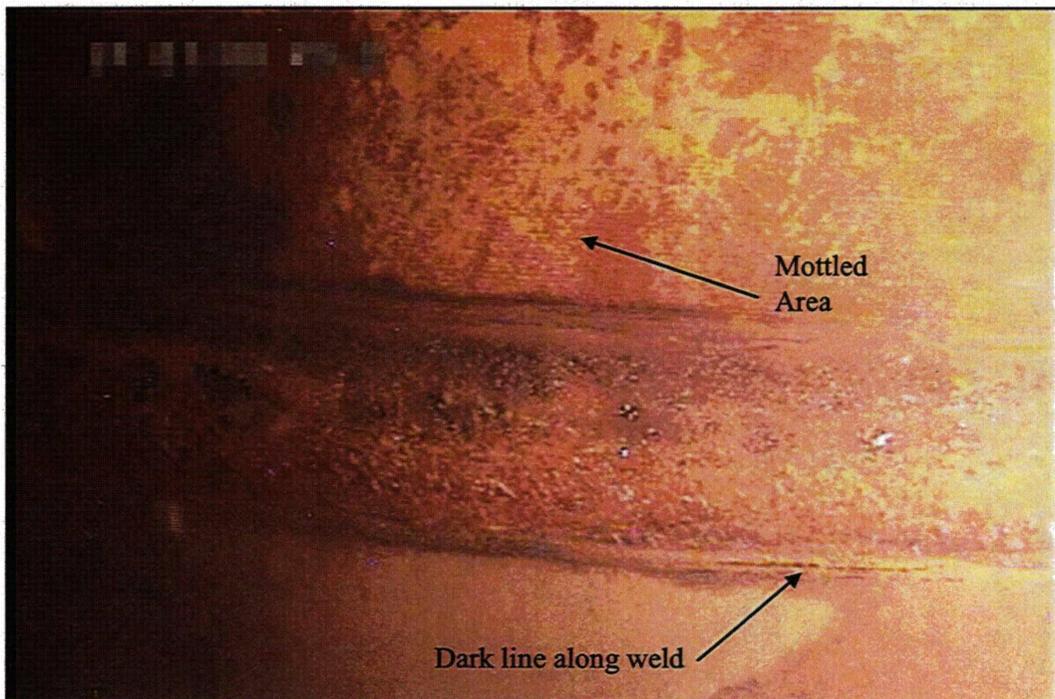
Weld root and crown conditions provide several challenges. As many cracks, especially IGSCC, tend to occur along welds, visual inspections often occur on and near weld roots and crowns. Weld roots and crowns can affect the flow of the colloidal deposits and thus create different thicknesses and color patterns of the deposits around the weld. An example of this is shown in Figure 6.9. Notice the dark linear mark along the bottom right portion of the weld. High magnification and resolution would be needed to discern such deposits from a small crack.

**Figure 6.9 Complex Surface Deposit Layering On and Near BWR Weld**
