SIGNIFICANT OPERATIONAL EXPERIENCE

7 MAJOR INDUSTRY EVENTS WITH REGULATORY IMPLICATIONS

Presented by John Thompson
NRR/ADRO/DIRS/IOEB

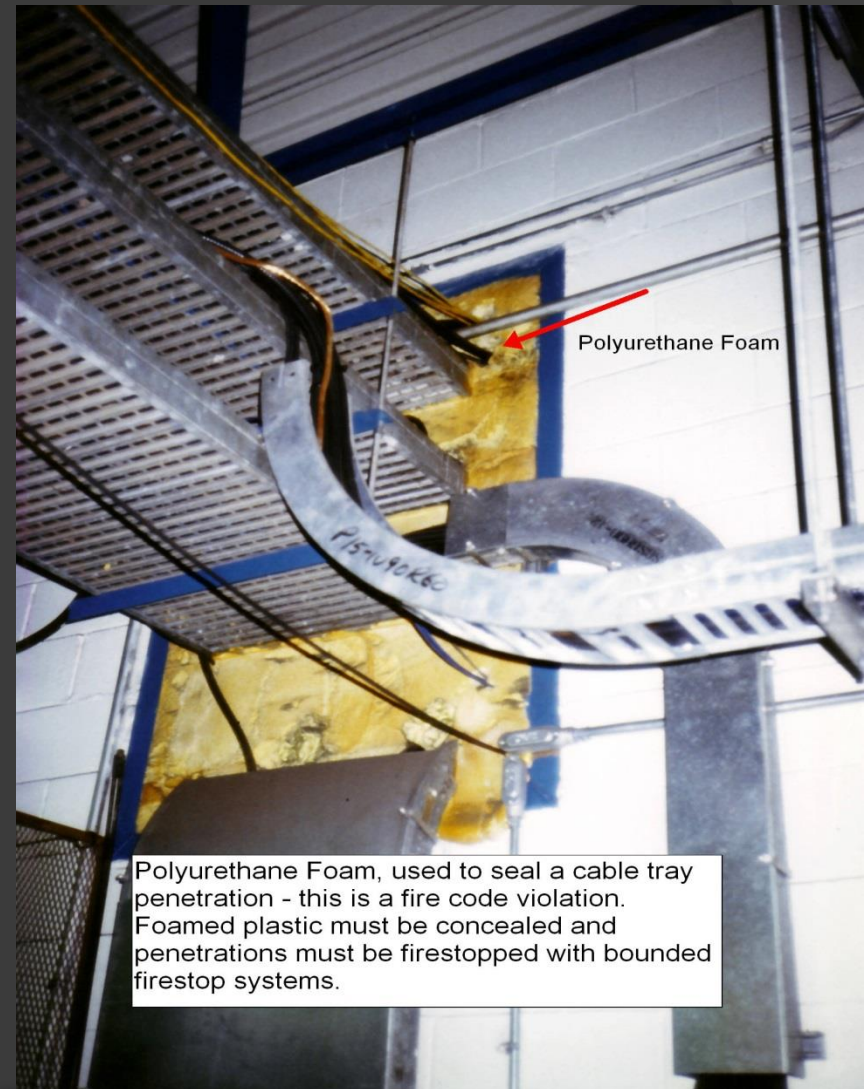
Browns Ferry Cable Tray Penetration

Polyurethane Foam, used to seal a cable tray penetration - this is a fire code violation. Foamed plastic must be concealed and penetrations must be firestopped with bounded firestop systems.

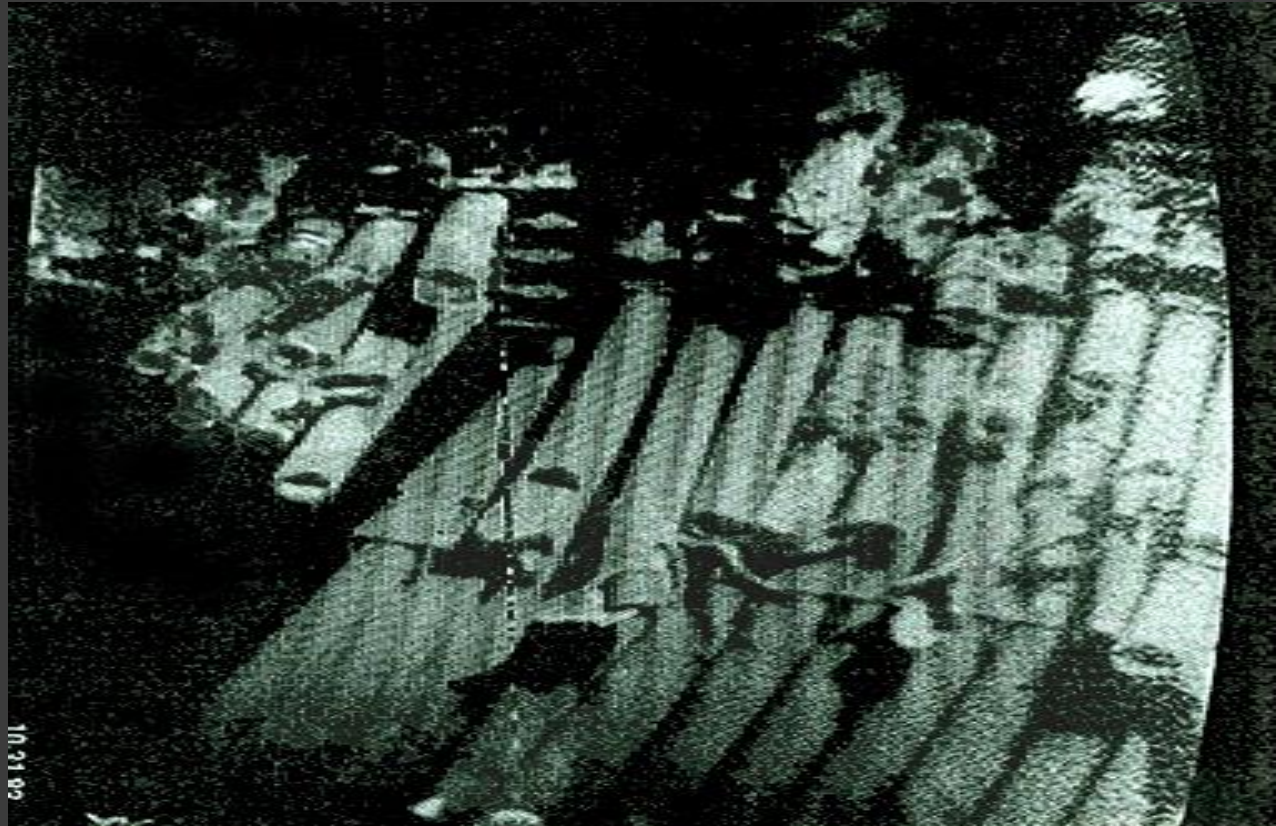
Damaged TMI Core

Photo of
damaged fuel

Approx. 44%
of the core
melted

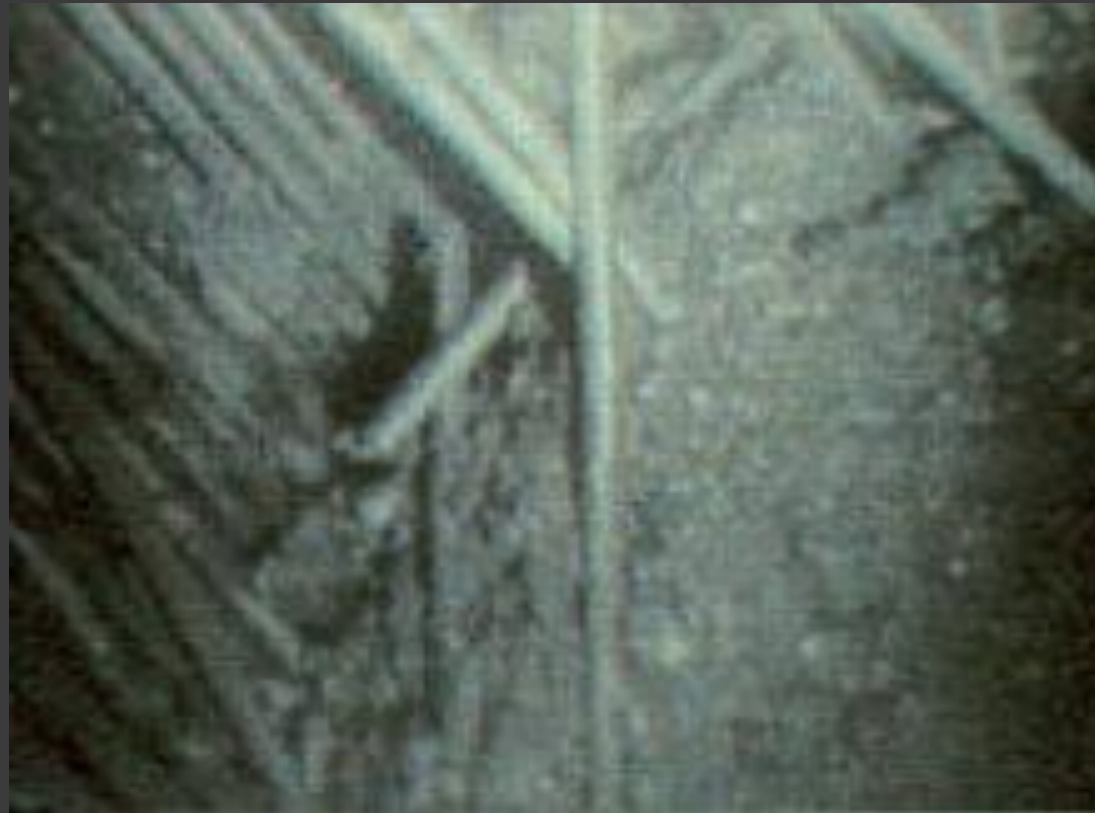
Damaged TMI Core

View inside
vessel
showing
damaged fuel
at the bottom

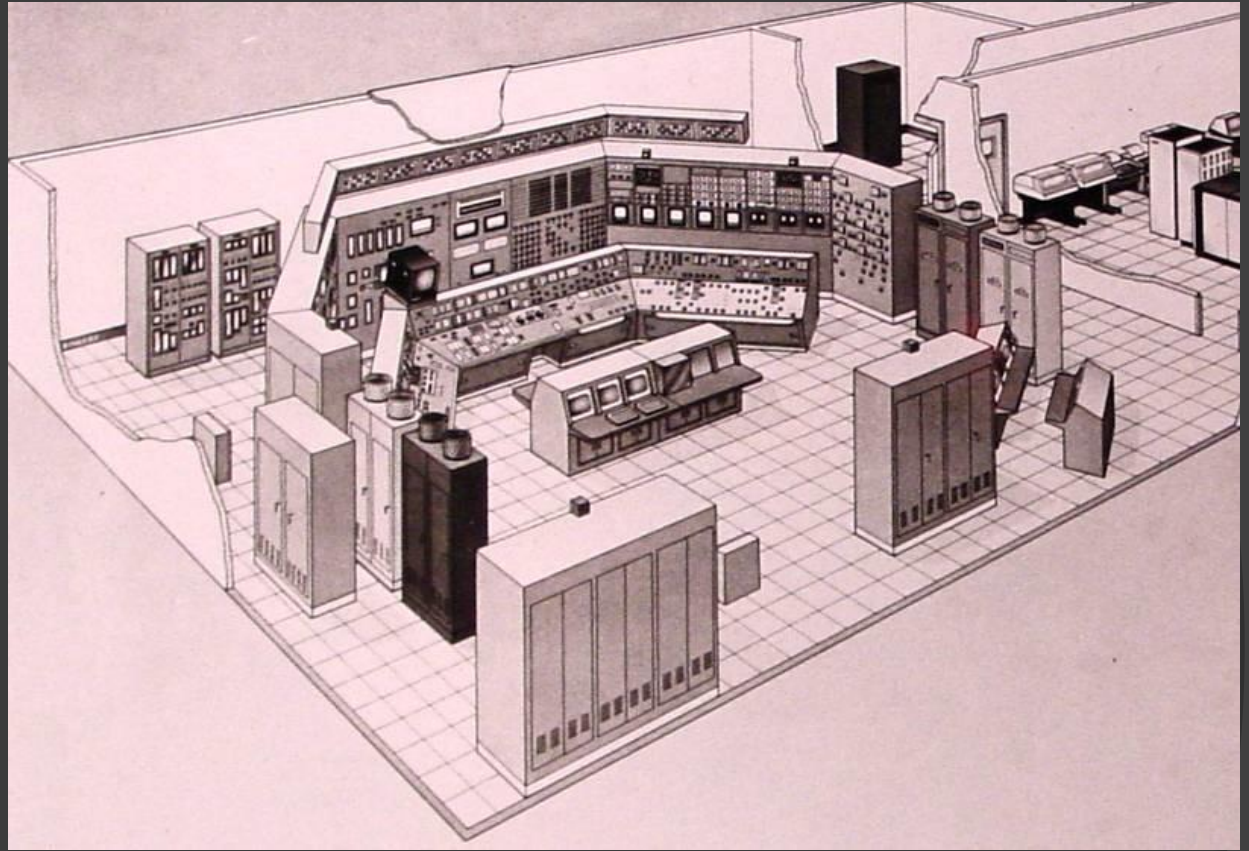
TMI- Control Room Opacity

- no visual feedback
- no audio feedback
- no feel for the machine

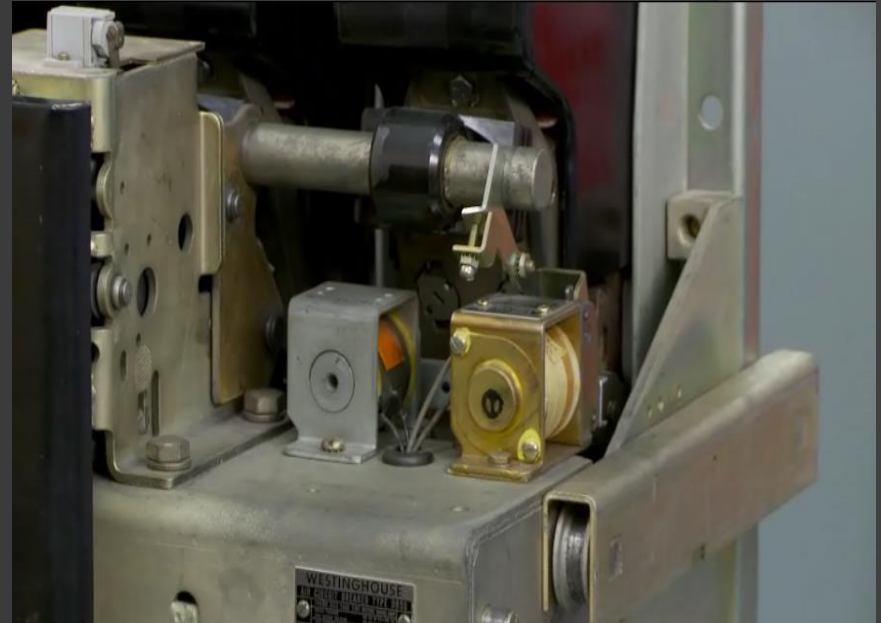
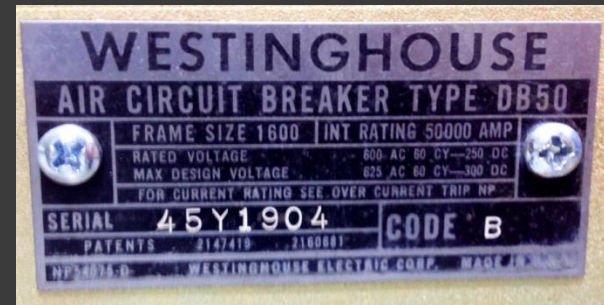
Salem ATWS Event

- Post event testing of the RTBs indicated that both breakers had failed to open due to mechanical binding in the under-voltage trip mechanisms.
- The breaker failures were attributed to excessive wear from improper maintenance of the under voltage relays.
- Root causes included: 1) inadequate attention to the importance of vendor-supplied information, 2) absence of an adequate preventive maintenance program, and 3) an inadequate supply, control, and verification of information by the vendor.

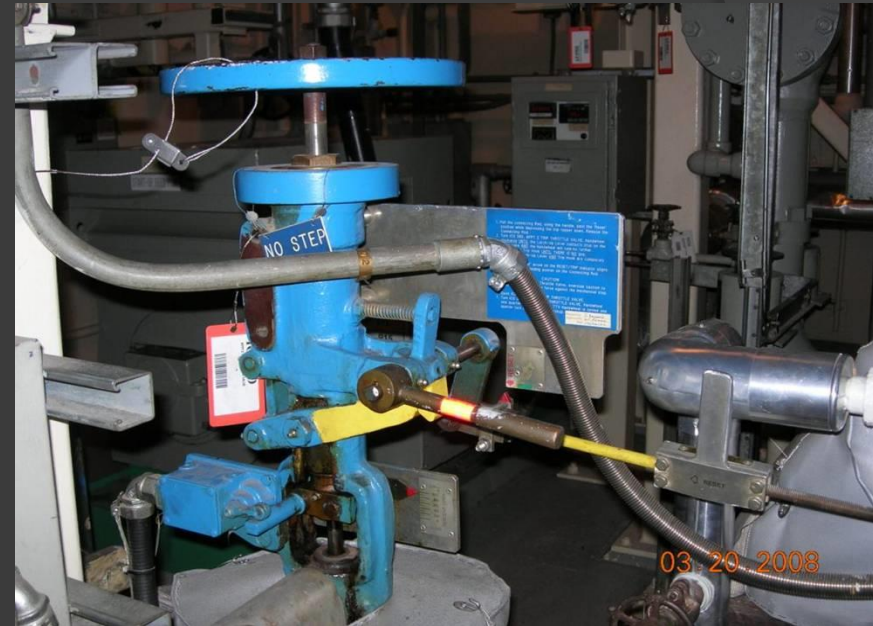
Inexperience with opening & resetting of TD AFW trip throttle valve and the over speed trip mechanism led to industry wide training

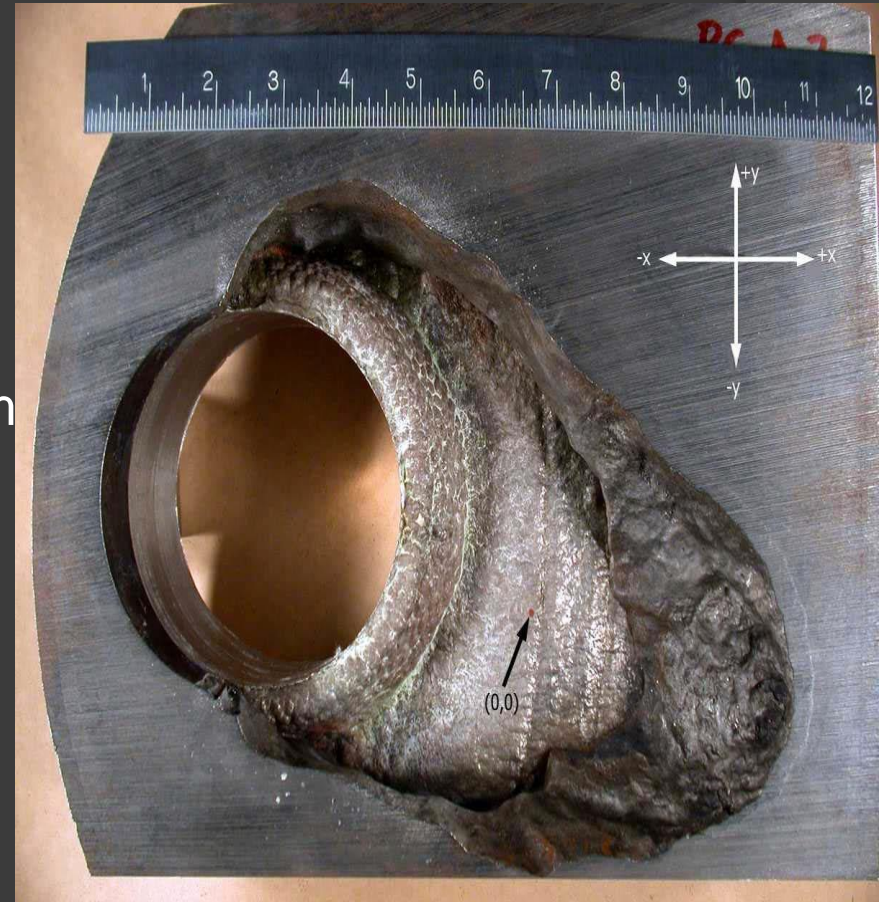
An undetected reactor coolant system (RCS) leak in a control rod drive mechanism (CRDM) nozzle flange resulted in severe degradation of the reactor pressure vessel head (RPV) due to boric acid corrosion.

- During the Refueling Outage (RFO), while removing a machining apparatus from CRDM nozzle no. 3, the nozzle tipped downward.
- Inspections revealed wastage of the steel RPV head material adjacent to the nozzle.
- The wastage extended 5 inches downward and was about 5 inches at its widest part.
- The minimum thickness of the RPV head remaining was only 3/8 inch of the stainless steel cladding on the underside of the RPV head.
