**SUBJECT: 2.206 Petition on Current Licensing Basis for Flooding at Pilgrim**

**Pilgrim's Flood Hazard Re-Evaluation**

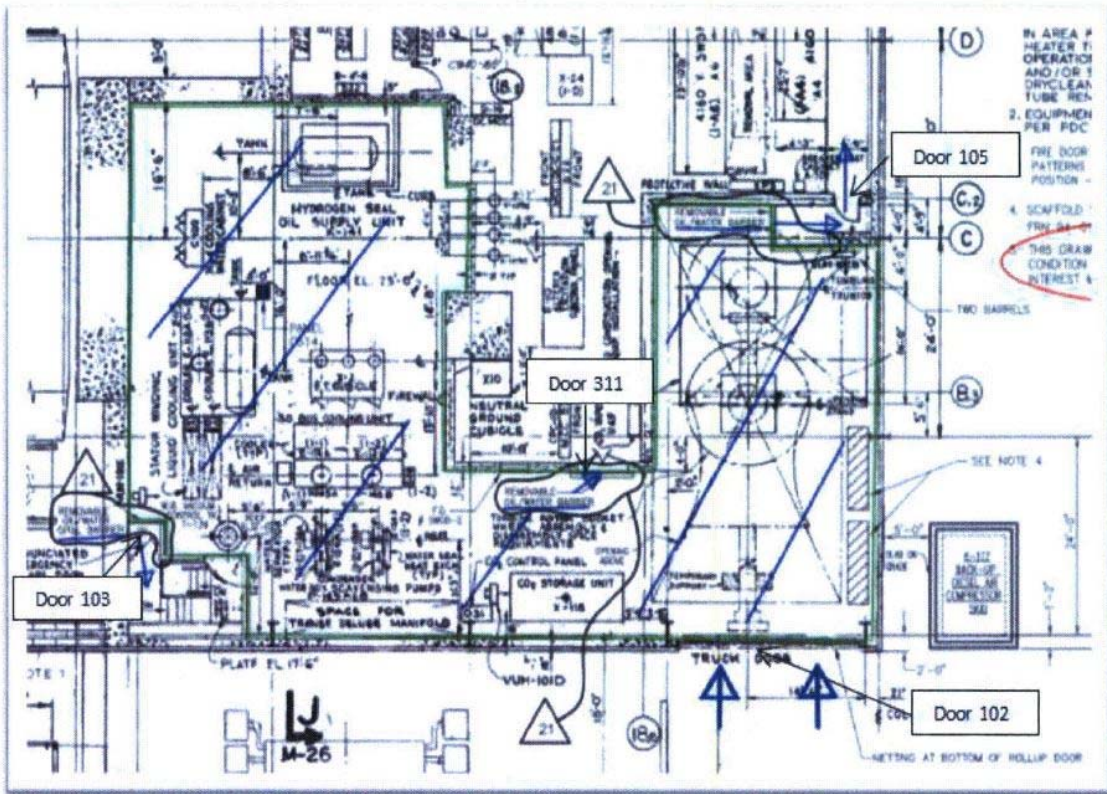
Notes:

1. Should water from the LIP seep through Door 102, potential flooding within Turbine Building areas is shown by the blue highlighting. It is anticipated that flood water would be contained within the walls and doors outlined in green highlighting.

Figure 2. This drawing looks downward at the southwest corner of the turbine building at Pilgrim. It is Figure 5-2 from Pilgrim's flood hazard re-evaluation report. It shows the location of external door 102 as well as internal doors 103, 105, and 311 that are credited in protecting important components from being submerged.

Second, the licensee's completed evaluation has already identified the locations where heavy rainfall events pose flooding challenges and has already identified the existing components (i.e., doors) that protect equipment important to safety from damage. Thus, no new equipment needs to be installed and no existing equipment needs to be modified or replaced.

2. Suppose the licensee wanted to permanently remove Door 311 (see Figure 2 for its location) from its hinges in the turbine building because it was impeding personnel movements within the turbine building. Again, because the only flooding hazard under the former current licensing basis came from extreme storm surges that did not exceed the entrance elevation (23 feet MSL) of the

turbine building, removing Door 311 would not undermine flooding protection measures. But if the current licensing basis included heavy rainfall events, this would either prevent Door 311's removal or condition it on providing some readily available alternative means of protecting important equipment from flooding damage.
