SUBJECT: 2.206 Petition on Current Licensing Basis for Flooding at Pilgrim

Pilgrim's Flood Hazard Re-Evaluation

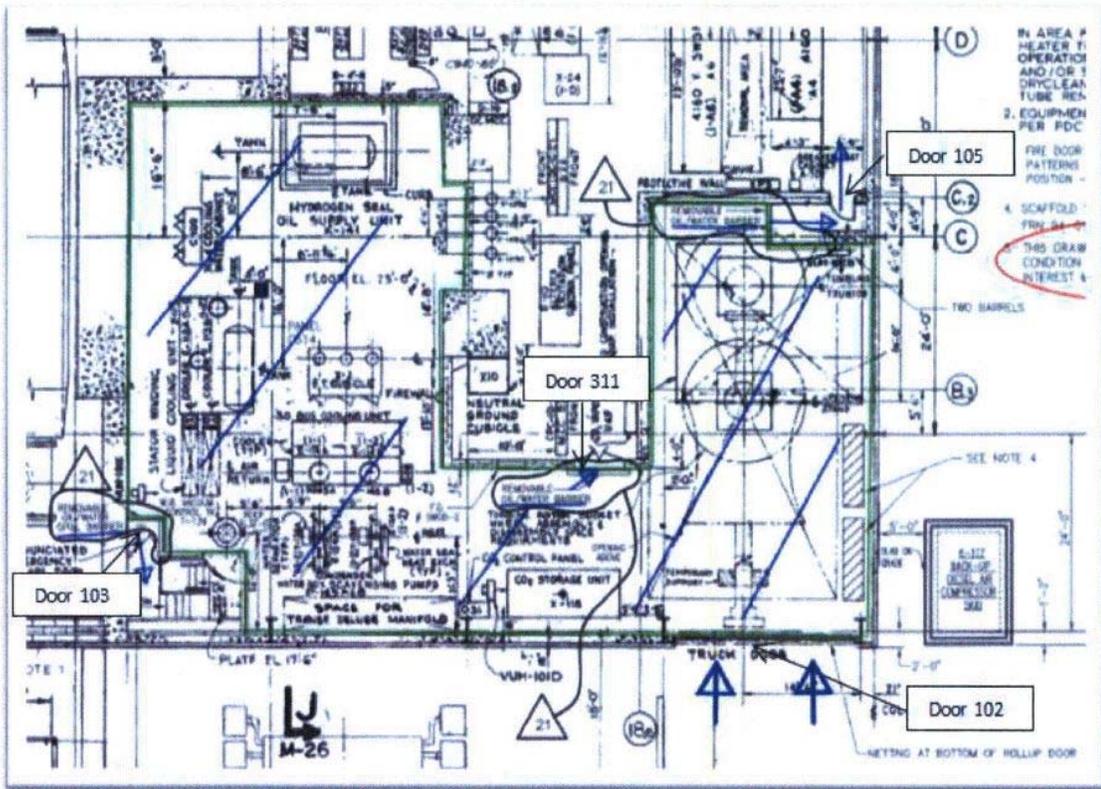
Notes:

1. Should water from the LIP seep through Door 102, potential flooding within Turbine Building areas is shown by the blue highlighting. It is anticipated that flood water would be contained within the walls and doors outlined in green highlighting.

Figure 2. This drawing looks downward at the southwest corner of the turbine building at Pilgrim. It is Figure 5-2 from Pilgrim's flood hazard re-evaluation report. It shows the location of external door 102 as well as internal doors 103, 105, and 311 that are credited in protecting important components from being submerged.

2. Suppose the licensee wanted to permanently remove Door 311 (see Figure 2 for its location) from its hinges in the turbine building because it was impeding personnel movements within the turbine building. Again, because the only flooding hazard under the former current licensing basis came from extreme storm surges that did not exceed the entrance elevation (23 feet MSL) of the

turbine building, removing Door 311 would not undermine flooding protection measures. But if the current licensing basis included heavy rainfall events, this would either prevent Door 311's removal or condition it on providing some readily available alternative means of protecting important equipment from flooding damage.
