PLANT NAME: Oconee

ENCLOSURES:
Response to AEC/RO Report No. 50-269/74-4 concerning the problem with the control rod drive absolute position indication (API) system.....

DUKE POWER COMPANY
OCONEE UNIT 1
RESPONSE TO AEC/RO REPORT NO. 50-269/74-4

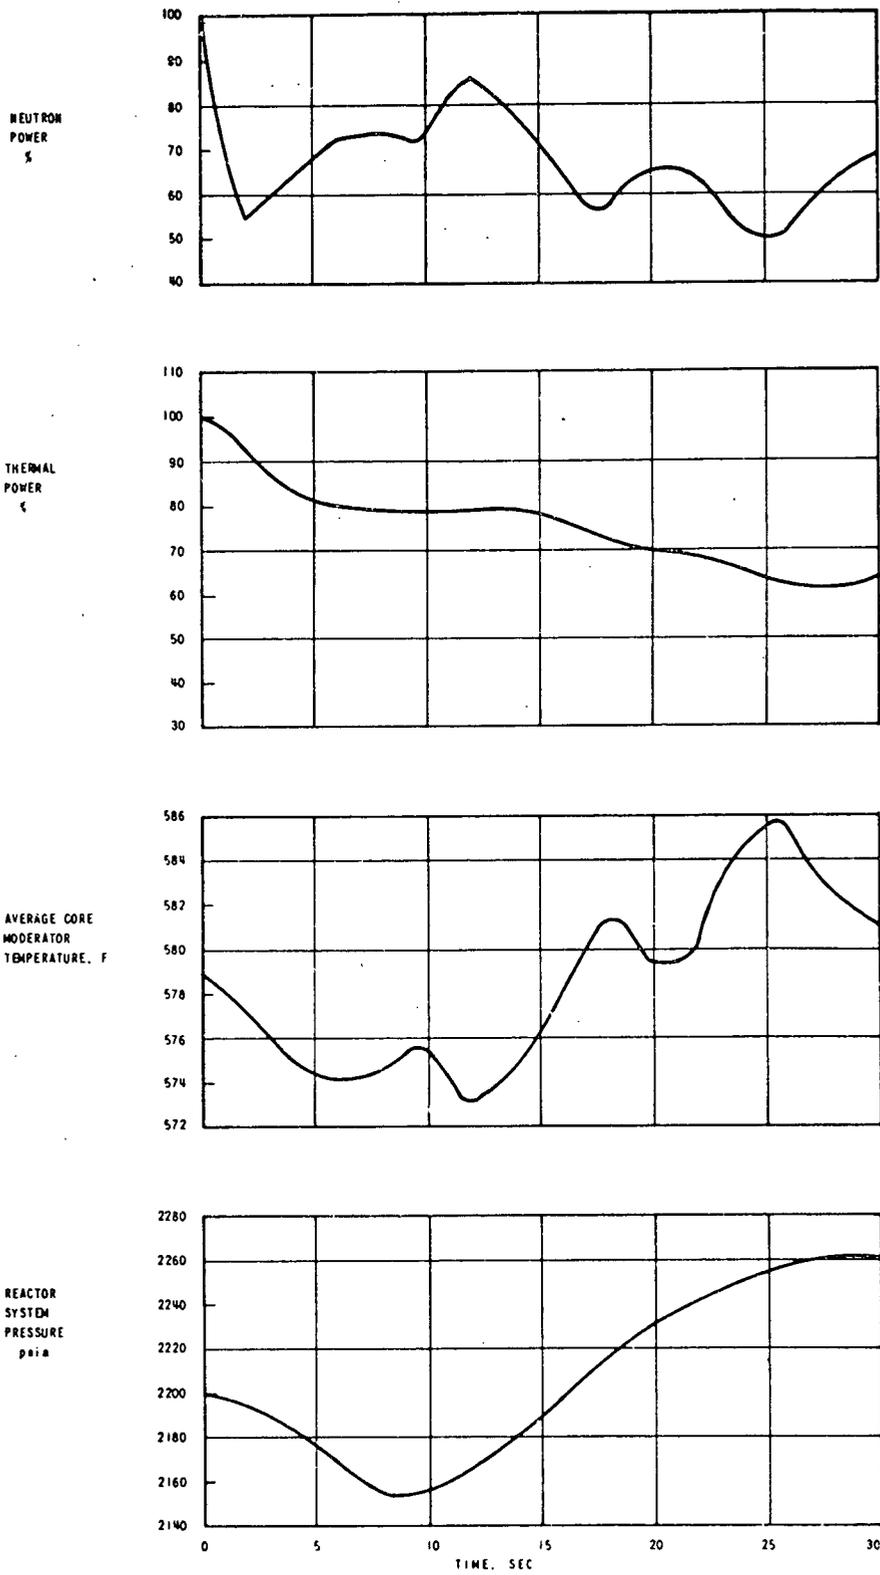
0.46% ΔK/K ROD DROP FROM RATED POWER
WITH AUTOMATIC RUMBACK TO 60% DEMAND
IN 12 SECONDS

The results of the analysis with ICS action are presented in Figures 14-18 and 14-19. Figure 14-18 shows the response to a 0.46% $\Delta k/k$ dropped rod. The neutron power decreases rapidly to about 55 percent of rated power. This causes rapid decreases in the core moderator temperature and fuel temperature. These temperature decreases over-compensate for the worth of the control rod, and the power rises until the reduced steam generator demand begins to increase the inlet temperature and decreases the power. The thermal power levels out briefly at about 78 percent of its initial value but soon begins to decrease in response to the decreased steam generator demand. The pressurizer pressure swing is about ± 60 psi before returning to equilibrium.

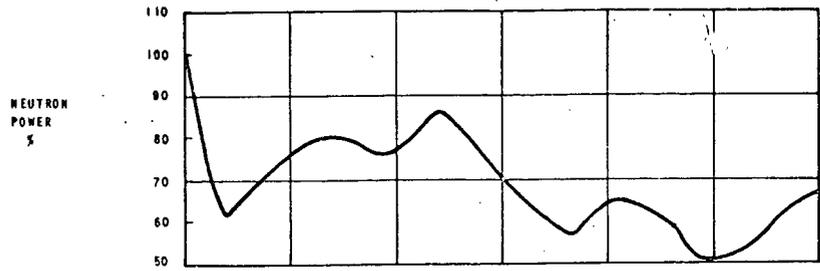
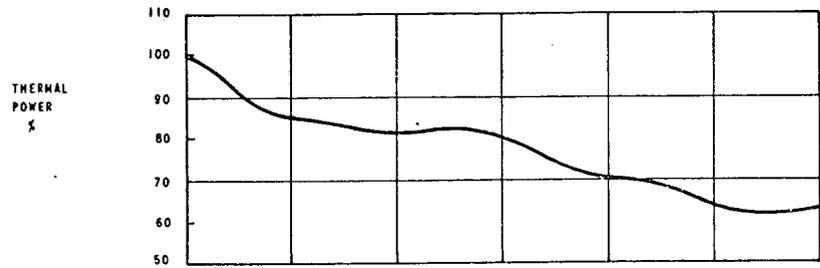
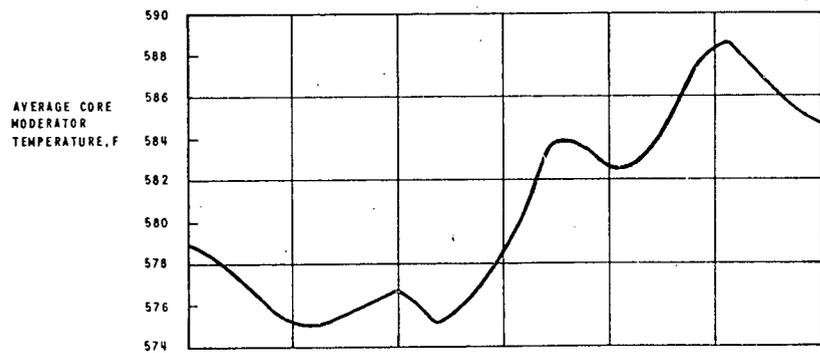
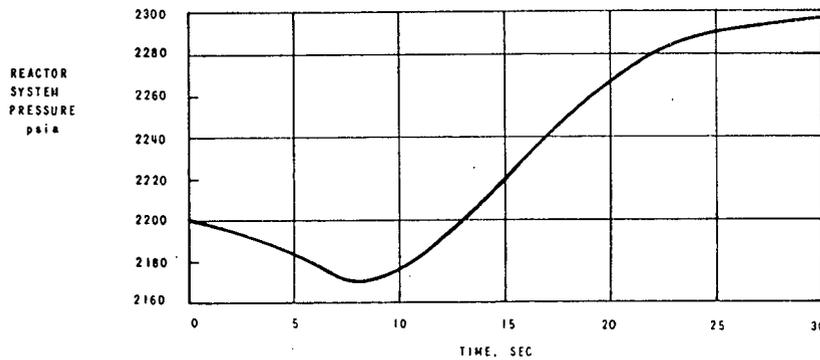
0.364 ΔK/K ROD DROP FROM RATED
POWER WITH AUTOMATIC RUNBACK TO
60% DEMAND IN 12 SECONDS

Figure 14-19 shows the results of the 0.36% $\Delta k/k$ rod drop. The initial neutron power decrease is slightly less in this case, resulting in the thermal power leveling off at 83 percent, a slightly higher value than in the 0.46% $\Delta k/k$ case. The pressurizer pressure peaks at a higher value due to this higher thermal power.

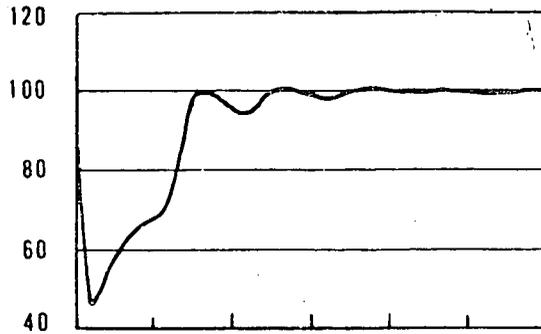
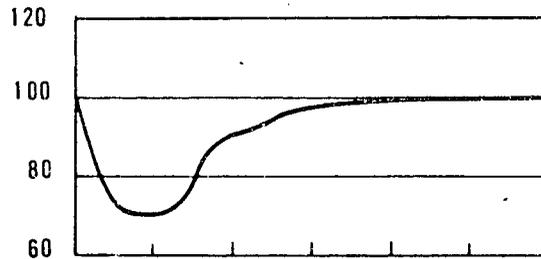
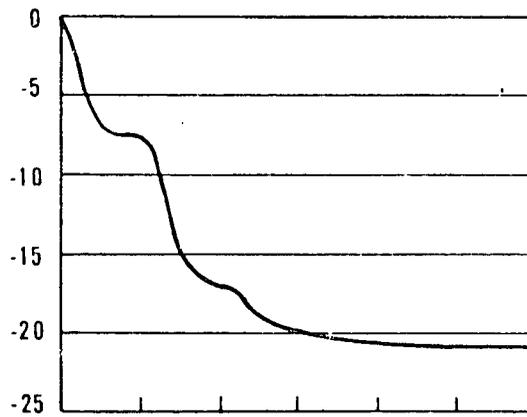
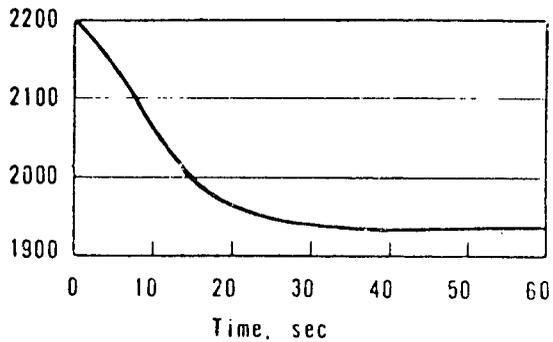
Neutron
Power, %

Thermal
Power, %

Average Core
Moderator
Temperature
Change, F

Reactor
System
Pressure,
psia

0.65% Ak/k ROD DROP FROM
RATED POWER AT EOL
CONDITIONS (2772 MWT)

Figure 14-19a shows the results of a 0.65% $\Delta k/k$ dropped rod analysis conservatively based on no ICS action and operation at higher than rated power level of 2772 mwt. The neutron power decreases causing a rapid decrease in both the core moderator temperature and the fuel temperature. These temperature decreases overcompensate for the worth of the control rod, and the neutron power rises slightly above the initial neutron power level. The neutron power then decreases to below the initial power level and eventually levels out at the initial power level. The thermal power response is similar to the neutron power; however, the thermal power level never exceeds the initial power value. Both the core moderator temperature and pressurizer pressure decrease during the transient and level out at a value lower than the initial value.

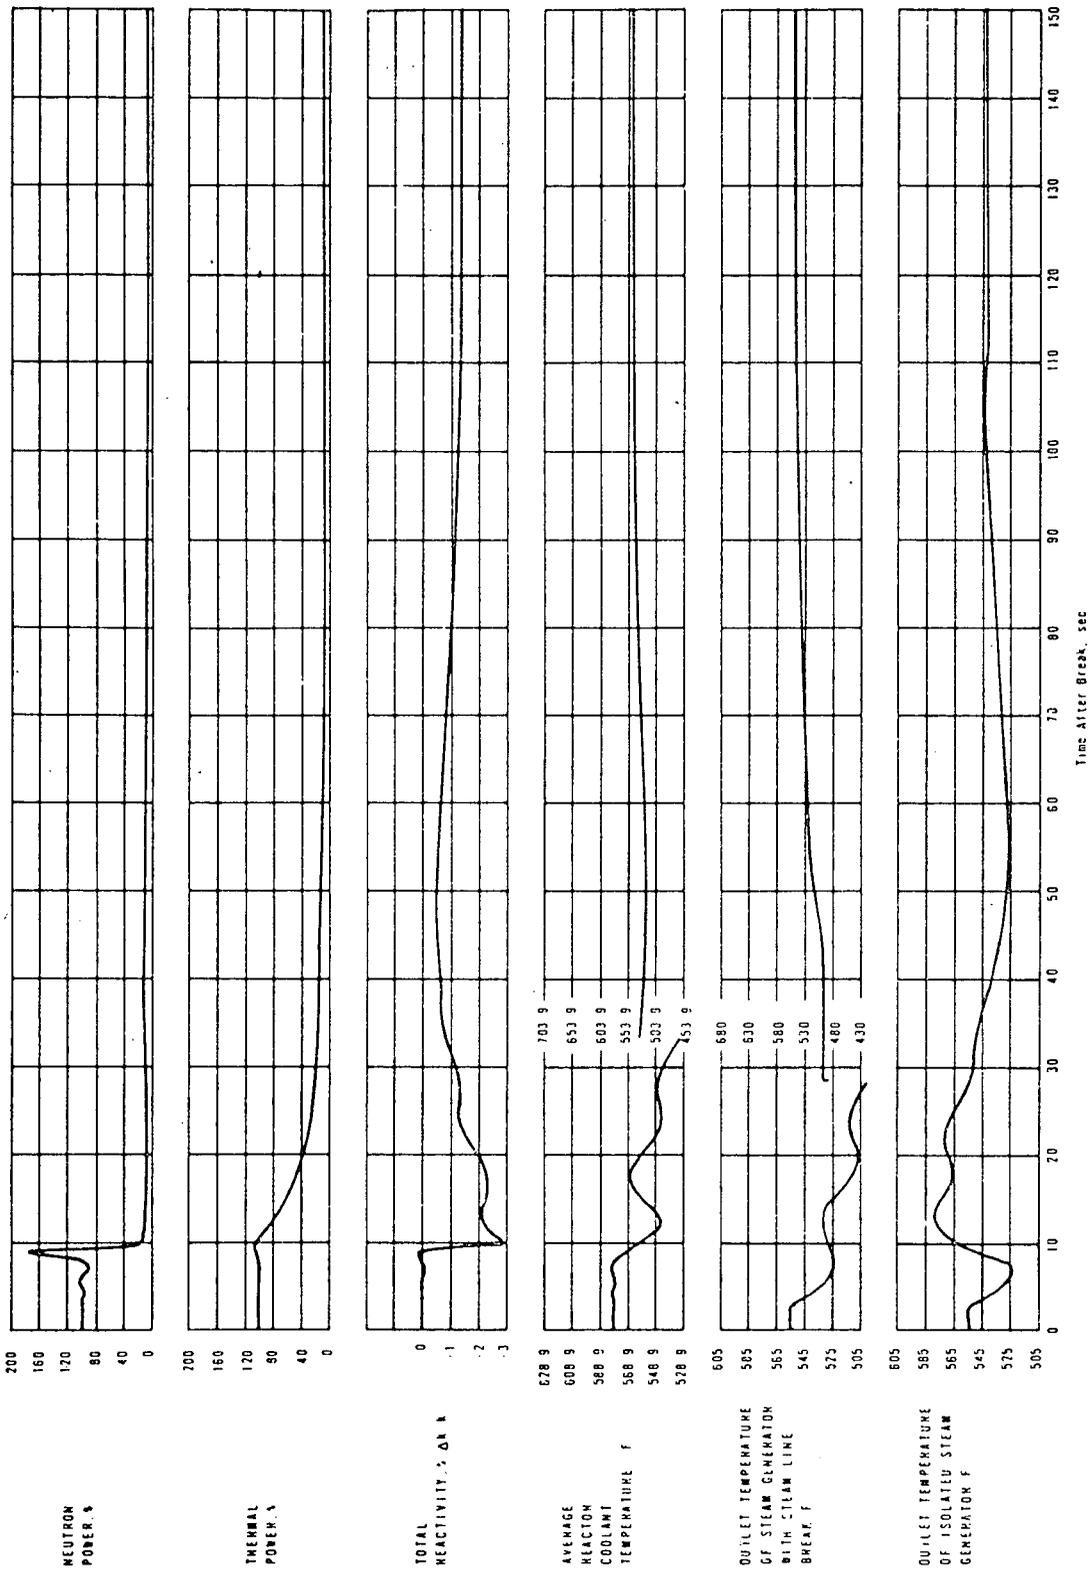
DOUBLE ENDED RUPTURE OF 34 IN STEAM LINE
 BETWEEN STEAM GENERATOR AND STEAM STOP VALVE
 (WITH FEEDWATER ISOLATION)
